**Star
Home
Inspection Services**

Home Inspection Report

7809 Booth St Prairie Village, KS 66208

Inspection Date: 10/09/2009

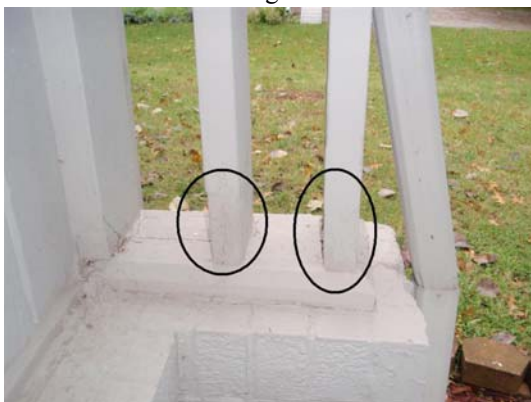
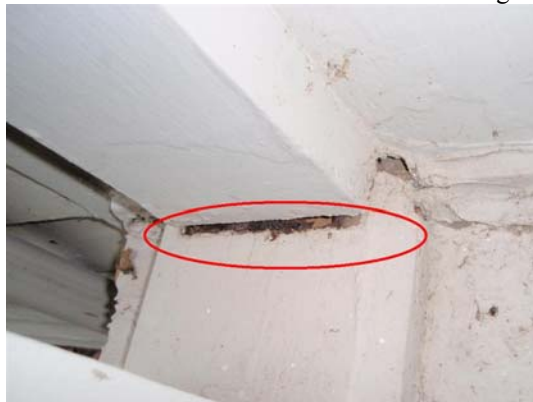
- **Monitor:** The masonry exterior wall shows evidence of spalling (surface deterioration of the masonry). Repair is not necessary at this time but this condition should be monitored.
- **Repair:** The exterior of the house needs to be painted.
- **Repair:** Localized rot was observed in the siding. Following repair of the damaged areas (which should be combined with exterior painting/maintenance) proper maintenance of the siding and control of water from roof or surface runoff can avoid further damage.
- **Repair:** Localized rot was observed in the trim/2x4's around the siding (i.e. front exterior soffit overhang supports). Following repair of the damaged areas (which should be combined with exterior painting/maintenance) proper maintenance of the siding and control of water from roof or surface runoff can avoid further damage.

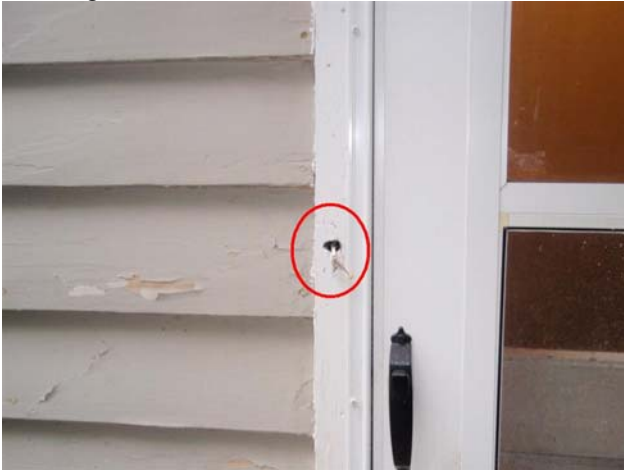
- **Repair:** Any openings in the exterior siding should be sealed. An example is at the laundry room exterior door trim. Caulking is needed.

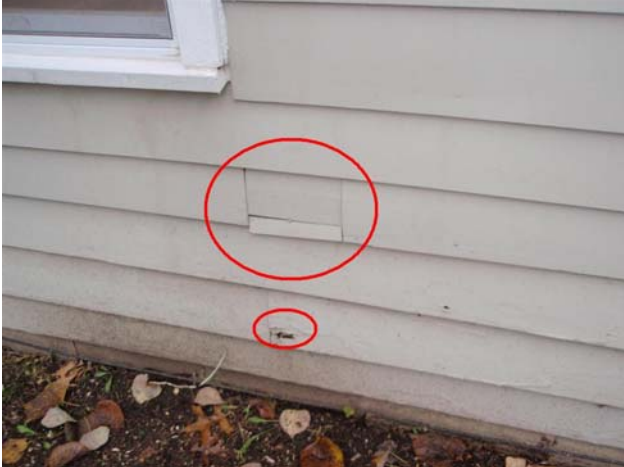
- **Repair:** Localized damage of the exterior walls should be repaired. There is extra risk of hidden damage in such areas.

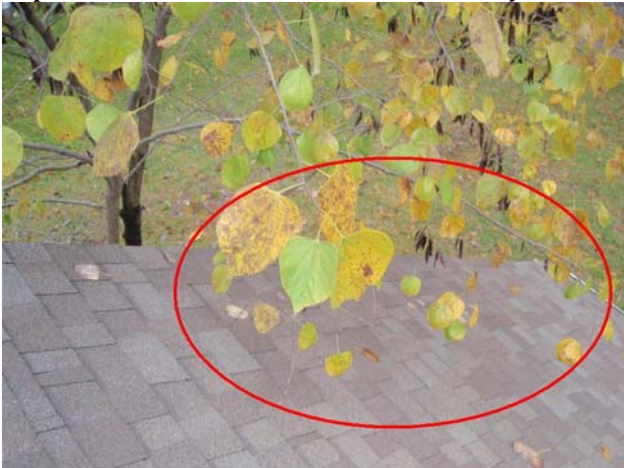
- **Monitor, Repair:** Localized rot/delaminating was observed in the front soffit. Improvement is not necessary at present, although this condition should be repaired when exterior painting or maintenance are planned.
- **Repair:** Tree branches should be trimmed away from the house to avoid damage to the building.

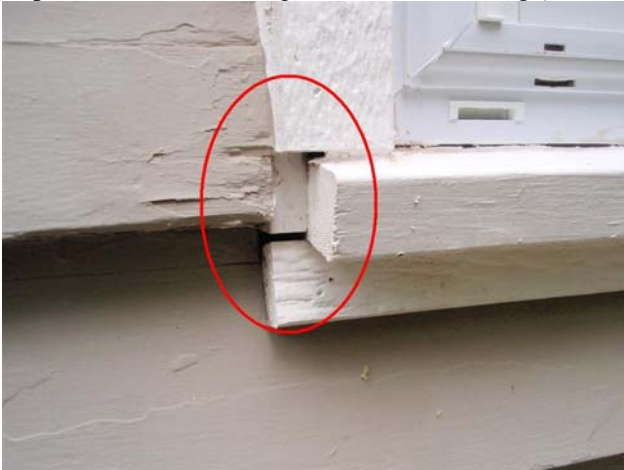
- **Repair:** The windows require localized caulking (i.e. kitchen window).

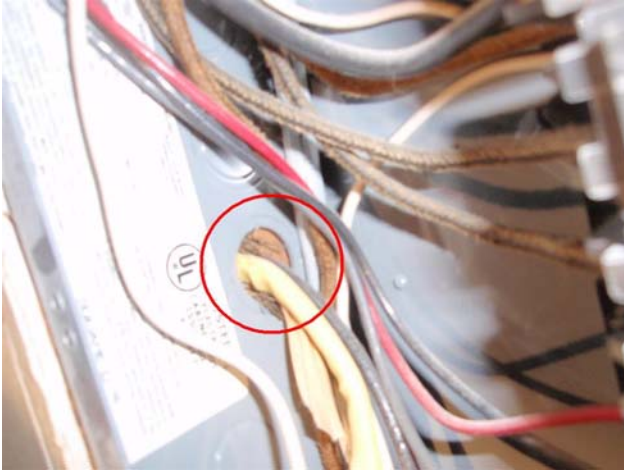
- **Repair:** Oversized breaker within the main distribution panel for the air condition should be replaced. The data plate on the unit specifies a maximum breaker size of 25 Amps and the one in the panel is 30 Amps.
- **Repair:** Cable clamps (sometimes referred to as bushings or grommets) are required where wiring passes into the main distribution panel. Cable clamps serve to protect the wiring from the metal edges of the panel openings.

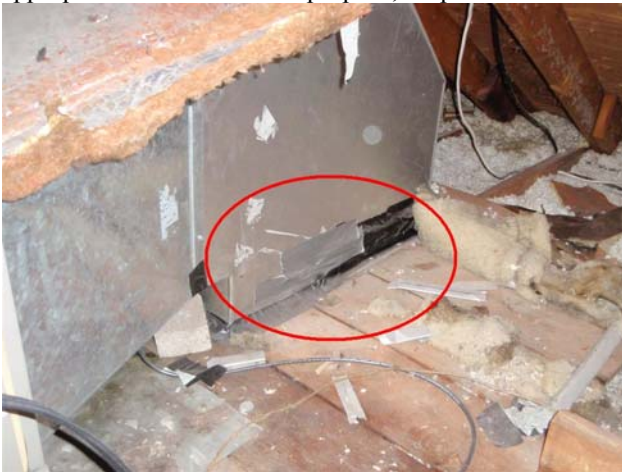
- **Improve:** Duct tape was observed on the return air ductwork near the furnace filter in the attic. This is not the appropriate material for this purpose, despite its name.

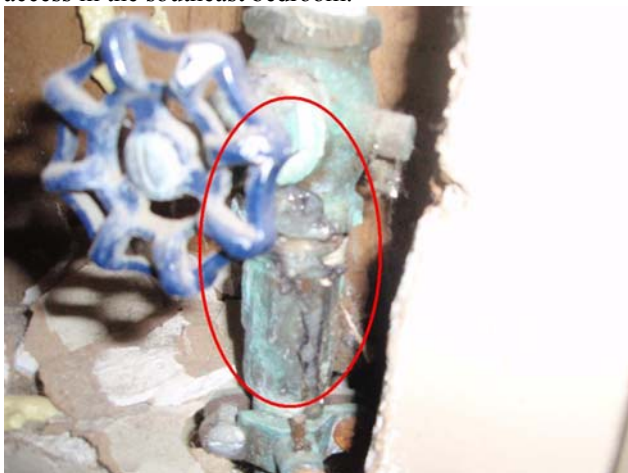
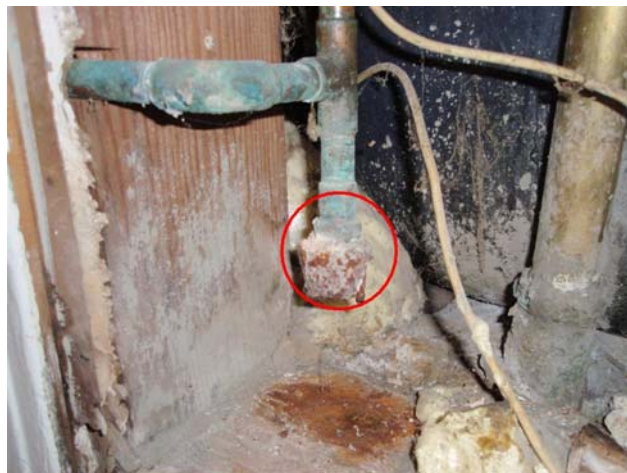
- **Monitor:** The old steel piping is subject to corrosion on the interior of the pipe. As corrosion builds up, the inside diameter of the pipe becomes constricted, resulting in a loss of water pressure. This piping is typically replaced when the loss of pressure can no longer be tolerated.
- **Repair:** The supply piping is leaking near the main shutoff handle and at the supply piping to the bathtub behind the access in the southeast bedroom.
