**Star  
Home  
Inspection Services**

*Home Inspection Report*

**7864 W 155<sup>th</sup> PI Overland Park, KS 66223**

**Inspection Date: 5/27/2008**

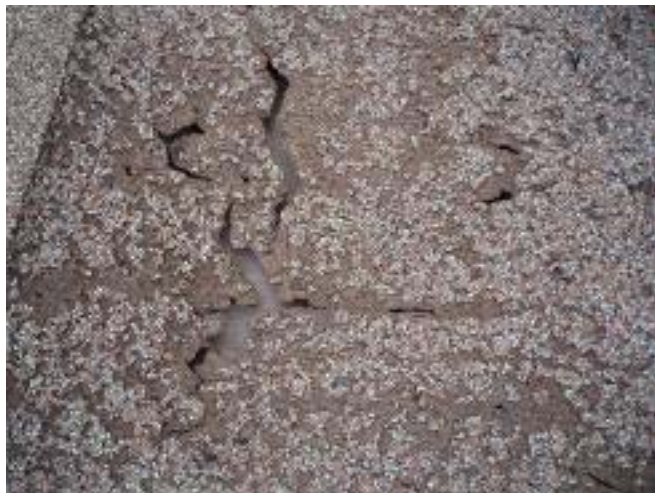
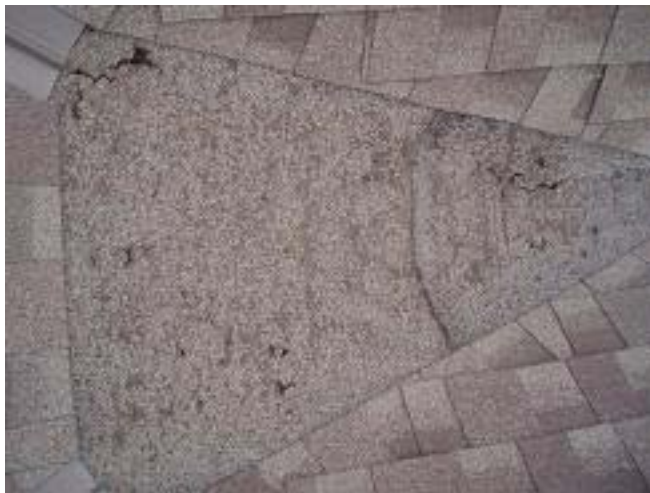
#### Sloped Roofing

- **Repair:** Minor repairs to the roofing are needed. Damaged or missing roofing material should be repaired. All roof penetrations should be examined and sealed as necessary.

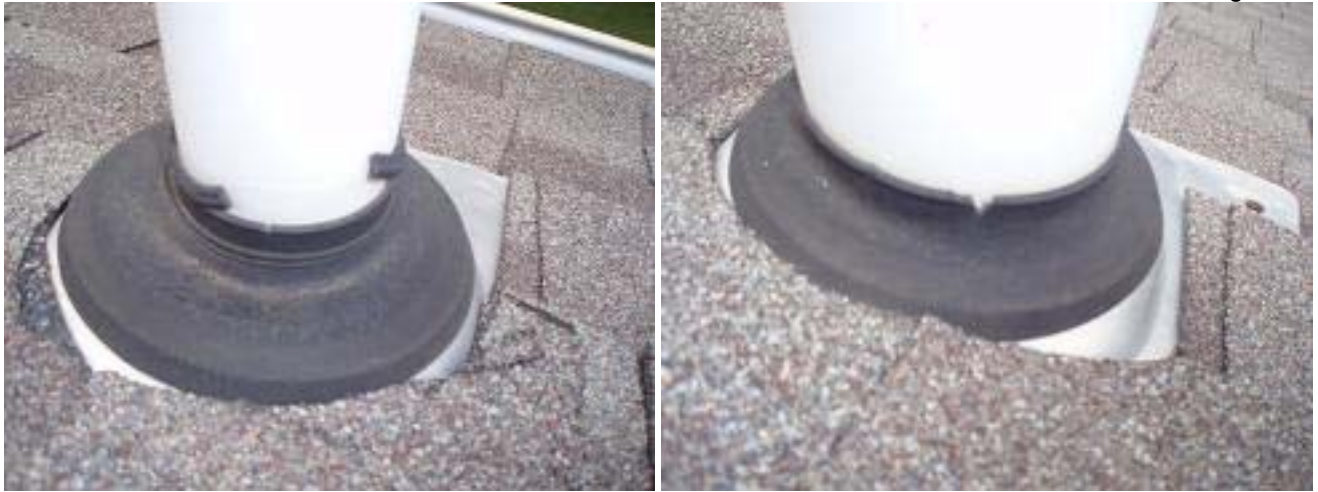
#### Flashings

- **Monitor:** The rubber boot flashing is vulnerable and should be carefully monitored for leaks.

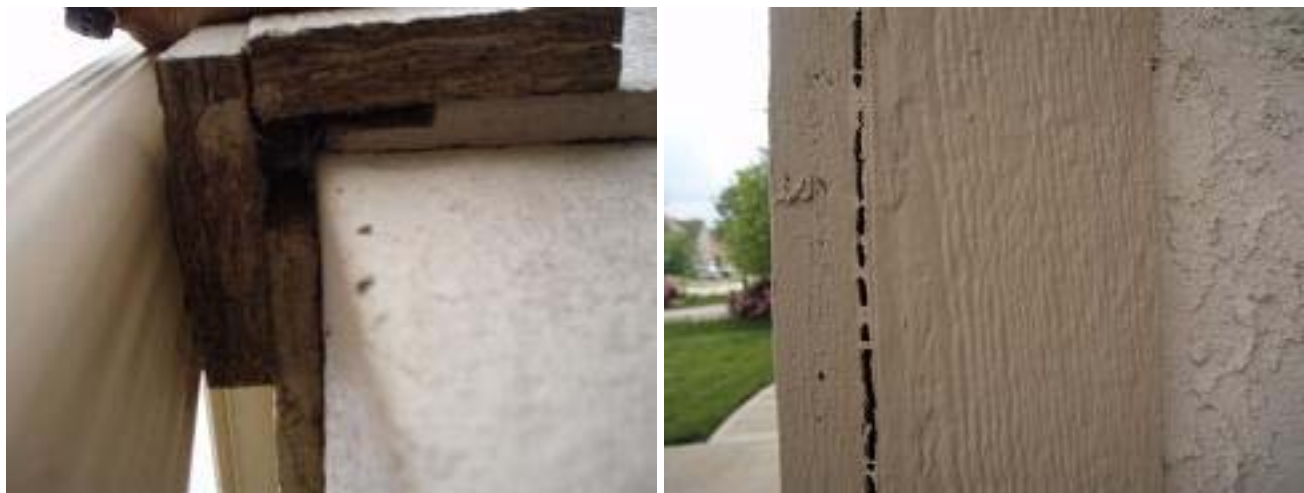
#### Exterior Walls

- **Repair:** The paint on trim around siding is sparse along the undersides. General caulking is needed as areas are separating and showing age. These areas should be caulked and painted to prevent water damage and rot.

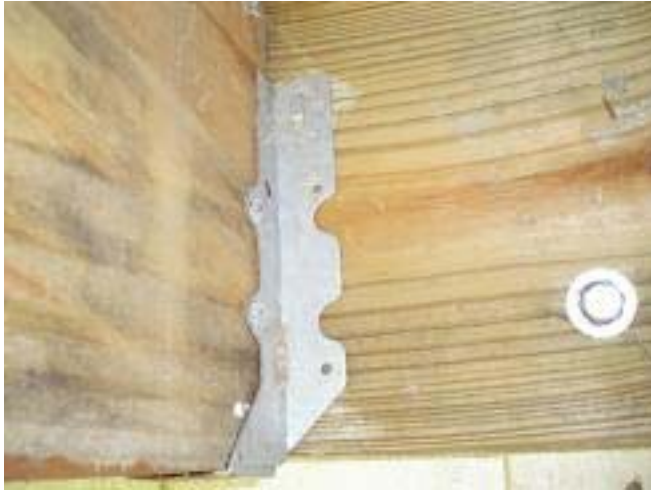
#### **Deck**

- **Repair:** The construction of the deck could be improved by fully nailing the joist hangers.

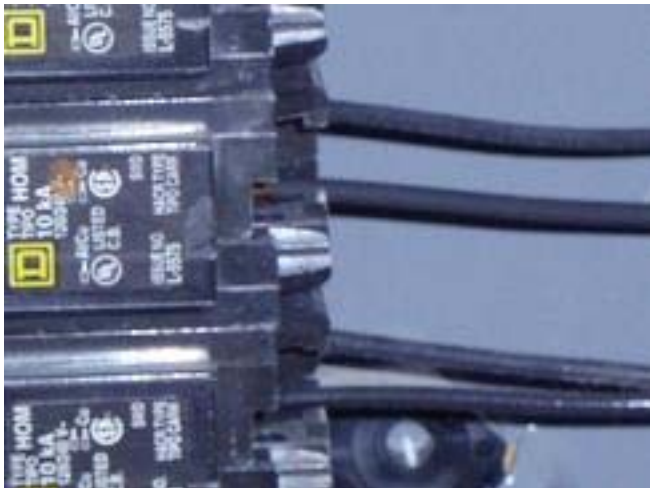
#### Main Panel

- **Repair:** Circuits within the main distribution panel that are doubled up (referred to as “double taps”) should be separated. Each circuit should be served by a separate fuse or breaker.
