**Star
Home
Inspection Services**

Home Inspection Report

8139 Barkley St, Overland Park, KS 66204

Inspection Date: 10/02/2009

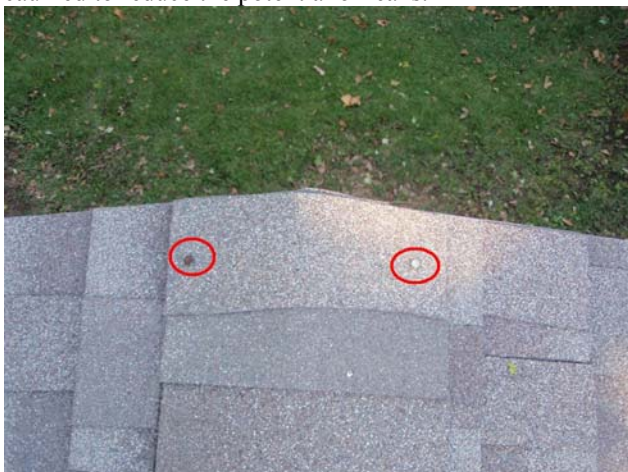
Sloped Roofing

- **Repair:** Exposed nail heads were observed in the roofing shingles and/or ridge caps. All exposed nail heads should be caulked to reduce the potential of leaks.

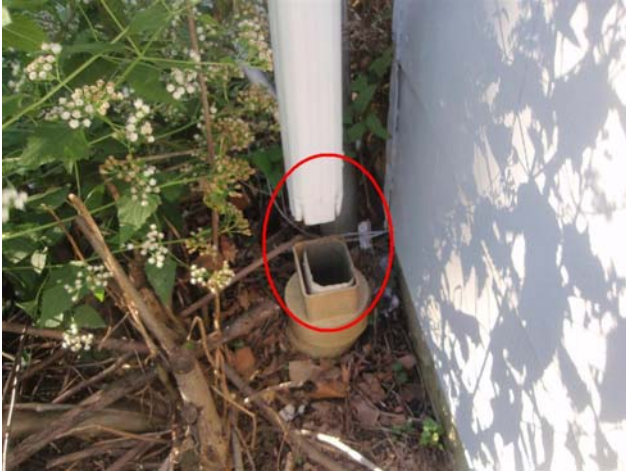
Gutters & Downspouts

- **Repair:** The gutters require cleaning to avoid spilling roof runoff around the building – a potential source of water entry or water damage.
- **Repair:** Loose downspout(s) should be repaired.
- **Repair:** The downspout is not inside the underground piping. This should be repaired so the water flows away from the foundation.

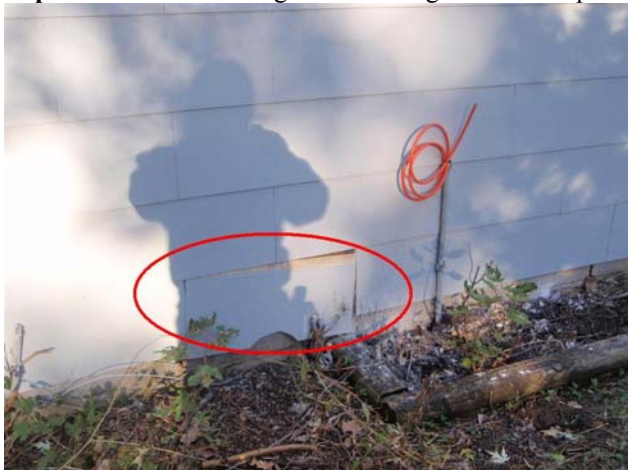
Exterior Walls

- **Repair:** Localized damage of the siding should be repaired. There is extra risk of hidden damage in such areas.

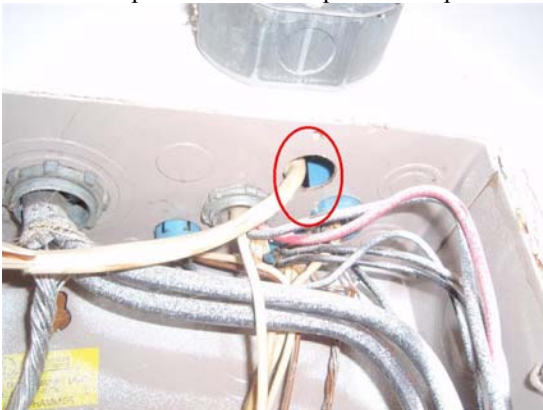
Main Panel

- **Repair:** Cable clamps (sometimes referred to as bushings or grommets) are required where wiring passes into the main distribution panel. Cable clamps serve to protect the wiring from the metal edges of the panel openings.

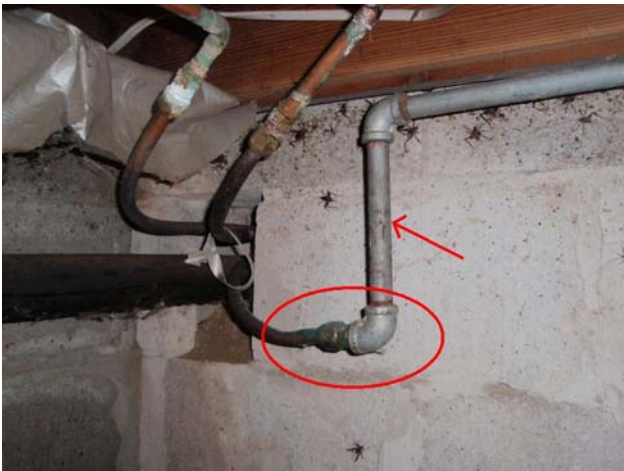
Gas Piping

- **Monitor, Repair:** Copper tubing is no longer suitable for gas piping by most gas utility companies. This should be confirmed or verified with the local gas company and if confirmed it's recommended this pipe be replaced with one of suitable material.
- **Monitor, Repair:** Galvanized steel pipe is no longer suitable for gas piping by most gas utility companies. This should be confirmed or verified with the local gas company and if confirmed it's recommended this pipe be replaced with one of suitable material.

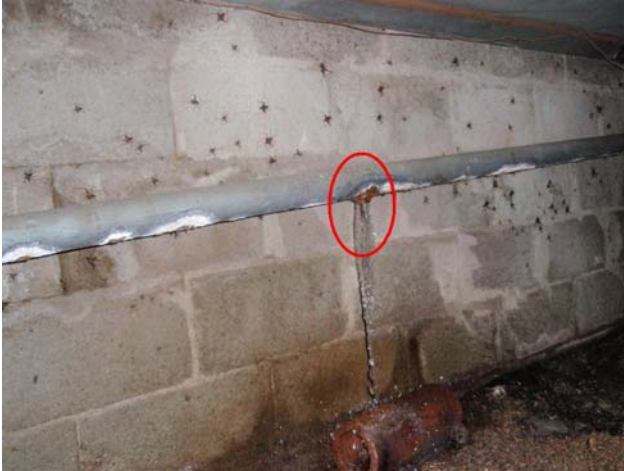
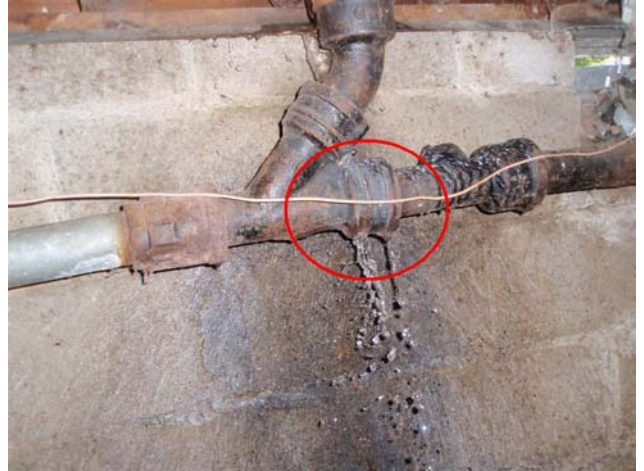
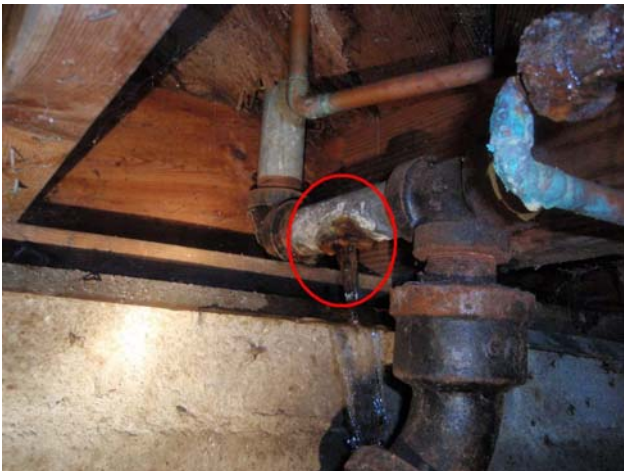
Waste / Vent

- **Repair:** The waste drain pipe in the crawl space is leaking.
