**Star
Home
Inspection Services**

Home Inspection Report

8218 Woodward St Overland Park, KS 66204

Inspection Date: 10/30/2009

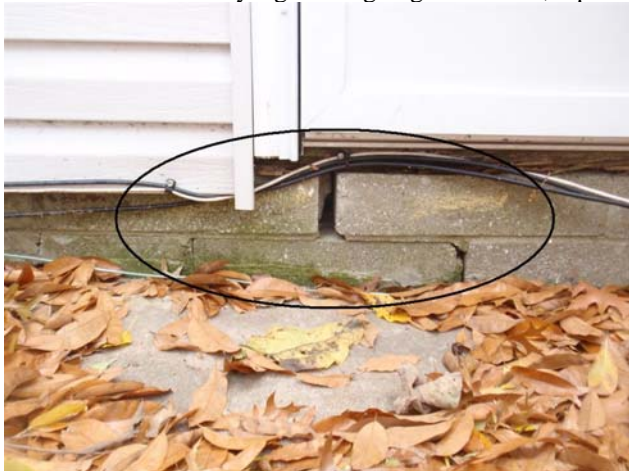
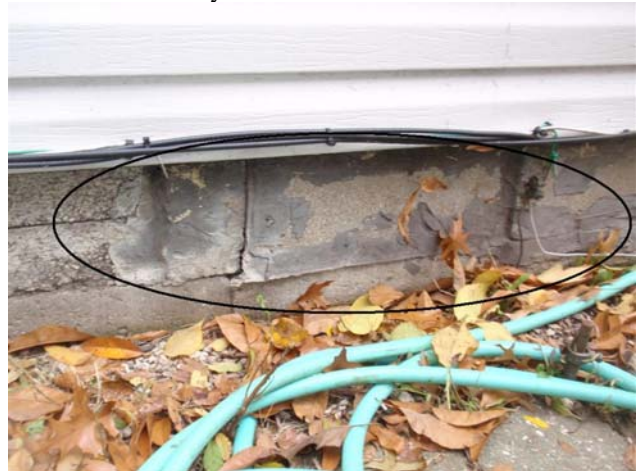
- **Monitor:** Common minor settlement cracks were observed in the foundation walls. This implies that some structural movement of the building has occurred. Cracks of this type should be watched for any sign of additional movement. In the absence of any sign of ongoing movement, repair should not be necessary.

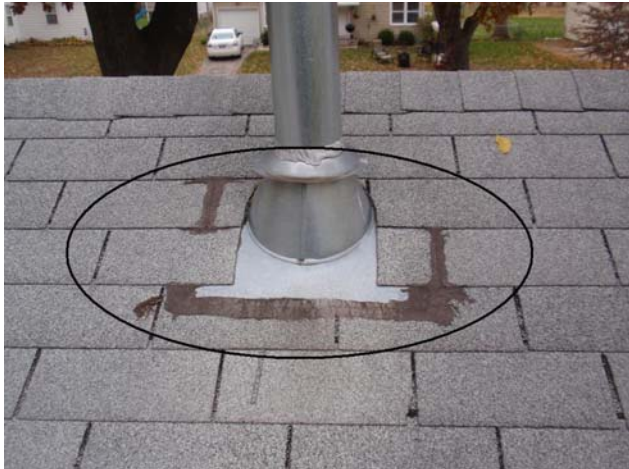
- **Monitor:** The furnace flue flashing has been caulked and may be vulnerable and should be carefully monitored for leaks.

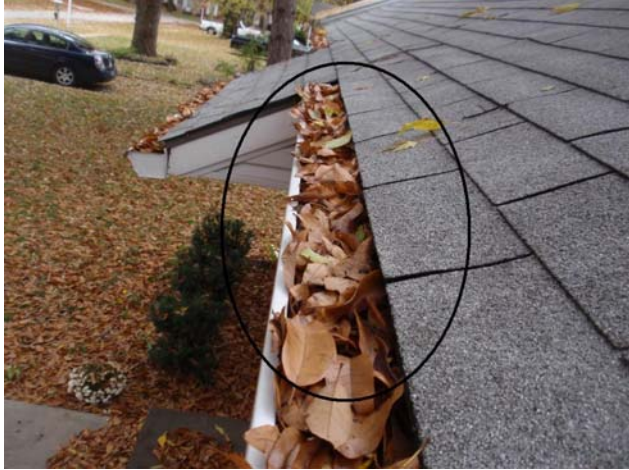
- **Repair:** The gutters require cleaning to avoid spilling roof runoff around the building – a potential source of water entry or water damage.

Covering the gutters with a protective mesh may help to avoid congestion with leaves and debris.

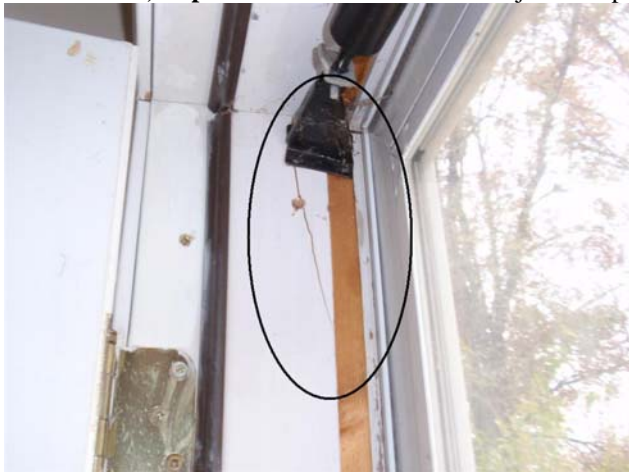
- **Monitor, Repair:** The north exterior door jamb is split and needs repair. Painting is also need on the trim.

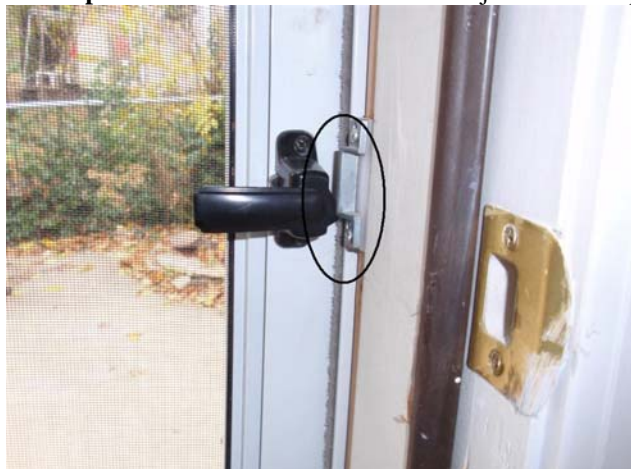
- **Repair:** The north storm door needs adjustment or repair to latch properly.

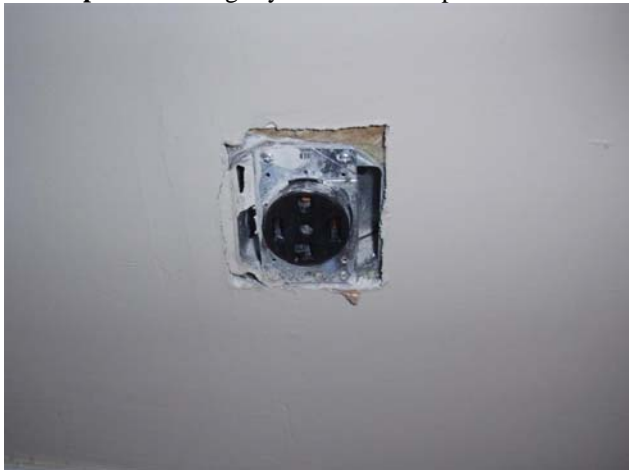
- **Note:** Not all outlets in the kitchen need to be GFCI outlets. Only the lead outlet is necessary.
- **Repair:** Missing dryer outlet cover plate should be replaced.

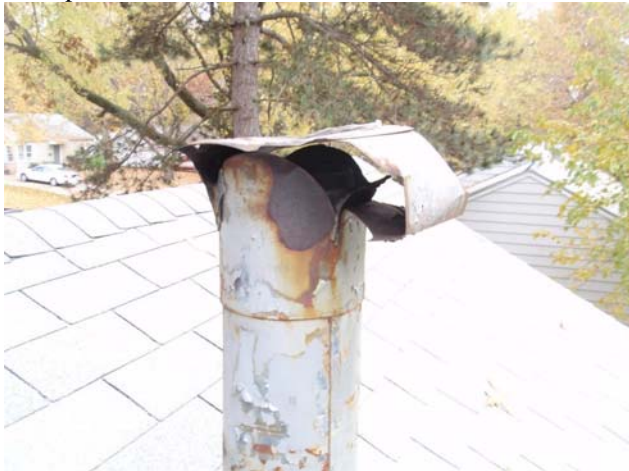
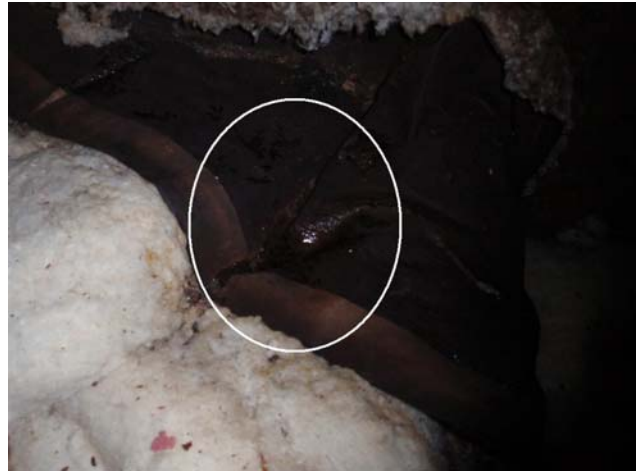
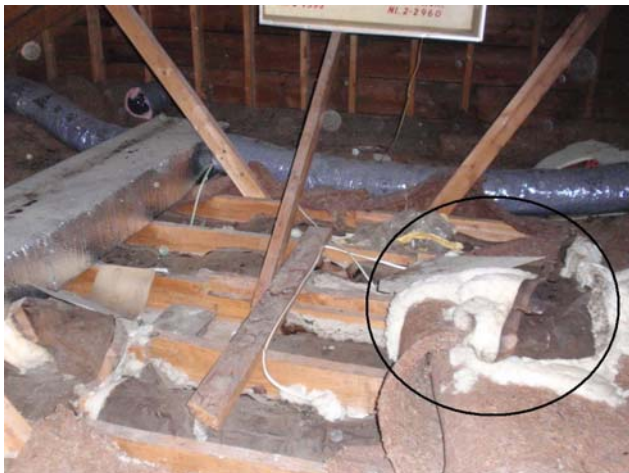
- **Repair:** The old furnace flue should be removed or capped. It is leaking to the attic where the insulation has been rolled up under it.

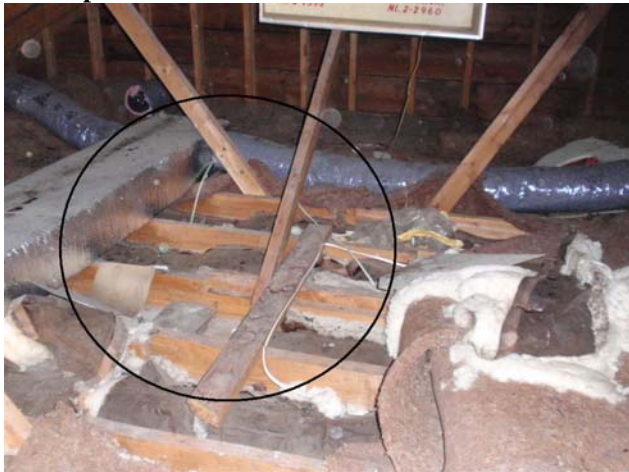
- **Repair:** Insulation should be evened out.

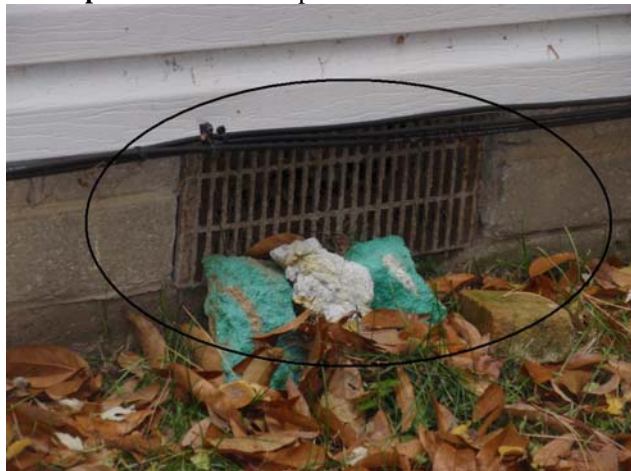
- **Repair:** Some crawl space vent screens are loose and need repair.

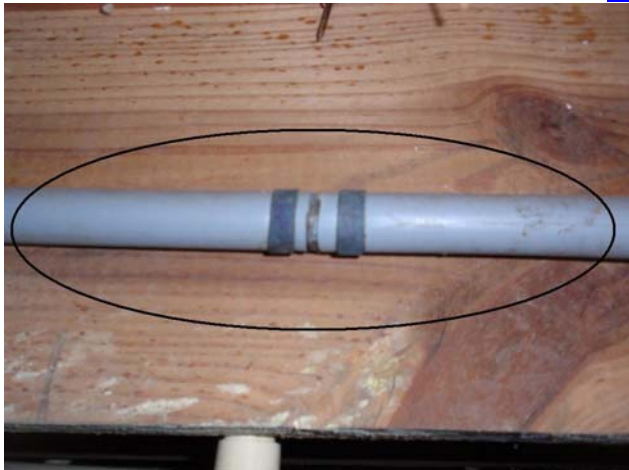
- **Note:** Polybutylene plumbing was noted as the main pipe to the water shut off. While scientific evidence is scarce it is believed that oxidants in the public water supplies, such as chlorine, react with the polybutylene piping and acetal fittings causing them to scale and flake and become brittle. Micro-fractures result, and the basic structural integrity of the system is reduced. Thus, the system becomes weak and may fail without warning causing damage to the building structure and personal property. It is believed that other factors may also contribute to the failure of polybutylene systems, such as improper installation, but it is virtually impossible to detect installation problems throughout an entire system. Throughout the 1980's lawsuits were filed complaining of allegedly defective manufacturing and defective installation causing hundreds of millions of dollars in damages. Although the manufacturers have never admitted that poly is defective, they have agreed to fund the Class Action settlement with an initial and minimum amount of \$950 million. More detailed information can be found at <http://www.polybutylene.com/poly.html>.

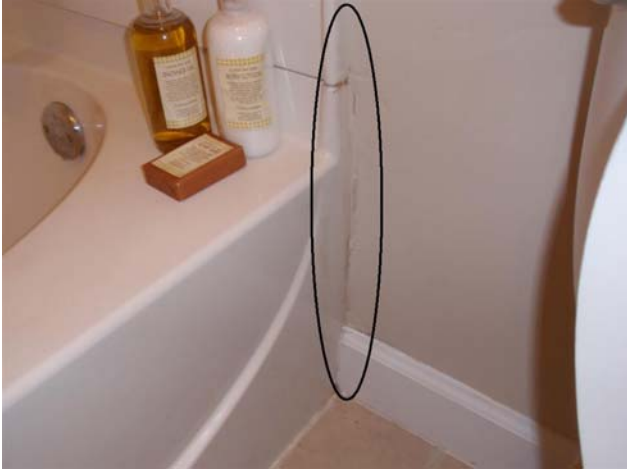
- **Monitor:** Evidence of minor water damage to the wall adjacent to the bathtub was observed.

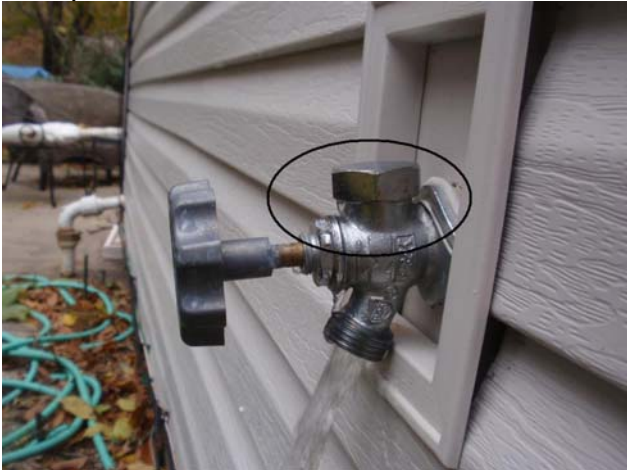
- **Repair:** The rear hose bib leaks from the anti-siphon cap when the water is running. The anti-siphon valve needs to be replaced.

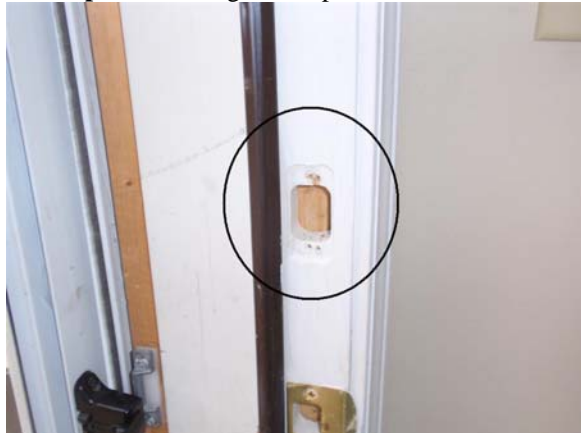
- **Repair:** Doors to the north bedroom and bathroom should be trimmed or adjusted as necessary to work properly.
- **Repair:** The bathroom door should be adjusted as necessary to latch properly.
- **Repair:** Missing striker plate on north exterior door should be installed
