Star Home Inspection Services

Home Inspection Report

8405 Richards Rd, Lenexa, KS 66215

Inspection Date: 3/24/2009

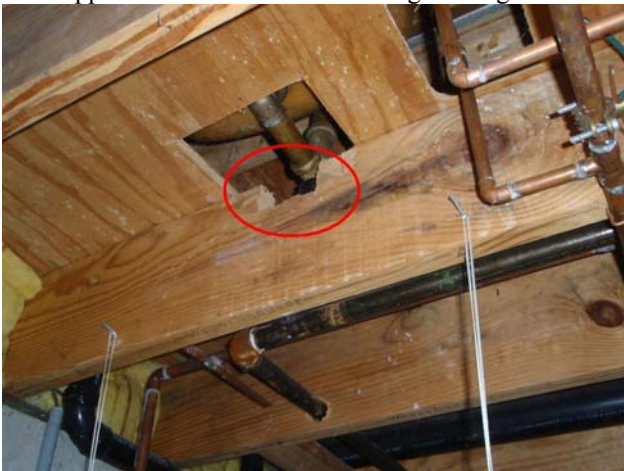
- **Monitor:** Floor joists at northwest corner of unfinished basement is notched and or cut. This weakens the joist and risks structural damage; if any further movement is or cracking is observed repairs or additional support will be needed. This work appears to have been done during the original construction.

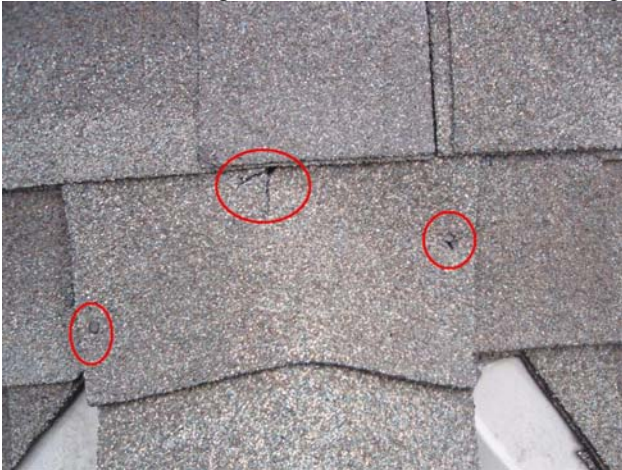
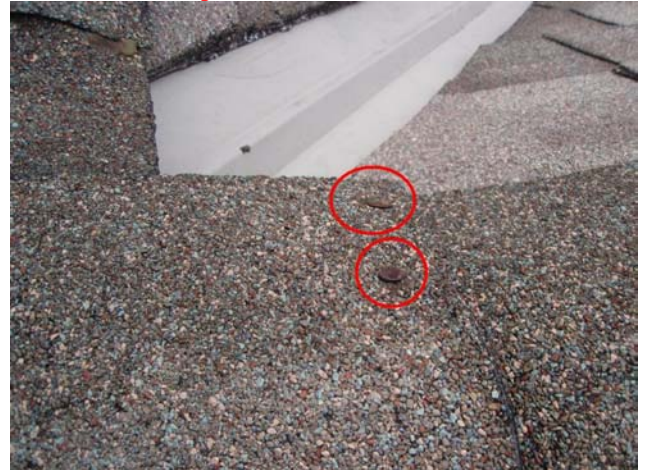
- **Repair:** Exposed nail heads were observed in the roofing shingles and/or ridge caps. All exposed nail heads and any minor cracks at shingles should be caulked to reduce the potential of leaks. **Repaired**

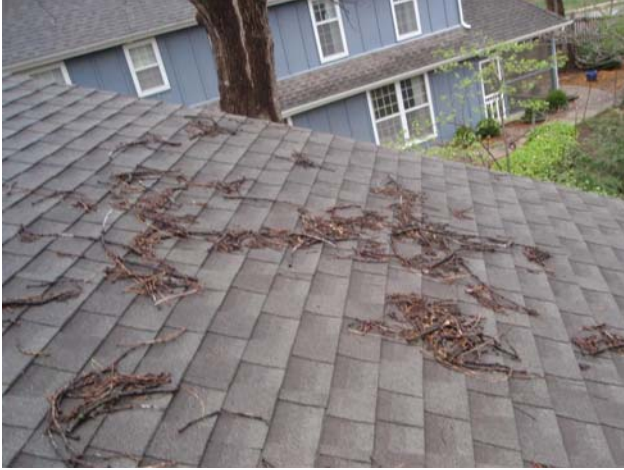
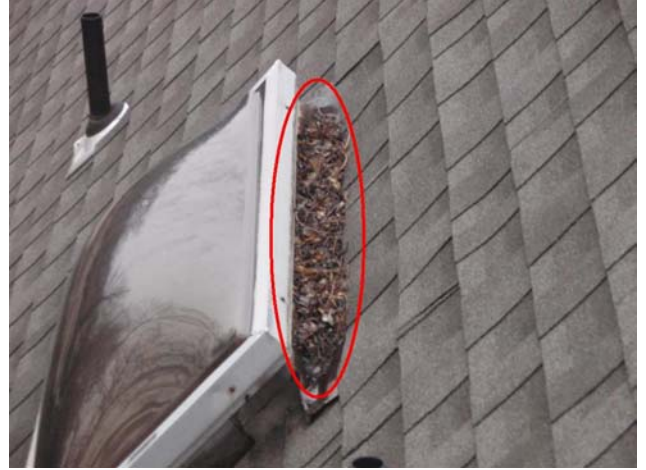
- **Improve:** Debris should be removed from the roofing to reduce risk of leaks and early roof wear.

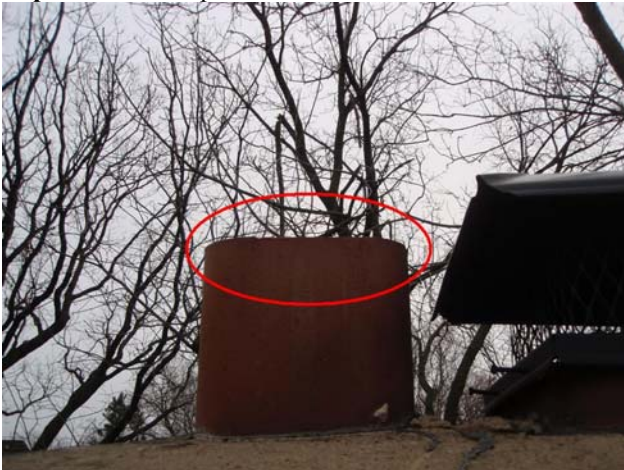
- **Repair:** A rain cap and vermin screen should be installed on the uncapped portion of the masonry chimney. **Repaired**

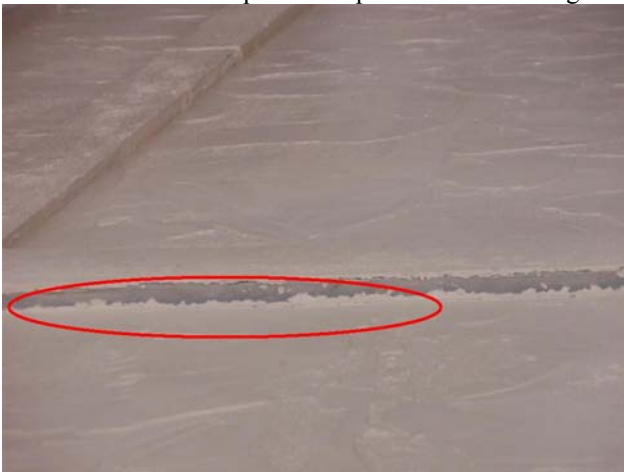
- **Repair:** The exterior siding paint is peeling and/or worn thin in localized areas. These areas should be painted to prevent water damage or rot in the future (example under front windows). **Repaired/Repainted**
- **Repair:** The paint on the horizontal trim around the siding is peeling at localized area on south side of house upper trim. These areas should be painted to prevent water damage and rot. **Repaired/Repainted**

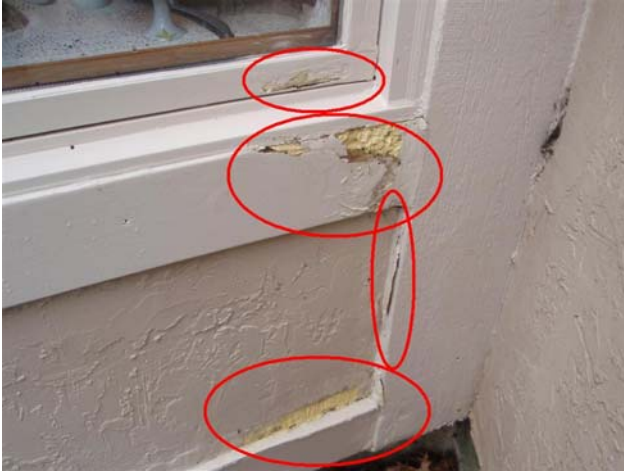
- **Repair:** Localized rot was observed in the trim around siding (example under front windows and minor damage at lower edge of some siding trim pieces). Following repair of the damaged areas (which should be combined with exterior painting/maintenance) proper maintenance of the siding and control of water from roof or surface runoff can avoid further damage. **Repaired/Repainted**
- **Repair:** Localized damage of the stucco exterior walls should be repaired (example under front windows). There is extra risk of hidden damage in such areas. **Repaired/Repainted**

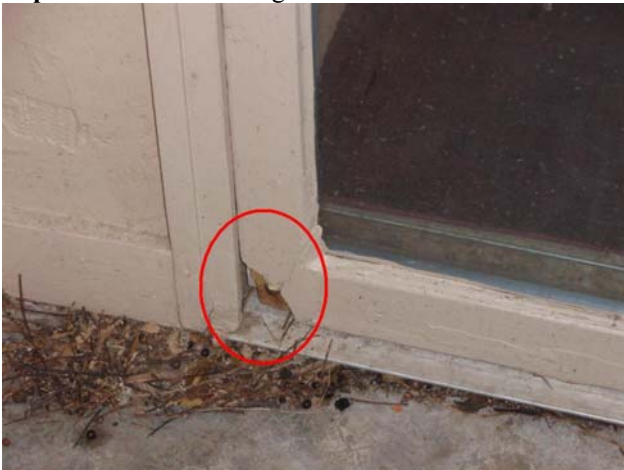
- **Repair:** Localized damage was observed on the back slider door frame. **Repaired/Repainted**

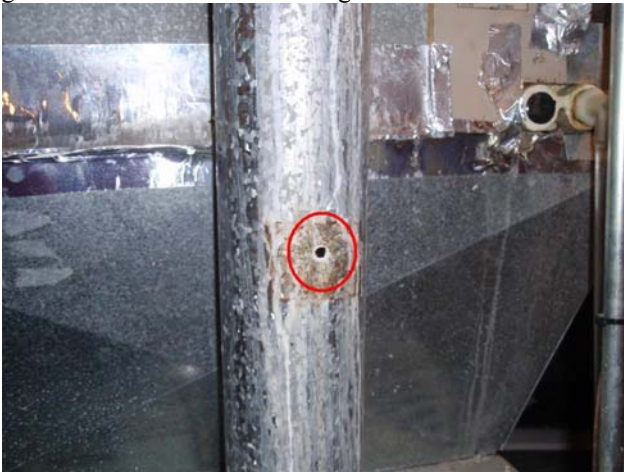
- **Repair, Safety Issue:** *Damaged exhaust flue at furnace should be improved immediately.* Poor exhausting risk flue gas and carbon monoxide leakage or other unsafe conditions. **Repaired**

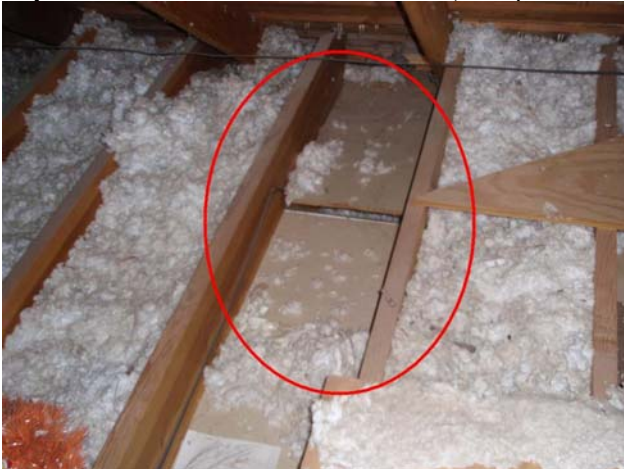
- **Repair:** Insulation should be evened out (example at south upstairs bedroom side attic).
