# Star Home Inspection Services

## *Home Inspection Report*

**8410 Lewis Dr, Lenexa, KS 66227**

**Report Number: 03302009-1A**

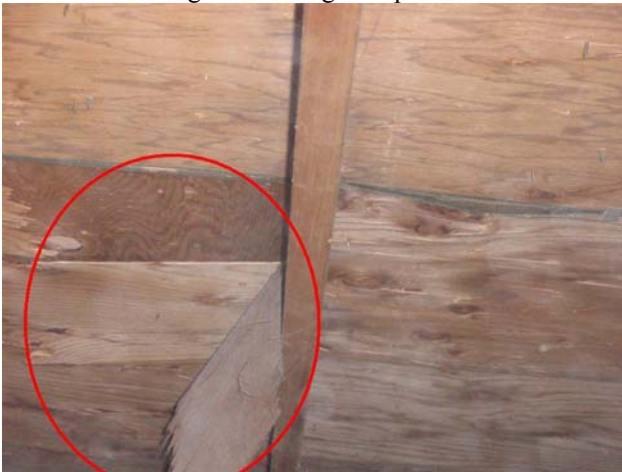
- **Monitor:** The roof sheathing is delaminating at a localized area at southwest side of attic (deterioration caused by moisture). In most cases, damaged roof sheathing must be replaced prior to re-roofing. Improved roof and attic ventilation (see Insulation and Ventilation) reduce moisture levels and cut future damage to the roof structure. Recommend amaged sheathing be replaced when re-roofing.

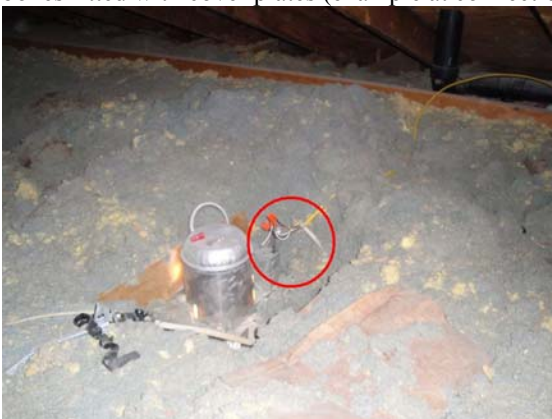
- **Repair:** Loose wiring should be secured (example in furnace room).
- **Repair:** Improper electrical connections should be repaired. All electrical connections should be made inside junction boxes fitted with cover plates (example at connection in attic).
