**Star
Home
Inspection Services**

Home Inspection Report

8413 Belleview St, Kansas City, MO 64114

Report Number: 09182009-1A

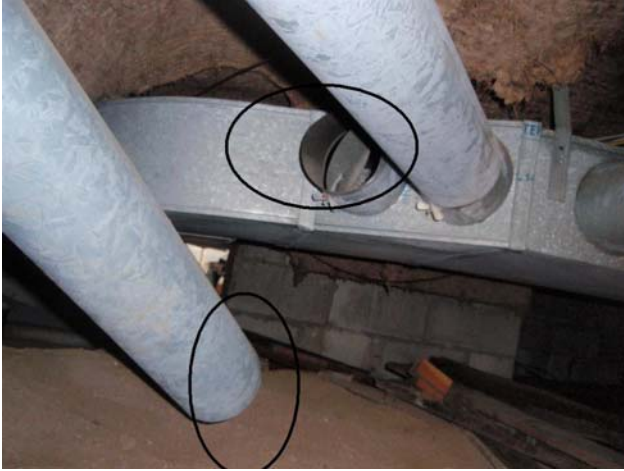
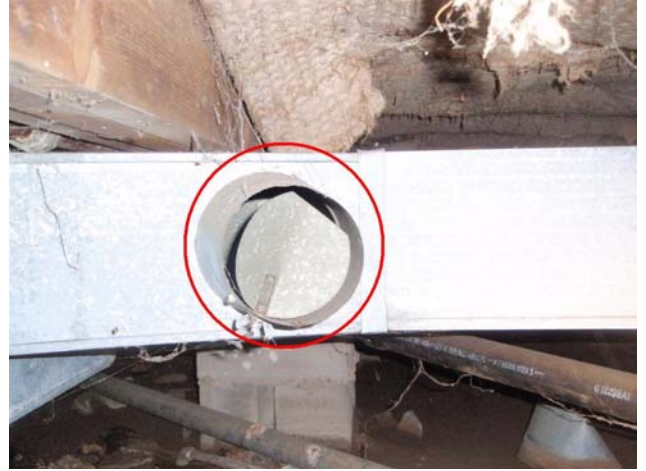
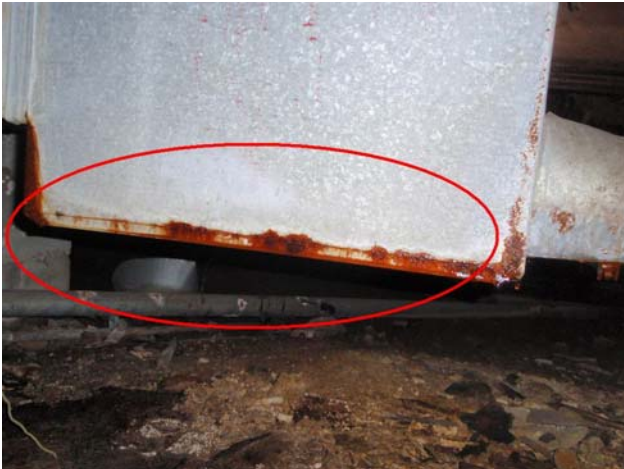
- **Improve:** All wood debris and/or trash should be removed from the crawl space. Organic debris around a property increases risk of insect or rot damage.
- **Repair:** Disconnected ductwork in the crawl space should be repaired. Disconnected duct work increases heating/cooling costs, can cause building damage, and in some instances can be unsafe where combustion gases can be vented to the living area.
- **Monitor, Repair:** Corroded ductwork in the crawl space was noted below furnace. Further deterioration may require repairs.

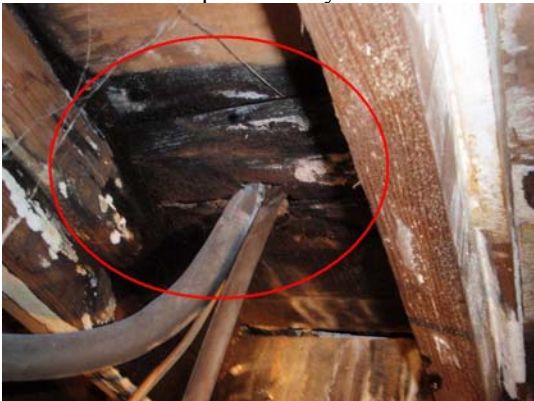
- **Repair:** Damaged subflooring (supporting layer of flooring atop floor joists and below finish flooring or carpeting) was found. It appears the A-Coil for the air conditioner may be leaking onto the subflooring. Further investigation is needed. This material should be re-supported or replaced to reduce risk of finish floor damage. Where only limited areas of damage exist this repair can be deferred until combined with other carpentry work at the property. Beware of damaged subfloor below carpet as it may be unsafe.

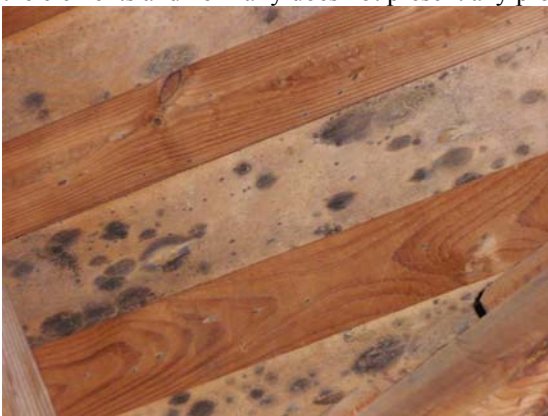
- **Monitor:** The rafters of the roof structure show evidence of sagging. Strengthening the roof structure would resist further movement. This improvement is not priority unless the roof is likely to be subjected to heavy loads such as from snow or additional layers of roofing material whose weight could cause further damage. Additional support can often be added easily.
- **Monitor:** Mold was visible on some roof sheathing in the garage. It is impossible to determine during a one time inspection when this mold occurred. Most homes have some level of this mold and it goes dormant once removed from the elements and normally does not present any problems.

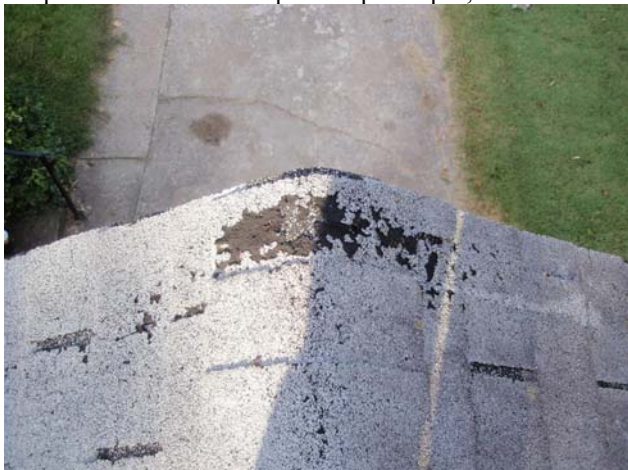
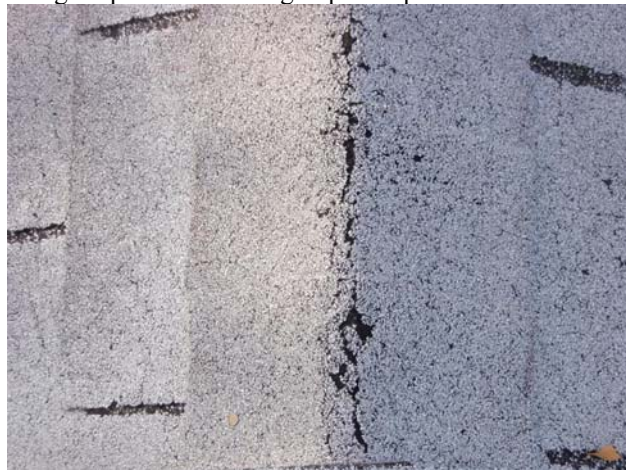
- **Repair:** Exposed nail heads were observed in the roofing shingles and/or ridge caps. All exposed nail heads should be caulked to reduce the potential of leaks.
- **Repair:** The roofing is at or near the end of its life. Watch for leaks and expect to replace the roof soon. Older roofs are, by their nature, a high maintenance roof. Annual inspection and repair should be anticipated. In addition, the older flashings should be monitored. In some cases, a deteriorated flashing can result in expensive repairs, because sections of the roofing have to be removed. As a rule of thumb, replacement of the entire roof covering may be logical if more than ten percent of the roof requires repair. Split, loose or damaged ridge caps of the roofing require repair.

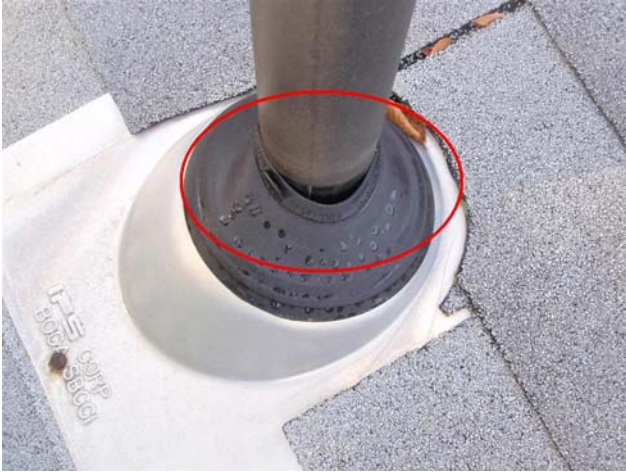
- **Monitor, Repair:** The plumbing vent flashing boot(s) is split making it vulnerable to leaks. It's recommended that the boot be caulked or the flashing replaced.

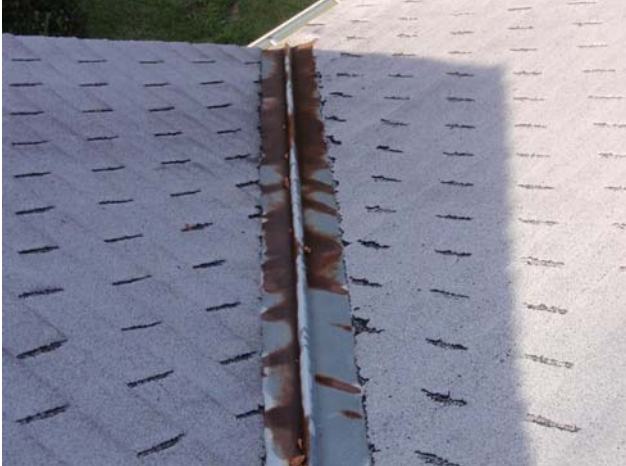
- **Repair:** The valley flashing is rusting. It should be painted to extend its life.

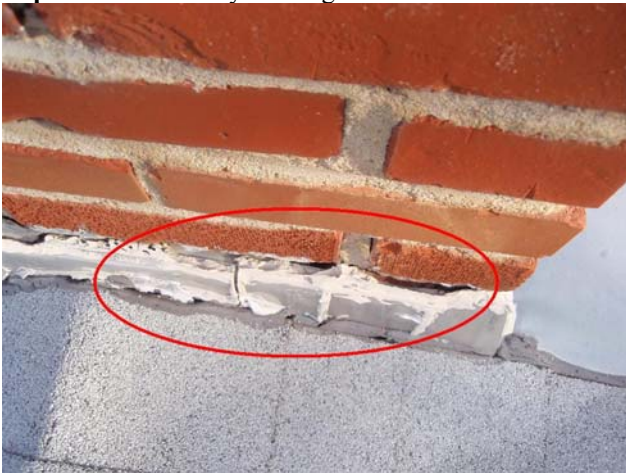
- **Repair:** The chimney flashing should be caulked to avoid leaks.

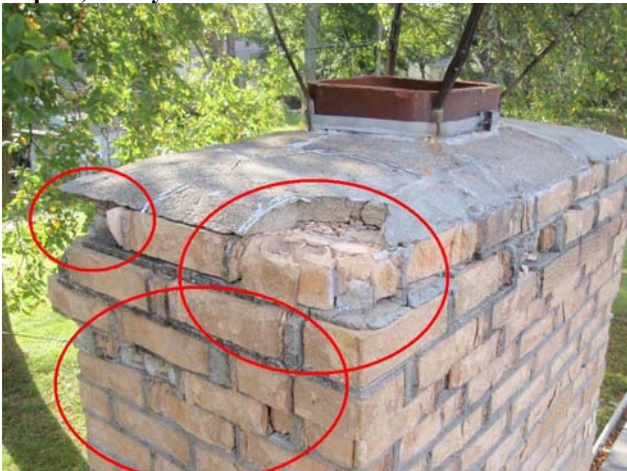
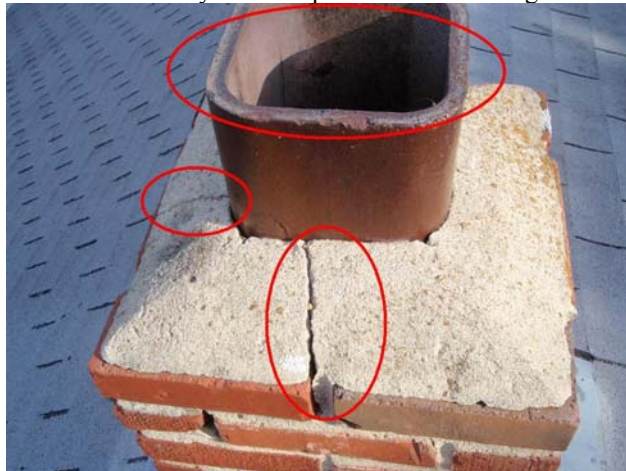
- **Repair:** The masonry chimney shows evidence of substantial spalling (surface deterioration of the masonry). Repair of this chimney is needed.
- **Monitor, Repair:** The cap of the masonry chimney is cracked. These cracks should be sealed or caulked before winter to prevent damage from freezing water.
- **Repair:** A rain cap and vermin screen should be installed on the furnace masonry chimney and the chimney flue should be checked for damage. Damaged flues can be unsafe.
- **Repair, Safety Issue:** A vermin screen should be installed on the east chimney to avoid possible flue blockage.

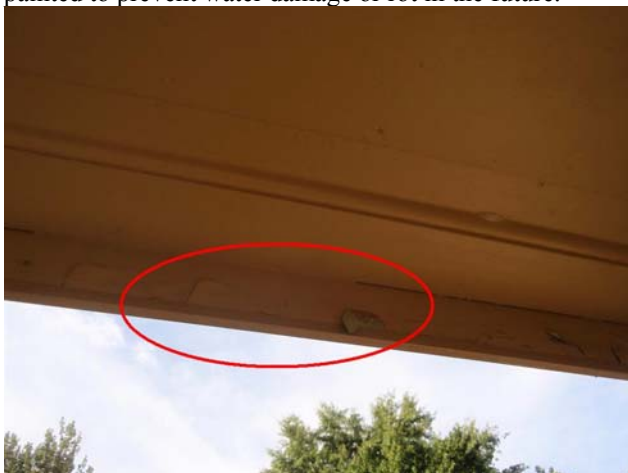
- **Repair:** The exterior paint is peeling and/or worn thin in at south side of back porch cover. These areas should be painted to prevent water damage or rot in the future.

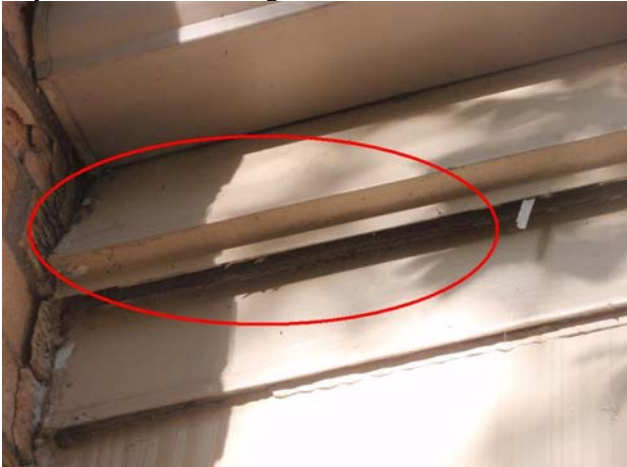
- **Repair:** The loose siding and fascia should be re-secured at localized areas in back to avoid water/wind damage.

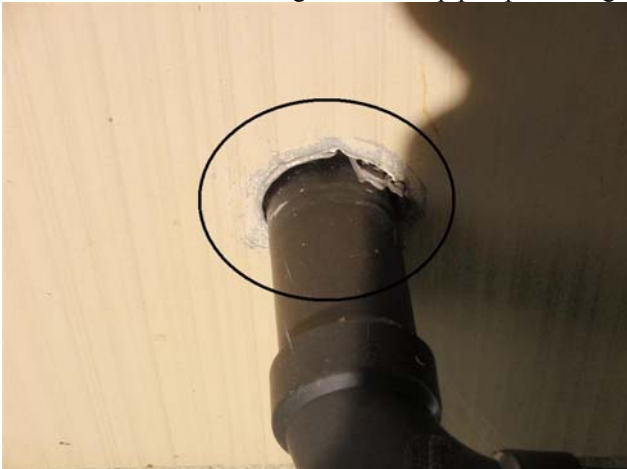
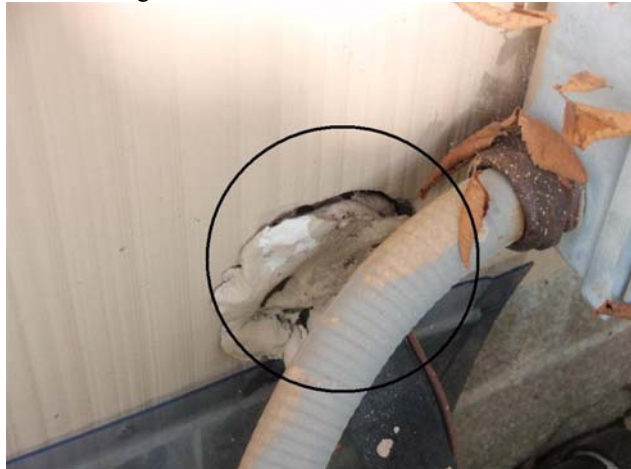
- **Repair:** Any openings in the exterior siding should be sealed. An example is where the air conditioner refrigerant lines enter the house and at siding around sump pump discharge line. Caulking is needed.

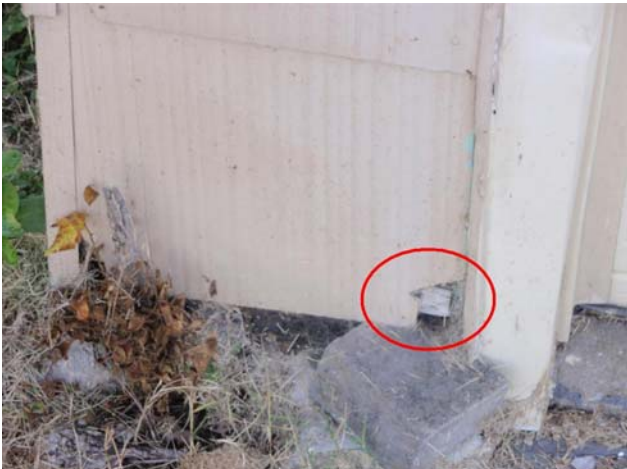
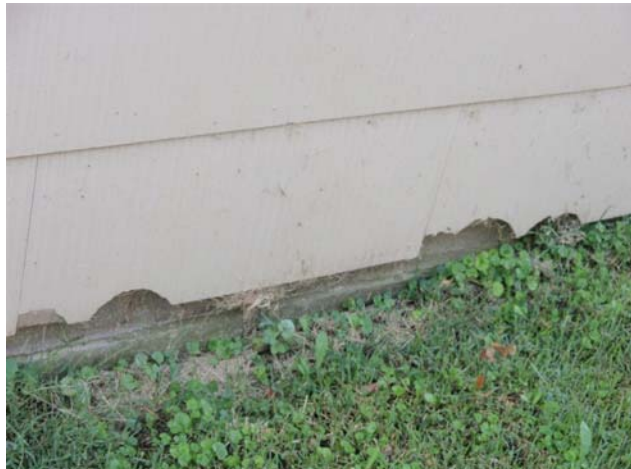
- **Repair:** Localized damage of the asbestos exterior walls should be repaired. There is extra risk of hidden damage in such areas.

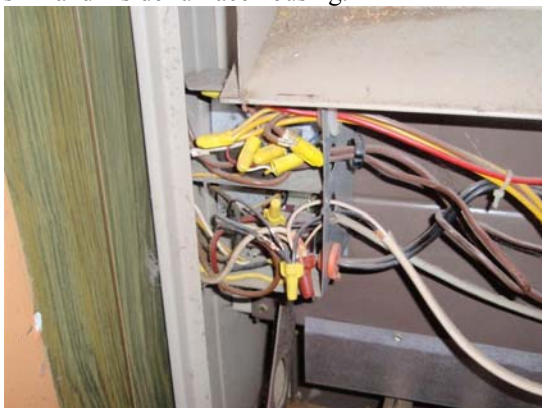
- **Repair:** Loose wiring at the basement stairway should be in conduit.
- **Repair:** Loose junction box under the kitchen sink should be properly secured.
- **Repair:** All junction boxes should be fitted with cover plates, in order to protect the wire connections (i.e. under kitchen sink and inside furnace housing).

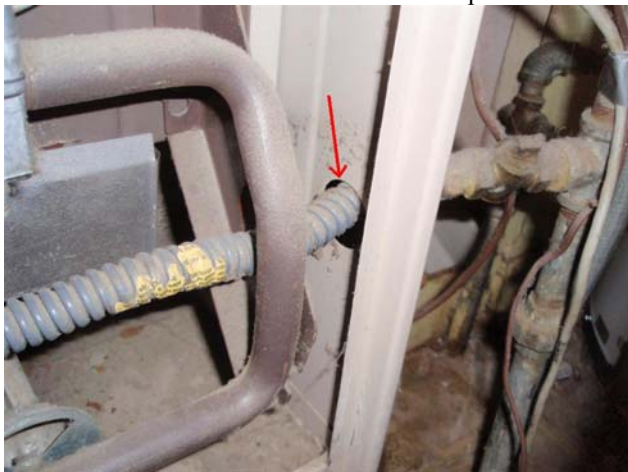
- **Repair:** Flexible gas appliance connections should not pass through walls, floors or the appliance housing as is the case of the furnace. This connector should be replaced with one of suitable solid gas piping.
