**Star
Home
Inspection Services**

Home Inspection Report

8426 Rosehill Rd Lenexa, KS 66215

Inspection Date: 06/05/2010

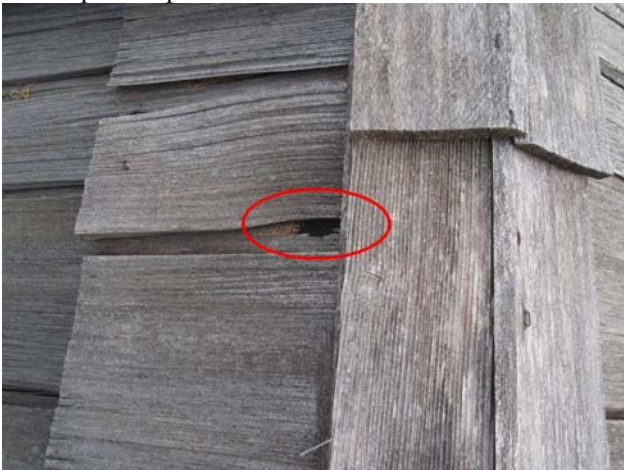
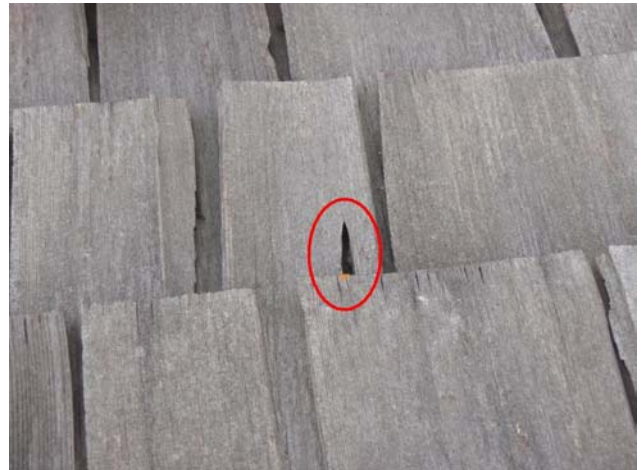
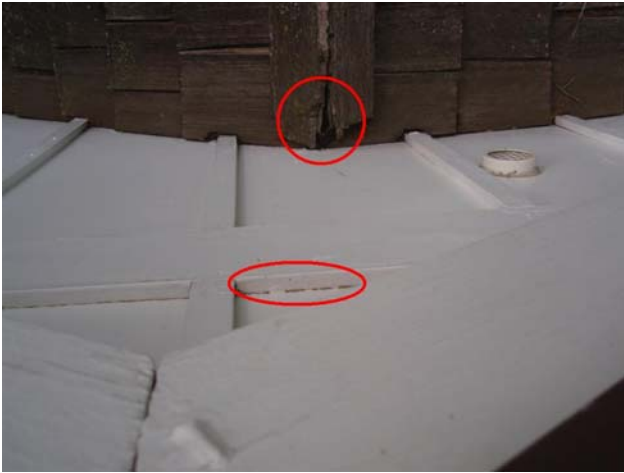
- **Repair:** Exposed sheathing is visible where the roofing is damaged. Damaged or missing roofing material should be repaired. Split, loose or damaged ridge caps of the roofing require repair. The life expectancy of wood roofs is generally 15 to 20 years with tune-ups normally needed around the 10th year. This will depend on several factors such as the quality of shingle or shake, the slope of the roof (steeper is better), the amount of exposed shingle, and the amount of sun or shade. As with all roofs, annual maintenance is needed. Cracked, curled, or displaced shingles or shakes should be repaired. As a rule of thumb, replacement of the entire roof covering may be logical if more than ten percent of the wood roof requires repair.

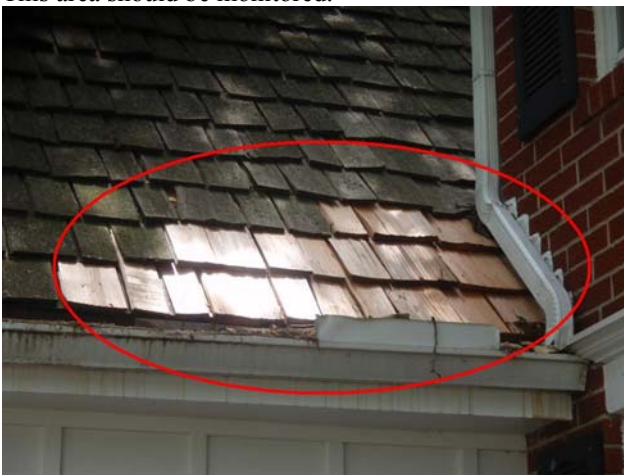
- **Monitor:** Prior repairs to the roofing are evident. This would suggest that problems have been experienced in the past. This area should be monitored.

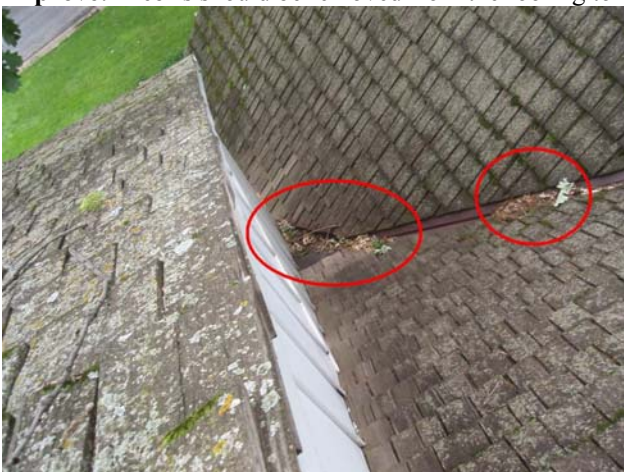
- **Improve:** Debris should be removed from the roofing to reduce risk of leaks and early roof wear.

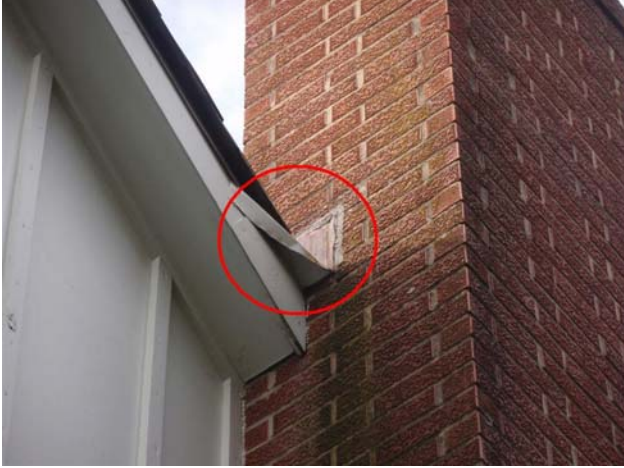
- **Monitor, Repair:** Water staining was noted at the north side chimney brickwork, recommend the installation of a kickout flashing at this location.

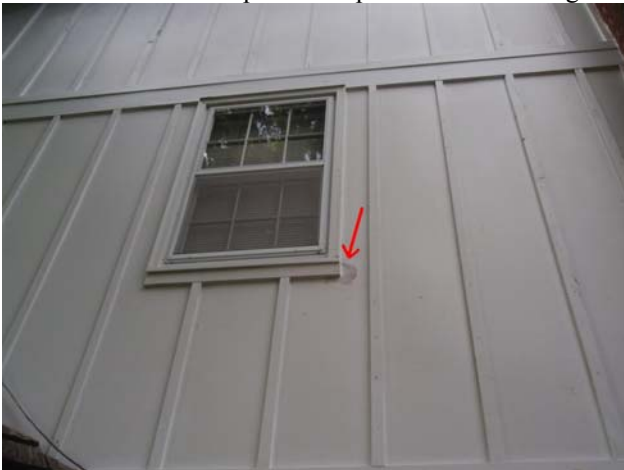
- **Repair:** The exterior siding paint is peeling and/or worn thin in localized areas including the bottom edge of the siding. These areas should be painted to prevent water damage or rot in the future.

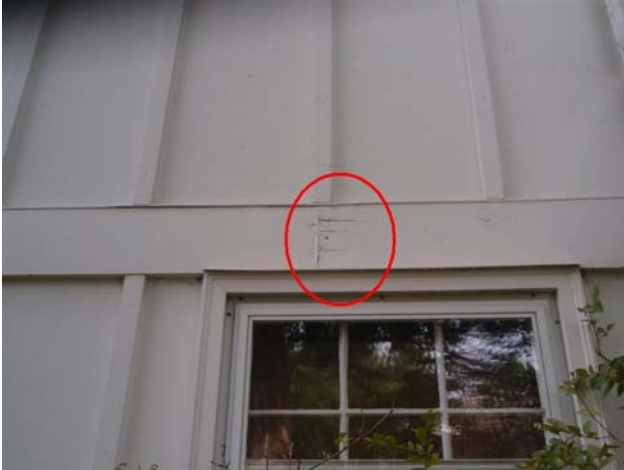
- **Repair:** The paint on the trim around the siding is peeling in localized areas. These areas should be painted to prevent water damage and rot.
- **Repair:** Localized rot was observed in the trim around the siding. Following repair of the damaged areas (which should be combined with exterior painting/maintenance) proper maintenance of the siding and control of water from roof or surface runoff can avoid further damage.

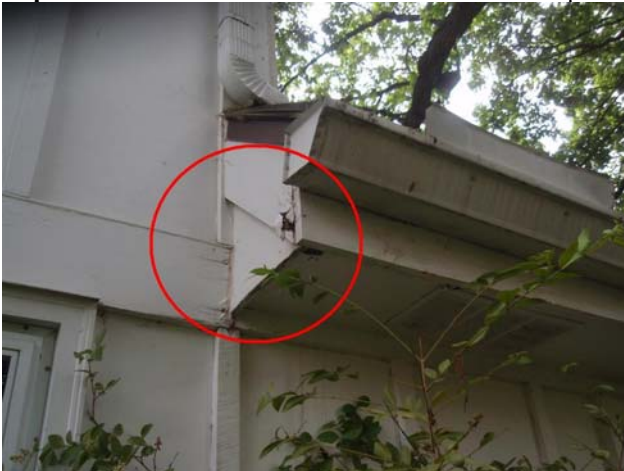
- **Repair:** The eaves are peeling and they should be painted to prevent water damage and rot.
- **Repair:** Localized rot was observed in the eave. Following repair of the damaged areas (which should be combined with exterior painting/maintenance) proper maintenance of the siding and control of water from roof or surface runoff can avoid further damage.
- **Repair:** Localized rot was observed in the soffit. Repairs and painting is needed.

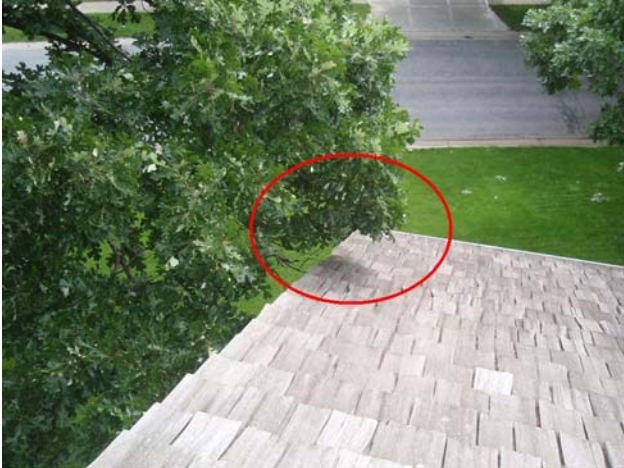
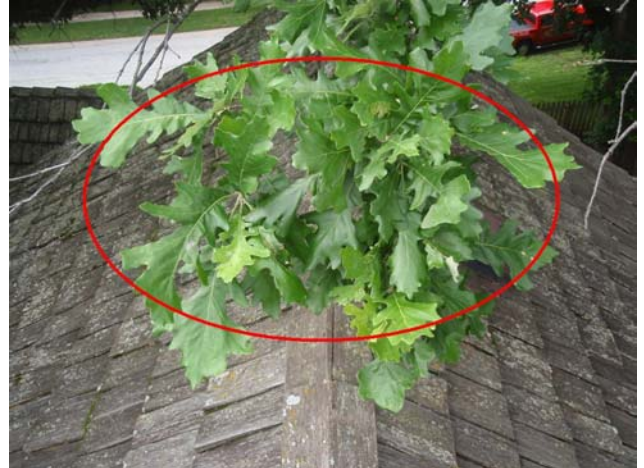
- **Repair:** Tree branches should be trimmed away from the house to avoid damage to the building.

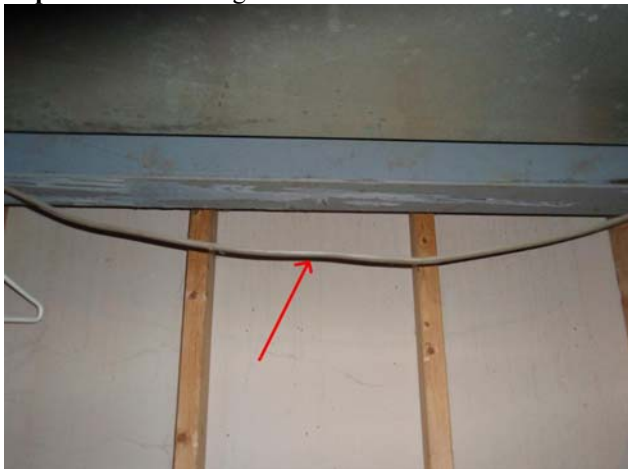
- **Repair:** Loose wiring in the furnace room should be secured.

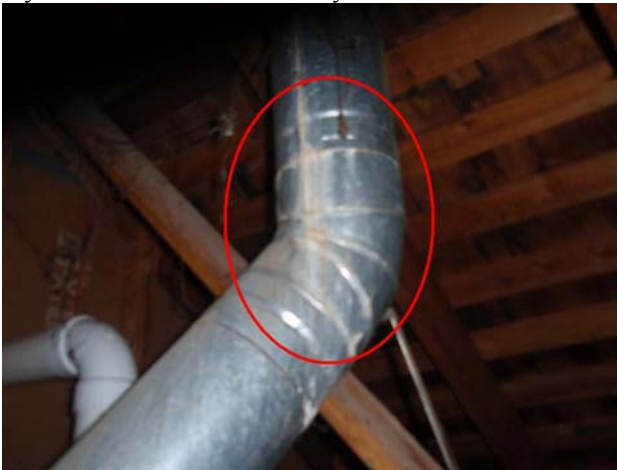
- **Monitor:** While in the attic water stains were observed on the lower sections of the furnace flue. The insulation below the elbow also showed signs of past moisture. It appears that rain blew in under the rain cap and came down the interior of the flue until it got to the first joint where it then transferred to the outside surface and dripped off the elbow. This is a common condition in 80% of homes but very seldom is enough to penetrate completely through the insulation to the drywall below. Monitor for any additional wetness after rains.

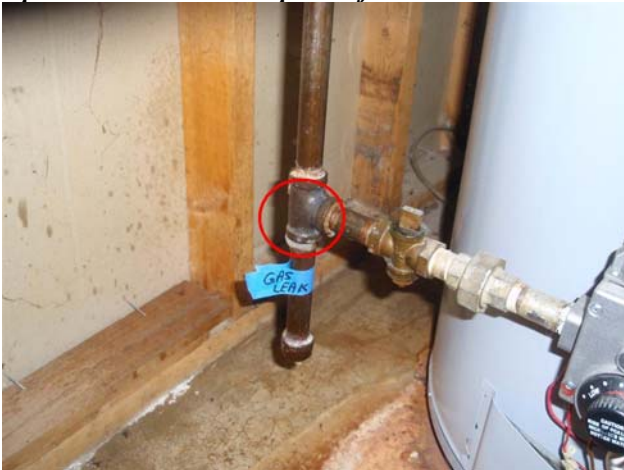
- **Repair, Safety Issue:** *A gas leak was detected (marked "GAS LEAK" with blue tape at water heater drip leg) with a TIF 8800 gas/carbon monoxide detector and confirmed with soapy water. This is a serious safety concern. It is recommended that the gas utility, HVAC company or plumber be engaged as soon as possible to make the necessary repairs. The current occupants of the home should also be notified.*

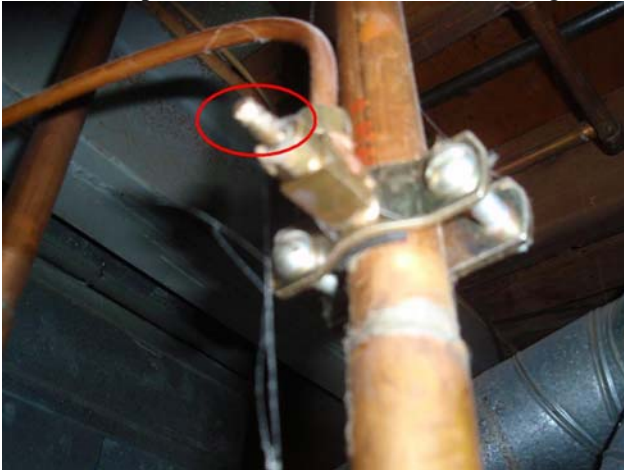
- **Monitor, Repair:** A saddle valve handle is missing for the humidifier water supply shut-off.
