# Star Home Inspection Services

## *Home Inspection Report*

**8443 Alden Ln, Lenexa, KS 66215**

**Inspection Date: 2/3/2009**

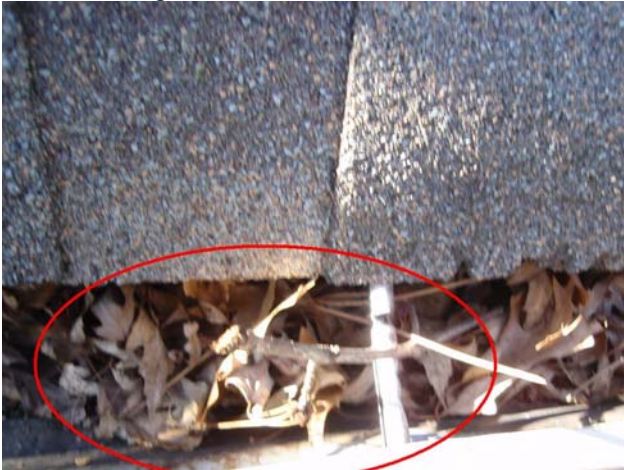
- **Repair:** The gutters require cleaning to avoid spilling roof runoff around the building – a potential source of water entry or water damage.

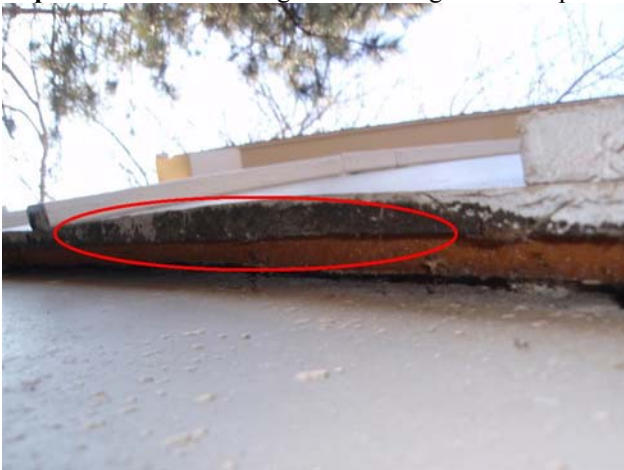
- **Monitor:** Localized rot was observed in the siding at the lower edge (example at back area kitchen bay windows). Following repair of the damaged areas (which should be combined with exterior painting/maintenance) proper maintenance of the siding and control of water from roof or surface runoff can avoid further damage.
- **Monitor:** Localized rot was observed in the bat trim around siding (example at north side). Following repair of the damaged areas (which should be combined with exterior painting/maintenance) proper maintenance of the siding and control of water from roof or surface runoff can avoid further damage.
- **Repair:** The siding should be sealed at front porch minor wood rot where siding meets house.
- **Improve:** The bottom edge of the siding should be painted to prevent water from wicking up and causing wood rot.

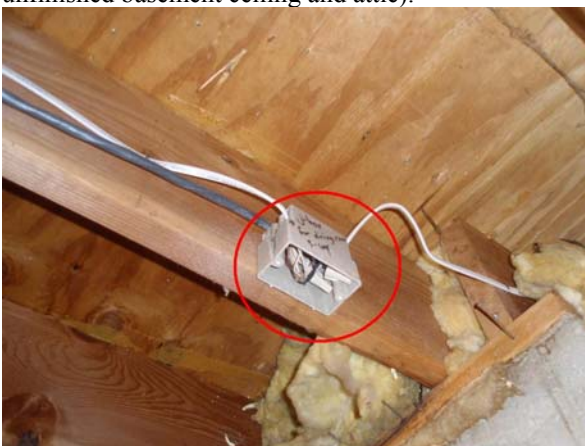
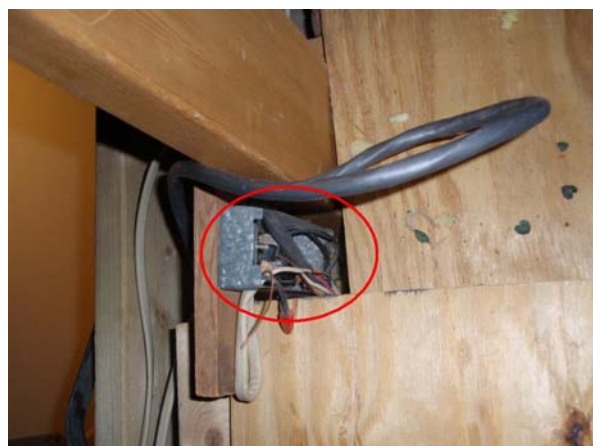
- **Repair:** All junction boxes should be fitted with cover plates, in order to protect the wire connections (examples in front unfinished basement ceiling and attic).

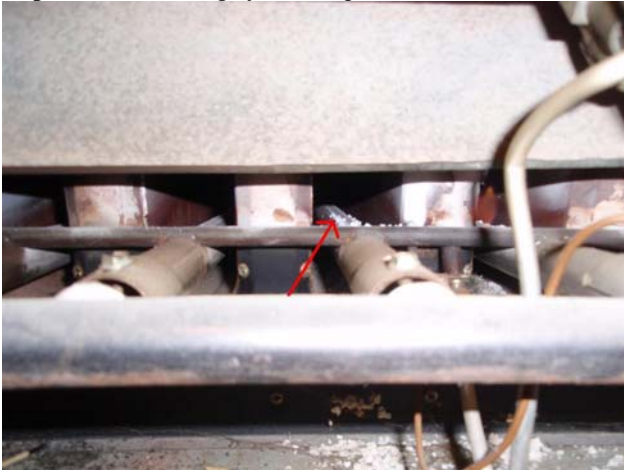
- **Repair:** The heating system requires service. This should be a regular maintenance item to assure safe, reliable heat.
