**Star
Home
Inspection Services**

Home Inspection Report

8501 Redbud Ln Lenexa, KS 66220

Report Number: 12102009-2A

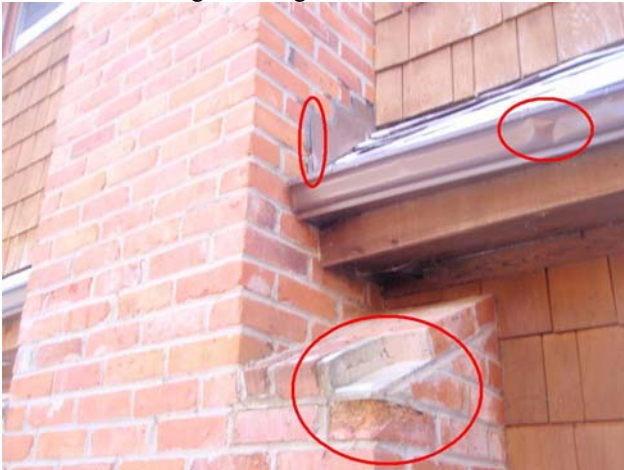
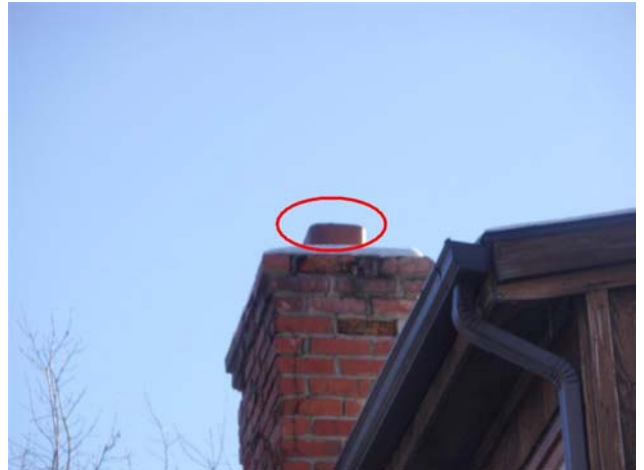
Chimneys

- **Repair:** The masonry chimney shows evidence of spalling (surface deterioration of the masonry) and brick(s) missing. Repair of this chimney is needed. **Repaired (replaced missing bricks)**
- **Repair:** A rain cap and vermin screen should be installed on the masonry chimney and the chimney flue should be checked for damage. Damaged flues can be unsafe.

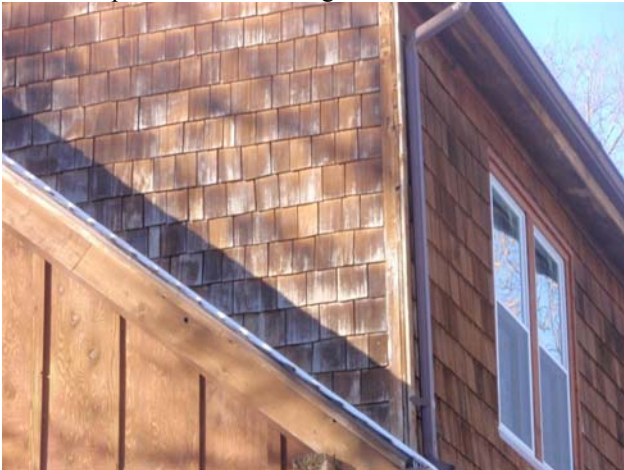
- **Repair:** The exterior siding paint is peeling and/or worn thin in localized areas. These areas should be painted or stained to prevent water damage or rot in the future.

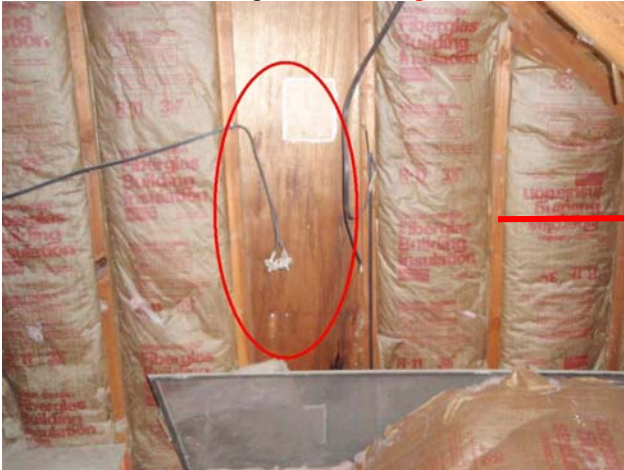
- **Repair:** Any openings in the exterior siding should be sealed. An example is at the south side of house where light is visible in attic. Caulking is needed. **Repaired**

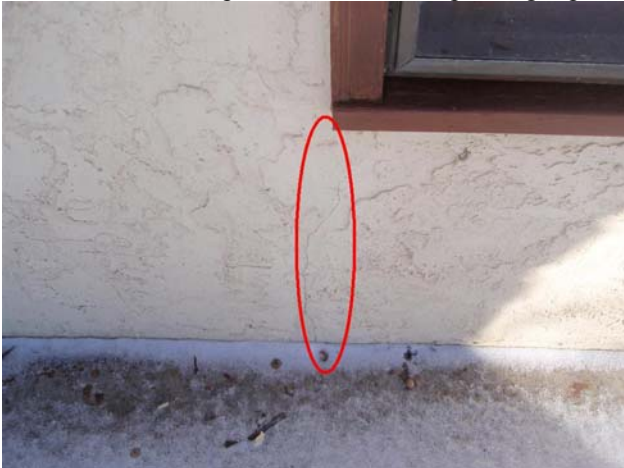
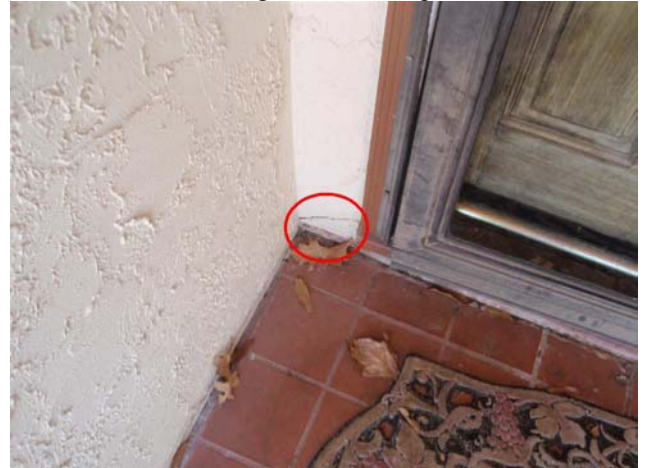
- **Repair:** The paint on the trim around the siding is peeling in localized areas. These areas should be painted to prevent water damage and rot. **Repaired**
- **Monitor, Repair:** Cracks were observed in the exterior stucco walls. Repair is not critical at this time but these cracks should be filled or repaired when exterior painting is planned. There is risk of damage if water can penetrate the walls.

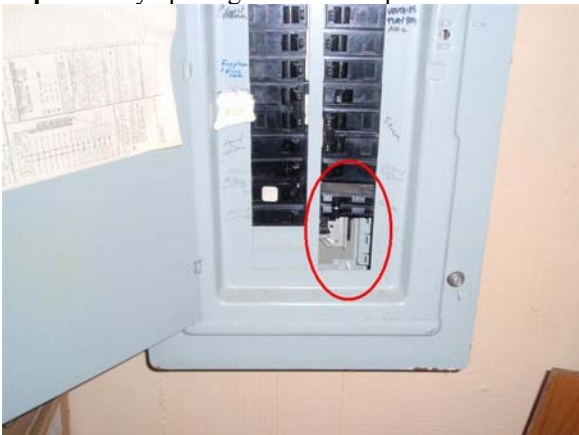
Main Panel

- **Repair:** Oversized breaker within the main distribution panel for the air condition should be replaced. The data plate on the unit specifies a maximum breaker size of 45 Amps and the one in the panel is 50 Amps. **Will Repair**
- **Repair:** Any openings in the main panel should be covered. **Repaired**
