**Star
Home
Inspection Services**

Home Inspection Report

8570 Hilltop Rd, DeSoto, KS 66018

Inspection Date: 2/24/2009

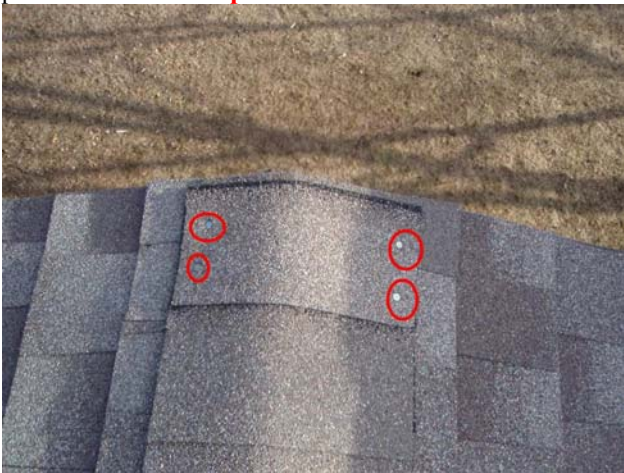
- **Repair:** Exposed nail heads were observed at the ridge cap. All exposed nail heads should be caulked to reduce the potential of leaks. **Repaired**

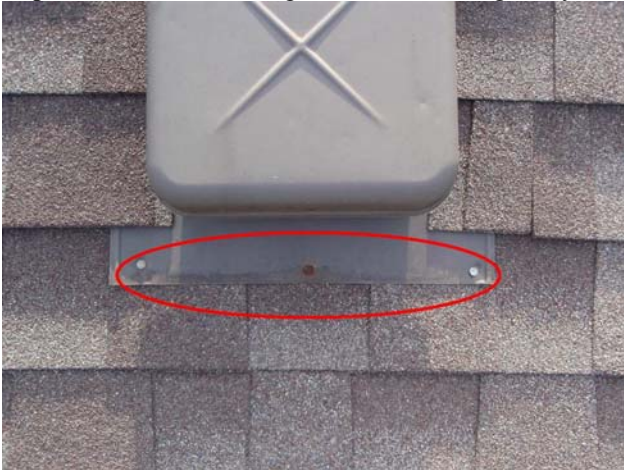
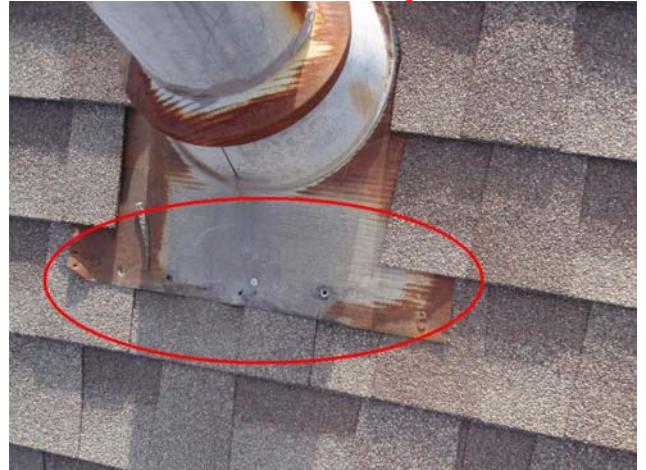
- **Repair:** Nail heads are exposed at the flashing. They should be sealed to reduce risk of leaks. **Repaired**

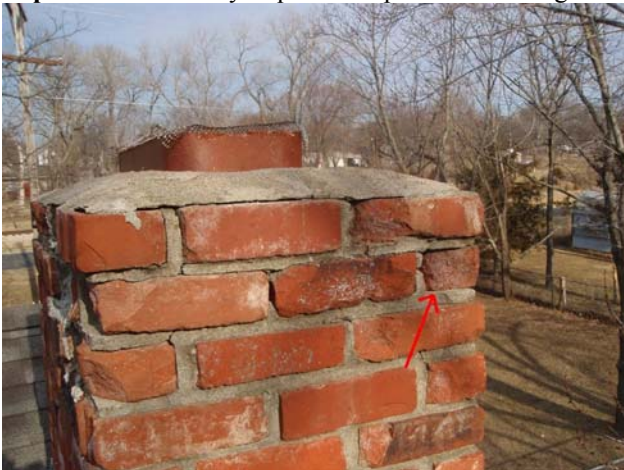
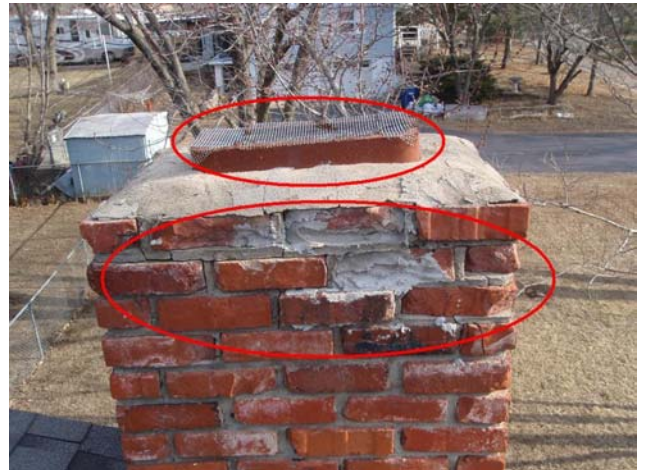
- **Monitor:** The masonry chimney shows evidence of spalling (surface deterioration of the masonry). Repair is not necessary at this time but this condition should be monitored.
- **Repair:** The chimney requires a cap to avoid damage.

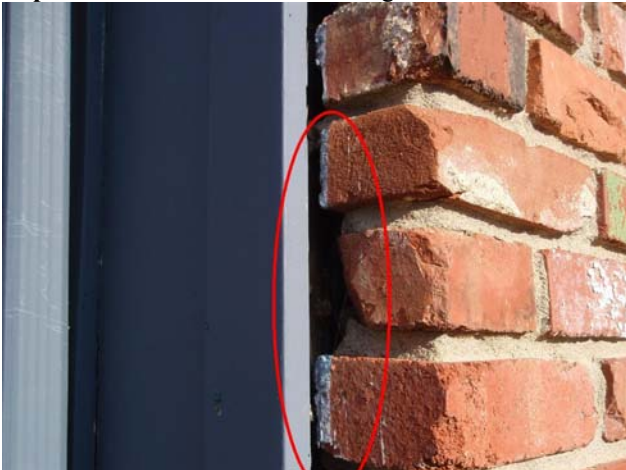
- **Repair:** The exterior brick covering should be sealed at corners where it meets siding to prevent insect entry. **Repaired**

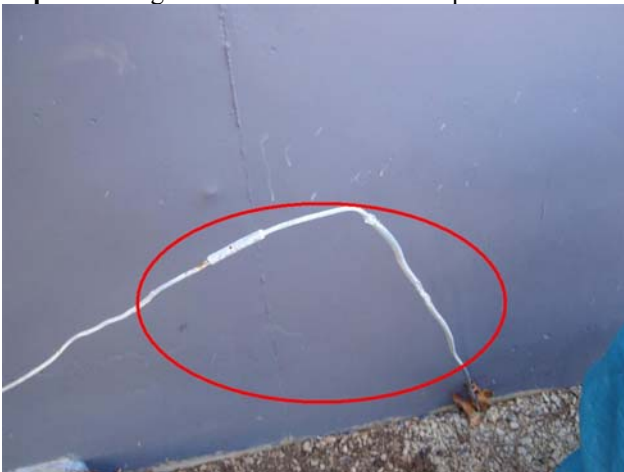
- **Repair:** The ground rod/wire at the back patio is loose and should be secured. **Repaired/Secured**

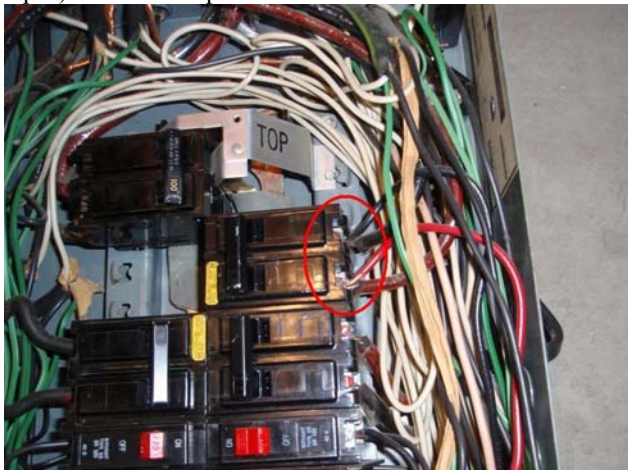
- **Repair:** Oversized breaker within the main distribution panel for the air condition should be replaced. The data plate on the unit specifies a maximum breaker size of 35 Amps and the one in the panel is 40 Amps. **Replaced with 30 Amp**
- **Repair:** Circuits within the main distribution panel marked with blue tape that are doubled up (referred to as “double taps”) should be separated. Each circuit should be served by a separate fuse or breaker.

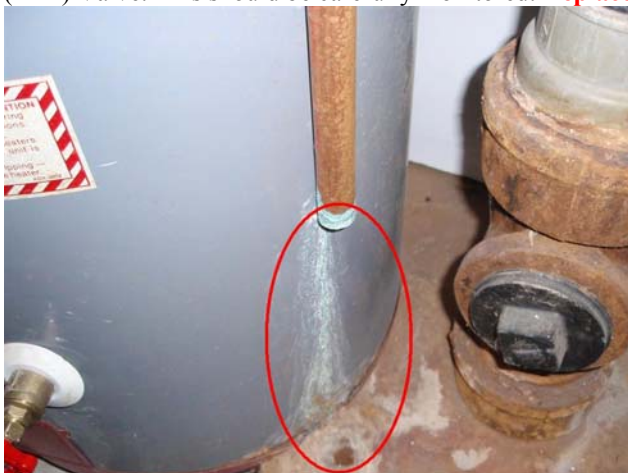
- **Monitor:** The water heater is an old unit that may be approaching the end of its useful life. It would be wise to budget for a new unit. One cannot predict with certainty when replacement will become necessary.
- **Monitor:** The water heater shows evidence of prior leakage at the drain valve and the Temperature and Pressure Relief (TPR) Valve. This should be carefully monitored. **Replaced drain valve**

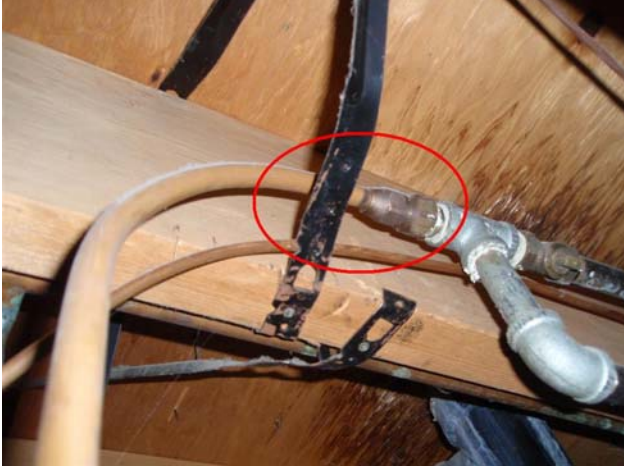
- **Repair:** Copper tubing is no longer suitable for gas piping. It's recommended this pipe servicing the water heater be replaced with one of suitable material. **Replaced copper tubing**

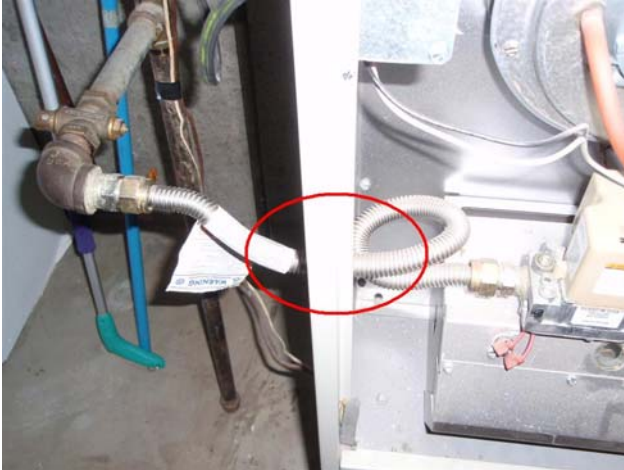
- **Repair:** Flexible gas appliance connections should not pass through walls, floors or the appliance housing as is the case of the furnace. This connector should be replaced with one of suitable solid gas piping. **Replaced with rigid gas piping**
