**Star
Home
Inspection Services**

Home Inspection Report

8617 Westridge Rd Raytown, MO 64138

Inspection Date: 05/18/2010

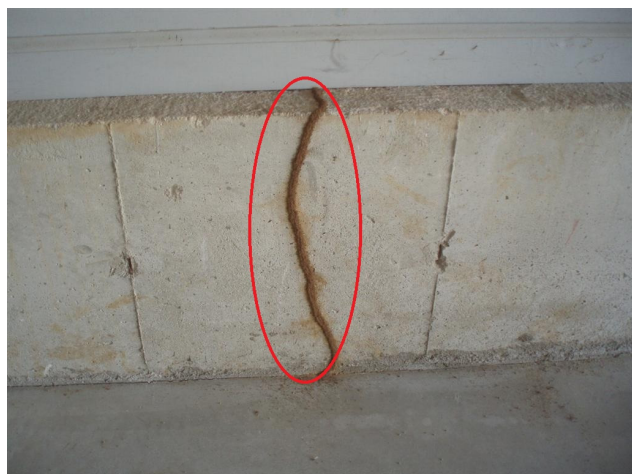
- **Monitor, Repair:** Evidence of termite activity was observed in the garage and there is risk of additional hidden damage. If the property has not already been treated, a licensed pest control specialist should be engaged. Termites can do a substantial amount of damage to the wood structural components of a home. See termite report by Pest Management Professionals for additional information and recommendations if any.

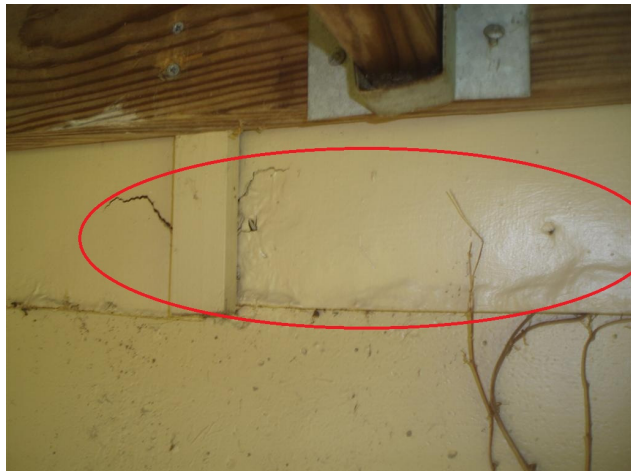
- **Repair:** Localized rot was observed in the siding primarily underneath the deck. Following repair of the damaged areas (which should be combined with exterior painting/maintenance) proper maintenance of the siding and control of water from roof or surface runoff can avoid further damage.

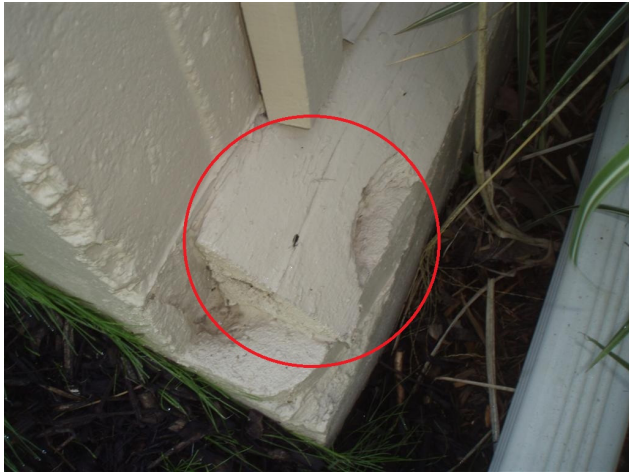
- **Repair:** Localized rot was observed in the trim around the siding mainly at the board along the base of the siding on the south side of the front of the house. Following repair of the damaged areas (which should be combined with exterior painting/maintenance) proper maintenance of the siding and control of water from roof or surface runoff can avoid further damage.

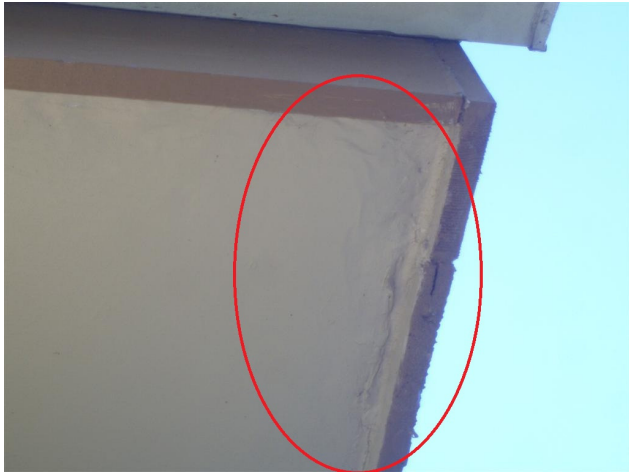
- **Monitor, Repair:** Localized peeling and rot were observed in the eaves. Following repair of the damaged areas (which should be combined with exterior painting/maintenance) proper maintenance of the siding and control of water from roof or surface runoff can avoid further damage.

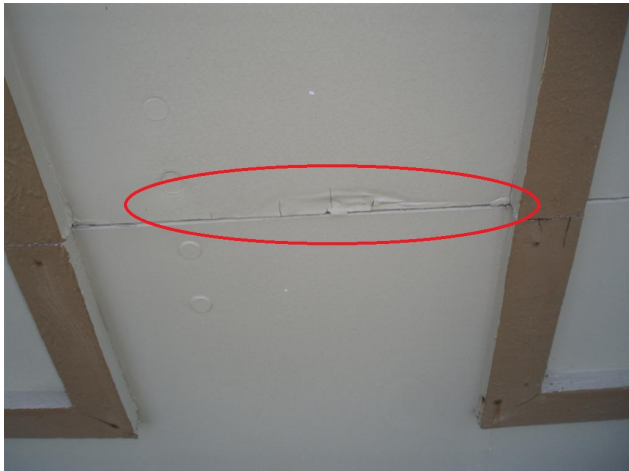
- **Monitor, Repair:** Localized rot and/or paint peeling was observed on the overhead garage door.

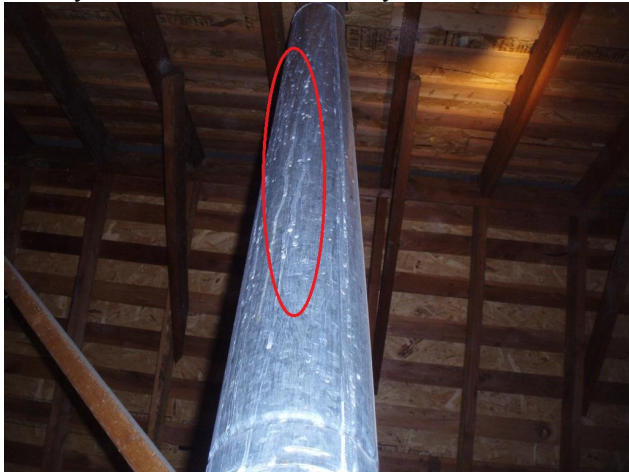
- **Monitor:** While in the attic water stains were observed on the lower sections of the furnace flue. The insulation below the elbow also showed signs of past moisture. It appears that rain blew in under the rain cap and came down the interior of the flue until it got to the first joint where it then transferred to the outside surface and dripped off the elbow. This is a common condition in 80% of homes but very seldom is enough to penetrate completely through the insulation to the drywall below. Monitor for any additional wetness after rains.

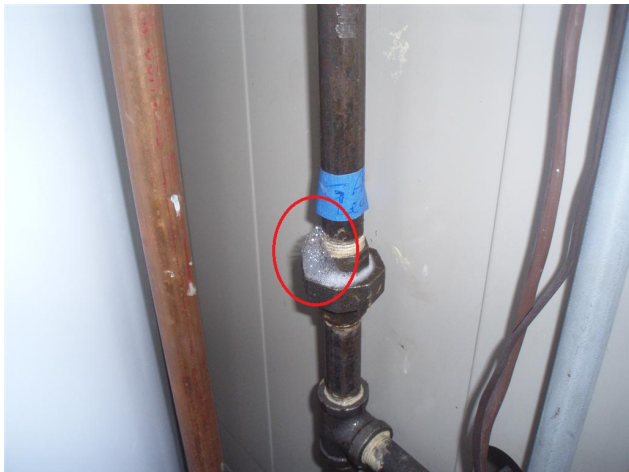
- **Repair, Safety Issue:** *A gas leak was detected with a TIF 8800 gas/carbon monoxide detector and confirmed with soapy water. This is a serious safety concern. It is recommended that the gas utility, HVAC company or plumber be engaged as soon as possible to make the necessary repairs.*

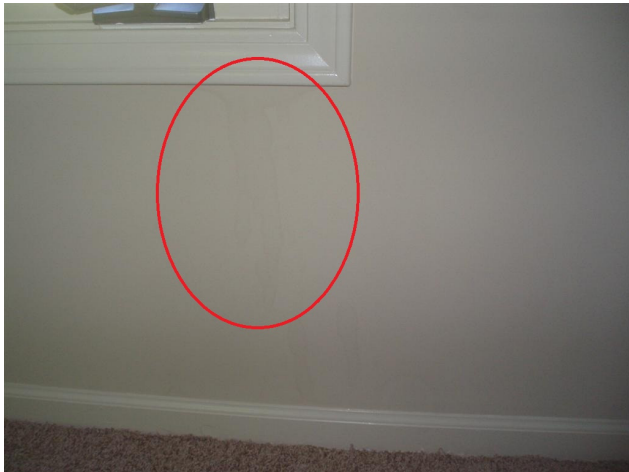
- **Monitor:** Water staining was noted on the wall in the front bedroom below the window.
