Star Home Inspection Services

Home Inspection Report

8634 Greenway Ln Lenexa, KS 66215

Report Number: 01212010-1A

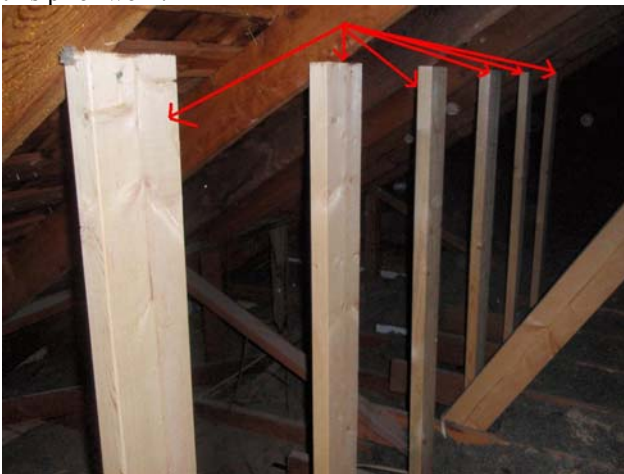
- **Monitor:** Prior repairs to the roof support structure over the front entry are evident. Consult the current owner regarding this prior work.

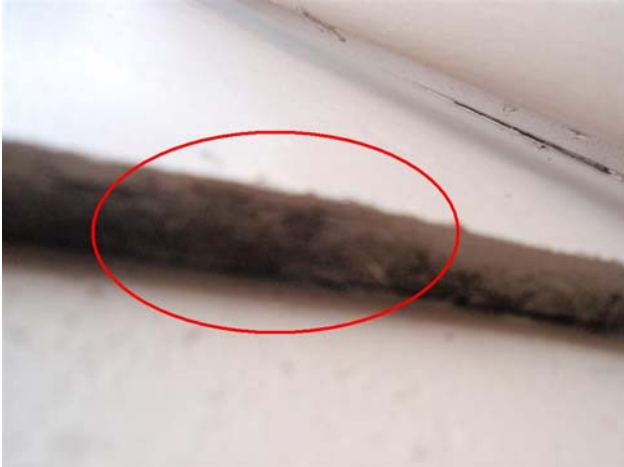
- **Repair:** The exterior siding paint is peeling and/or worn thin in localized areas (i.e. bottom edge at north side). These areas should be painted to prevent water damage or rot in the future.

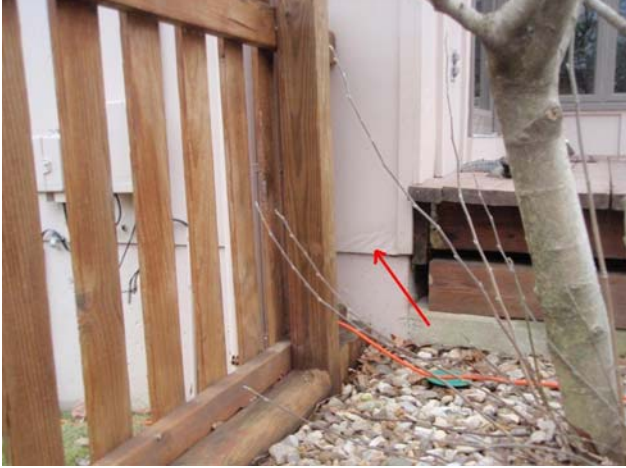
- **Repair:** Localized rot was observed in the siding (i.e. northwest corner). Following repair of the damaged areas (which should be combined with exterior painting/maintenance) proper maintenance of the siding and control of water from roof or surface runoff can avoid further damage.

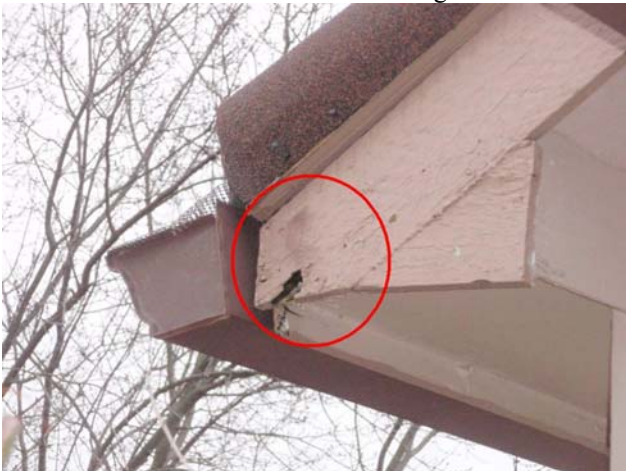
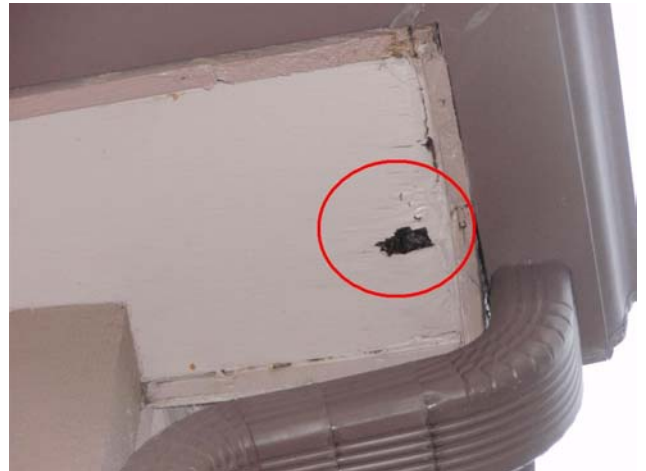
- **Monitor, Repair:** Localized rot was observed in the eave south of the front porch. Improvement is not necessary at present, although this condition should be repaired when exterior painting or maintenance are planned.
- **Repair:** Localized rot was observed in the front northeast corner soffit. Following repair of the damaged areas (which should be combined with exterior painting/maintenance) proper maintenance of the siding and control of water from roof or surface runoff can avoid further damage.

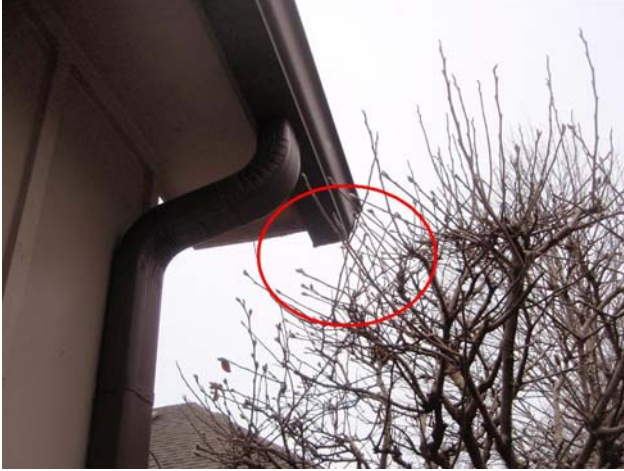
- **Monitor:** Tree branches should be kept trimmed away from the house to avoid damage to the building.

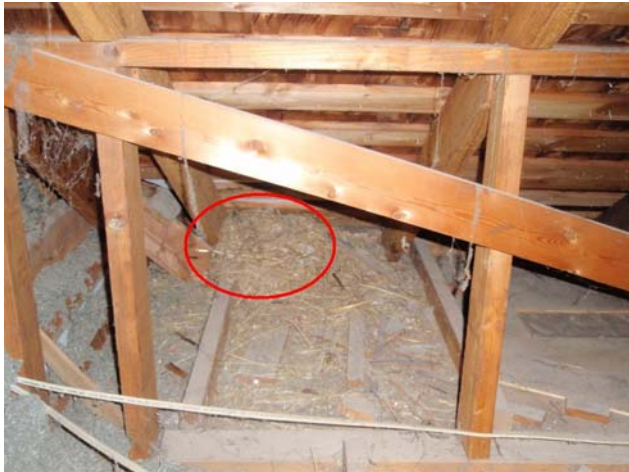
Recommend: There is a bird nest in the attic. It's recommended this be removed. **Repaired (removed nest)**

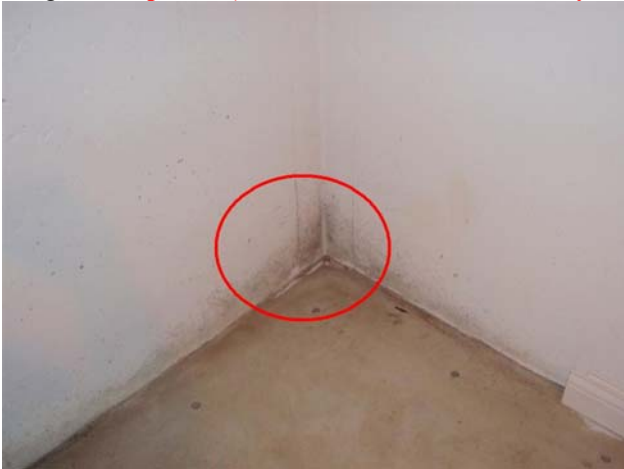
- **Monitor:** Typical drywall flaws were observed that could include rough seams, nail popping, minor patching, etc. Any repairs would be discretionary. Overall condition is above average.
- **Monitor:** Signs of mildew/mold were observed at the northwest corner wall of the basement. This can be easily mitigated. **Repaired (Mildew/mold were successfully cleaned off)**
