**Star
Home
Inspection Services**

Home Inspection Report

8677 NE 110th Terr Kansas City, MO 64157

Inspection Date: 05/25/2010

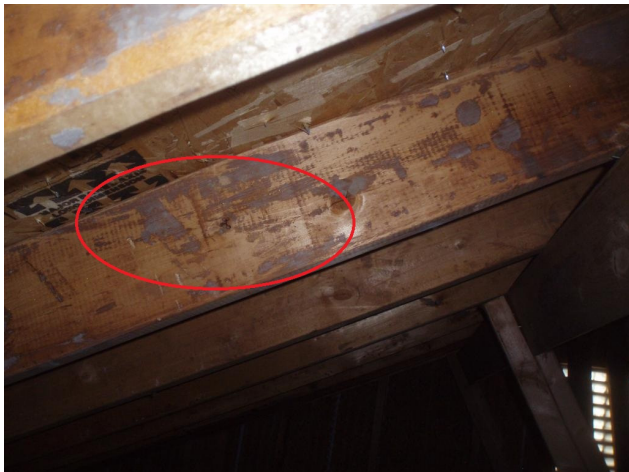
Roof

- **Monitor:** Construction mold was visible on some roof rafters. This is mold that grows on the lumber while lying in the weather during construction as evidenced by the strap marks. Most homes have some level of this mold and it goes dormant once removed from the elements and normally does not present any problems.

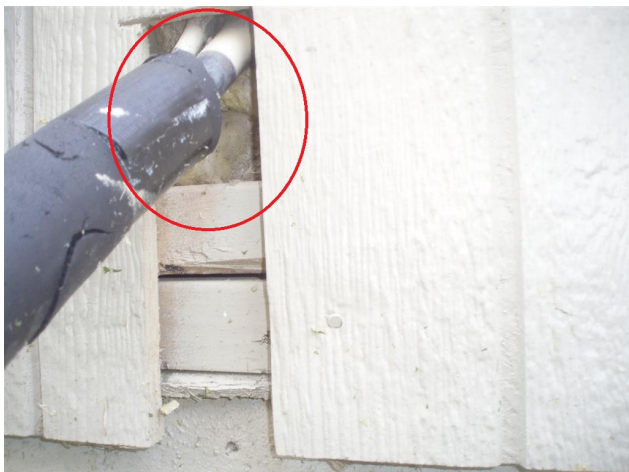
- **Repair:** Any openings in the exterior siding should be sealed. An example is where the air conditioner refrigerant lines enter the house. Caulking is needed.

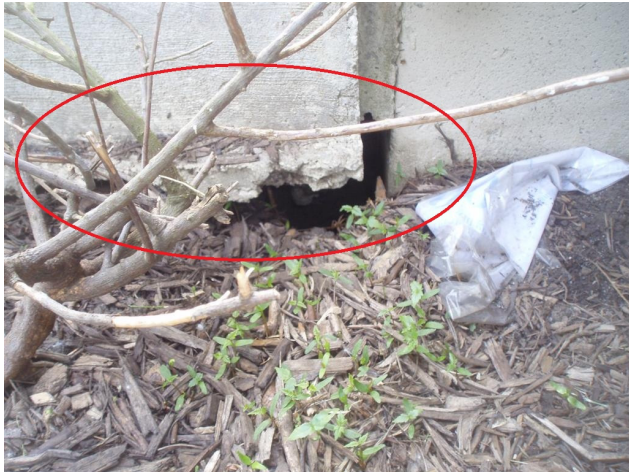
Porch

- **Monitor, Repair:** The steps serving the porch have settled and there is an absence of soil underneath due to settlement and/or erosion. It's recommended the cavity be filled to help prevent further settlement.

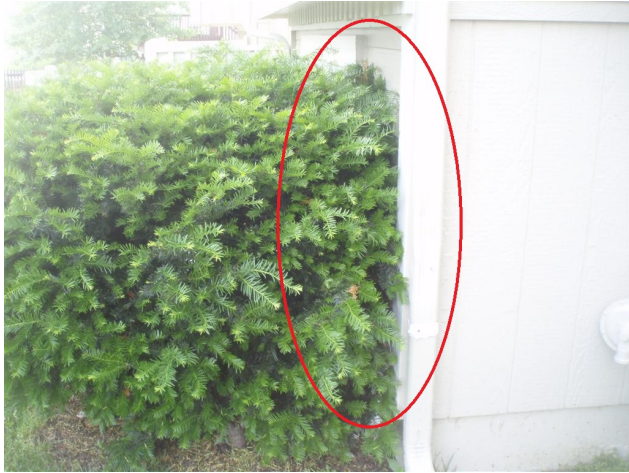
Landscaping

- **Repair:** Shrubs, bushes and/or vines growing on exterior walls need to be trimmed away from the structure to reduce the risk of water damage and insect infestation.

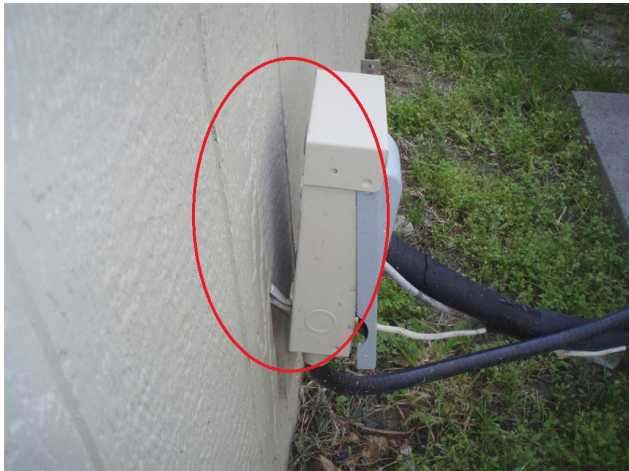
Air Conditioning

- **Repair:** The disconnect box at the air conditioning unit is loose.

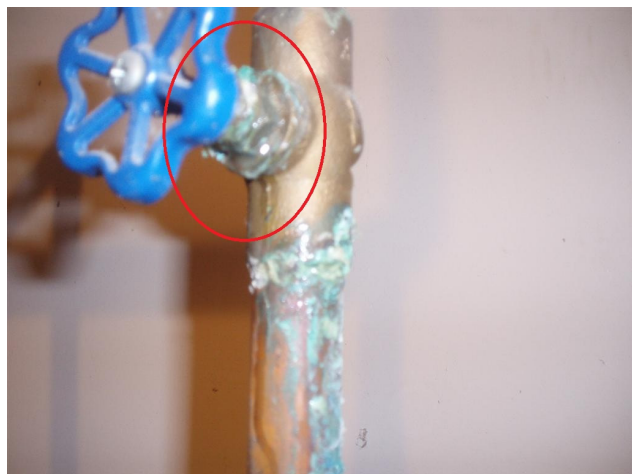
- **Monitor:** Water heaters have a typical life expectancy of 7 to 12 years. The existing unit is approaching or has exceeded this age range. One cannot predict with certainty when replacement will become necessary.
- **Monitor:** The supply piping shows evidence of corrosion where it meets the water heater. This condition is likely due to a water leak in the cold supply piping above.

- **Repair:** The cold supply piping is leaking above the water heater.

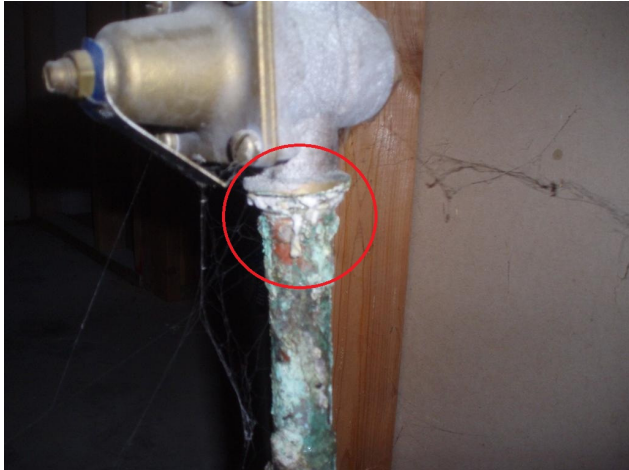
- **Repair:** The supply piping is leaking at the pressure regulator.

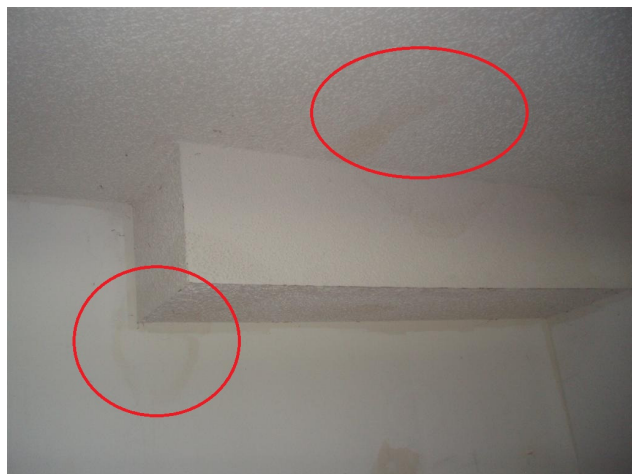
Wall / Ceiling Finishes

- **Monitor:** Water staining was noted on the ceiling in the garage and the hallway bathroom ceiling.
