**Star
Home
Inspection Services**

Home Inspection Report

9000 E 343rd St Drexel, MO 64742

Inspection Date: 12/18/2009

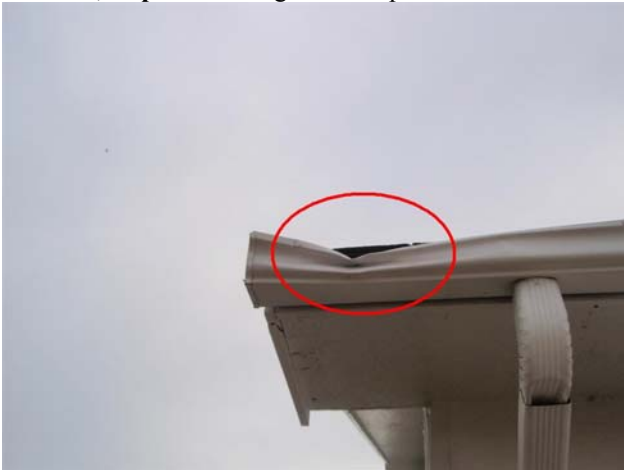
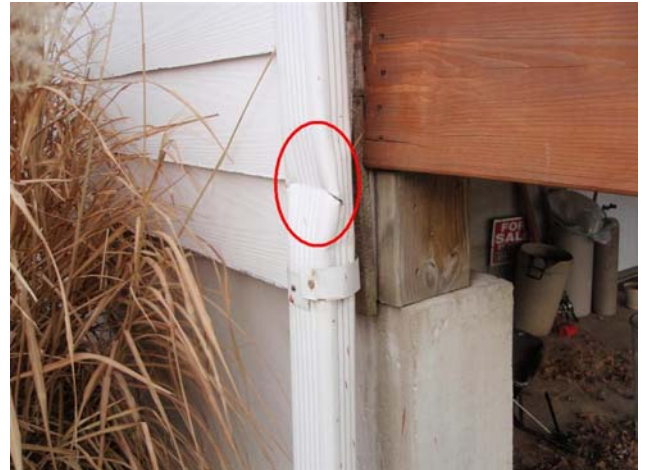
- **Monitor, Repair:** Damaged gutter at the northwest corner of the garage was observed. Repairs are discretionary.
- **Monitor, Repair:** Damaged downspout was observed at southeast corner of the home.

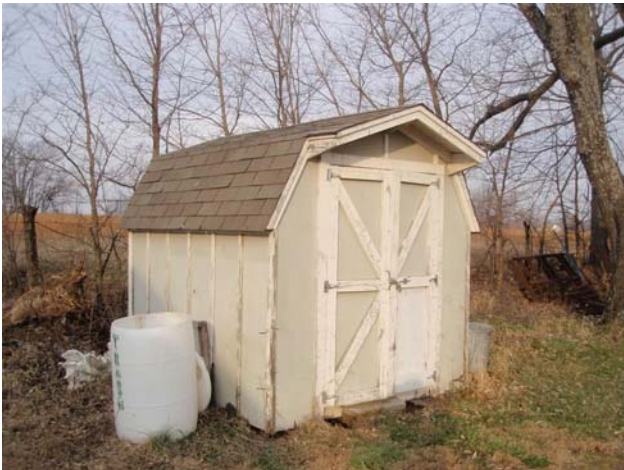
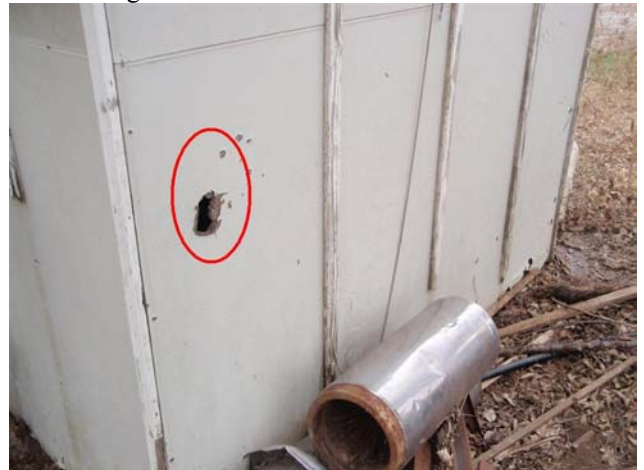
- **Repair:** The exterior of the small storage outbuilding at northwest side of driveway needs to be painted.
- **Repair:** Localized rot and siding damage was observed in the small storage building siding and trim. Following repair of the damaged areas (which should be combined with exterior painting/maintenance) proper maintenance of the siding and control of water from roof or surface runoff can avoid further damage.

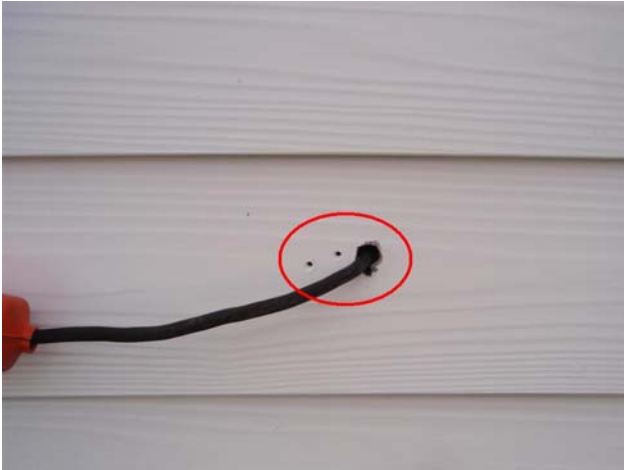
- **Repair:** Any openings in the exterior siding should be sealed. An example is at the back of the garage. Caulking is needed.

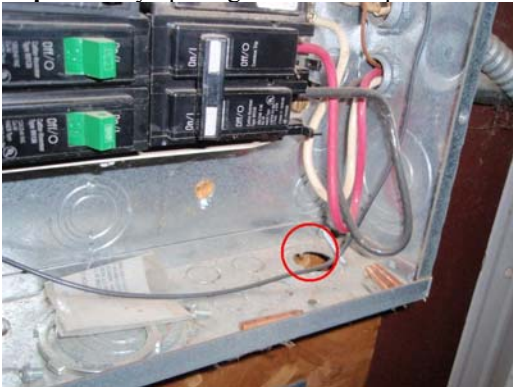
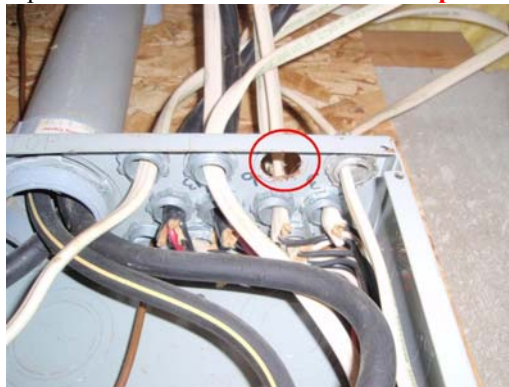
- **Repair:** Any openings in the main panels in the shop and basement should be covered. **Repaired**

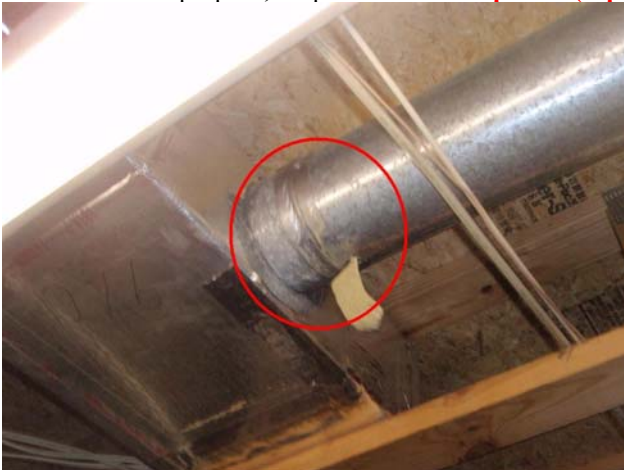
- **Improve:** Loose fitting joints and/or openings in the ductwork should be improved. Duct tape is not the appropriate material for this purpose, despite its name. **Repaired (replaced with proper tape)**
