Star Home Inspection Services

Home Inspection Report

904 Sweet Cherry Pl, Belton, MO 64012

Inspection Date: 2/25/2009

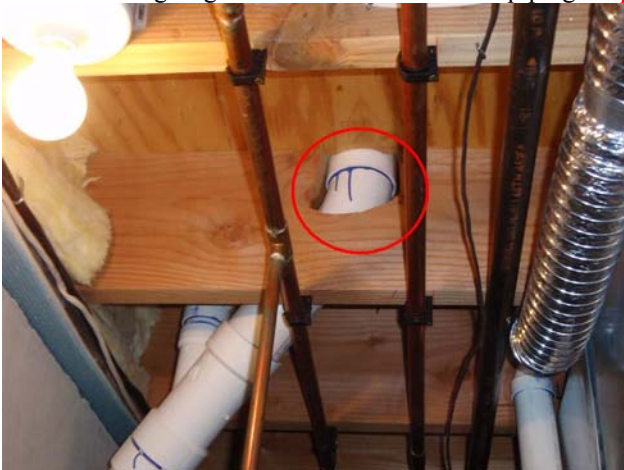
- **Monitor:** Floor joist in furnace room ceiling is notched and or cut. This weakens the joist and risks structural damage; if any further movement or cracking is observed, repairs or additional support will be needed. This notch appears to have been cut during original construction for waste piping. **Repaired**

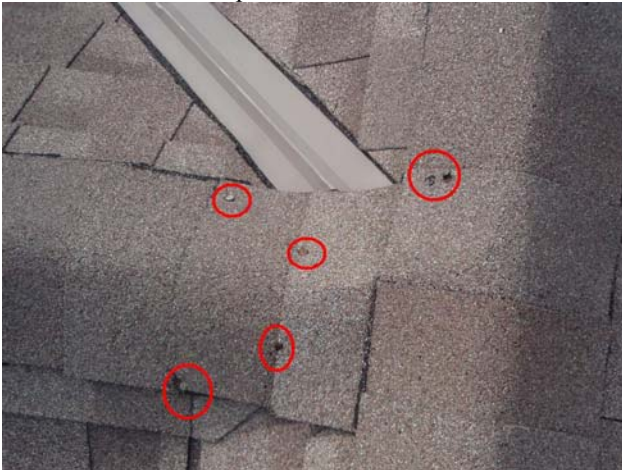
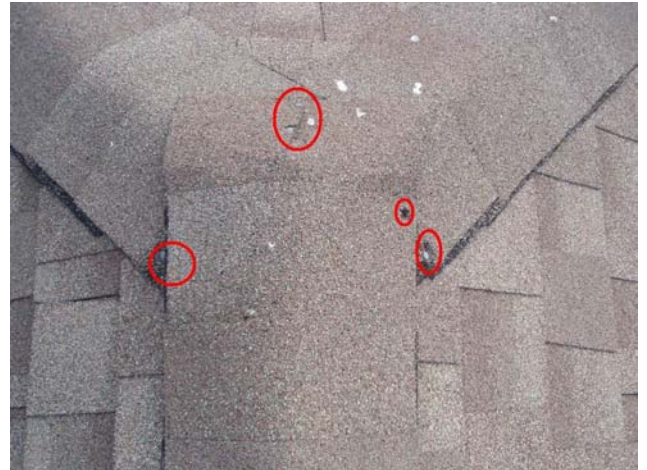
- **Repair:** Exposed nail heads were observed in the roofing shingles and/or ridge caps. All exposed nail heads should be caulked to reduce the potential of leaks.

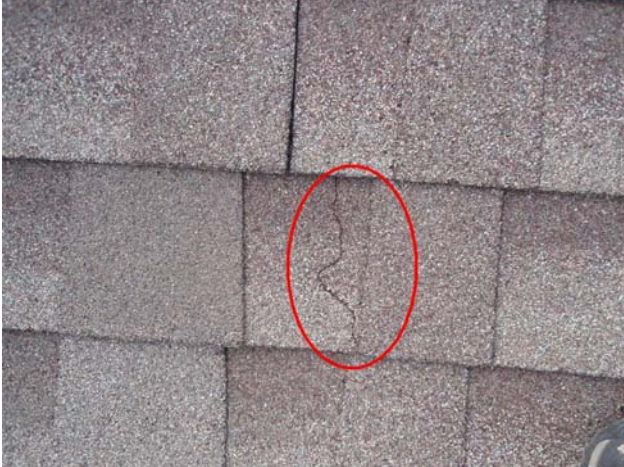
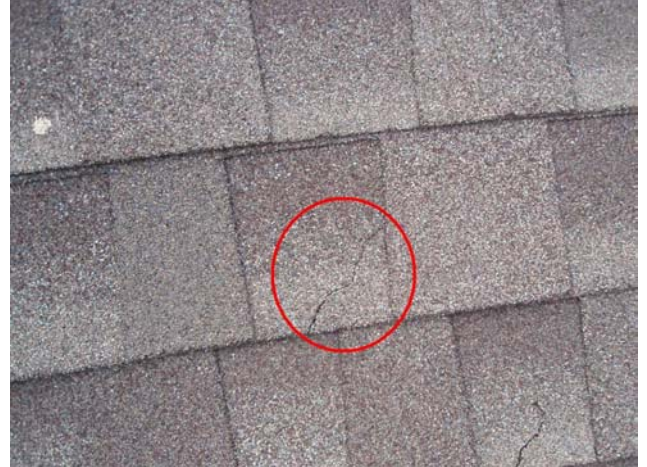
- **Recommend:** Minor cracks at a few shingles were noted. Recommend sealing these cracks with caulk.

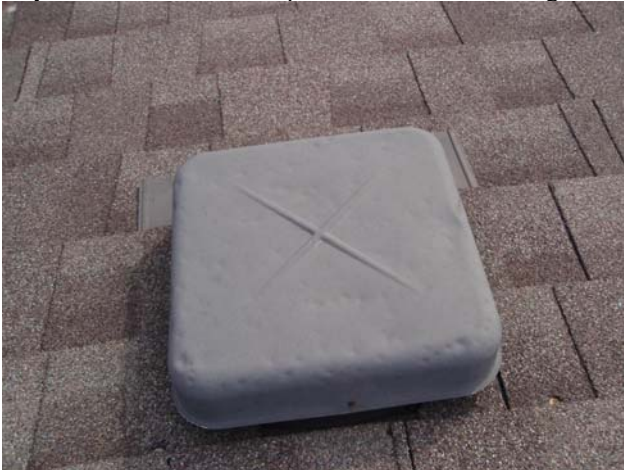
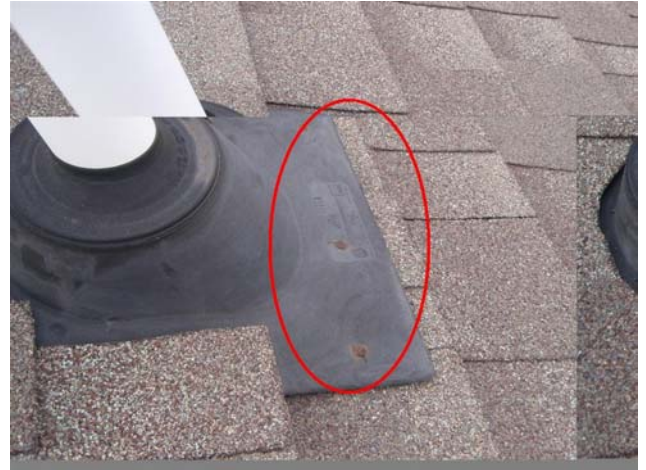
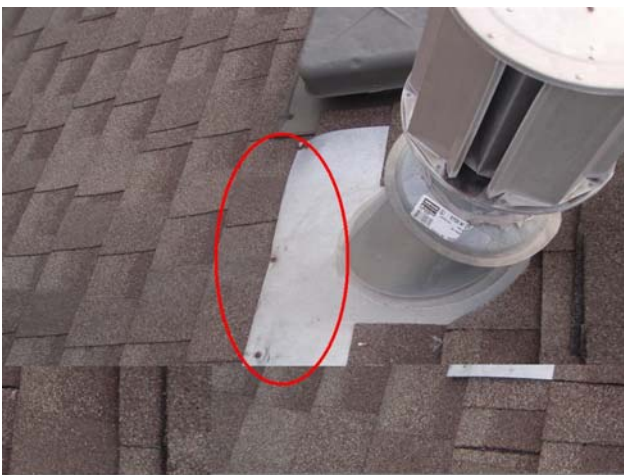
- **Monitor:** The roof vents show evidence of cosmetic hail damage.
- **Repair:** Nail heads are exposed at the vent flashings. They should be sealed to reduce risk of leaks.

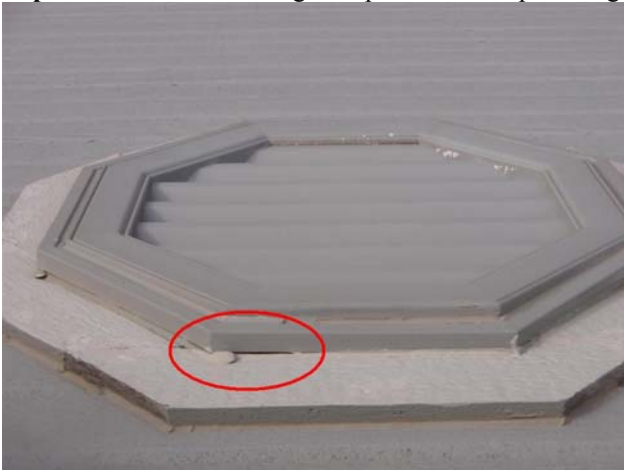
- **Repair:** Localized caulking is required at the top of the garage gable vent.

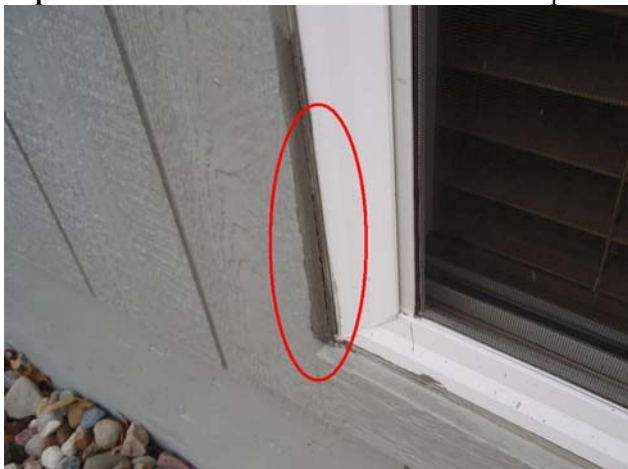
- **Repair:** The window at the west side basement requires caulking.
