**Star
Home
Inspection Services**

Home Inspection Report

9101 W 148th Terr Overland Park, KS 66221

Report Number: 04272011-1A

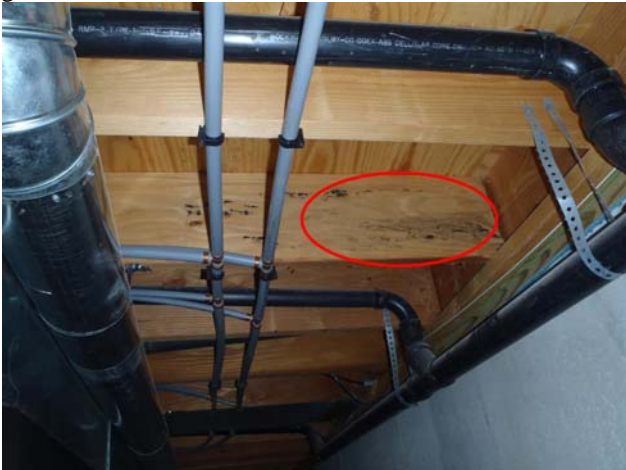
- **Monitor:** Construction mold was visible on some floor and wall joists in the unfinished basement. This is mold that grows on the lumber while lying in the weather during construction. Most homes have some level of this mold and it goes dormant once removed from the elements and normally does not present any problems.

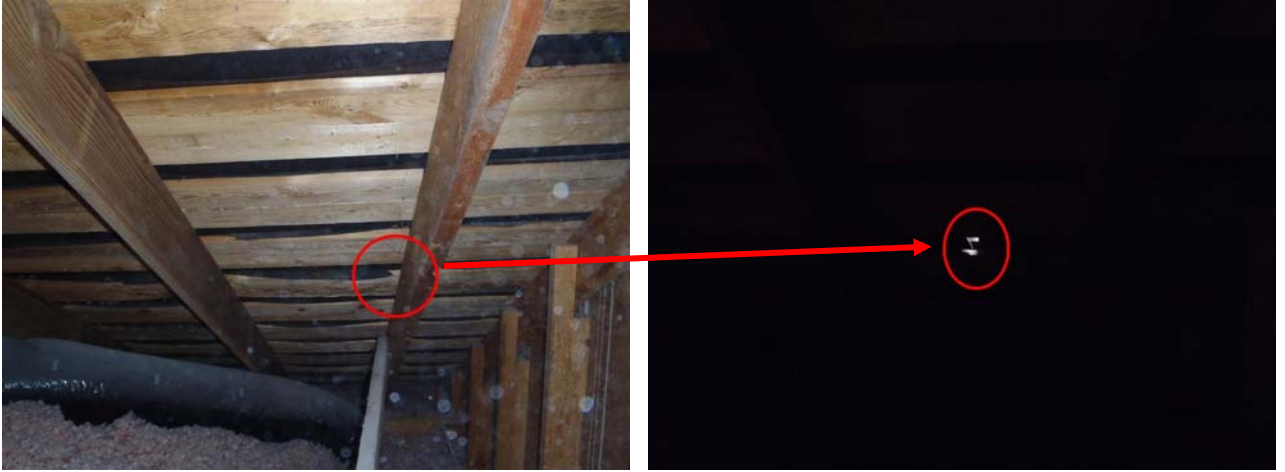
- **Repair:** While investigating the roof structure, outside light was visible. Any openings in the roof should be repaired to avoid leaks.

Repair: While investigating the roof structure, outside light was visible. Any openings in the roof should be repaired to avoid leaks. **Will Repair: Roof will be replaced by Larry Vaught Roofing.**

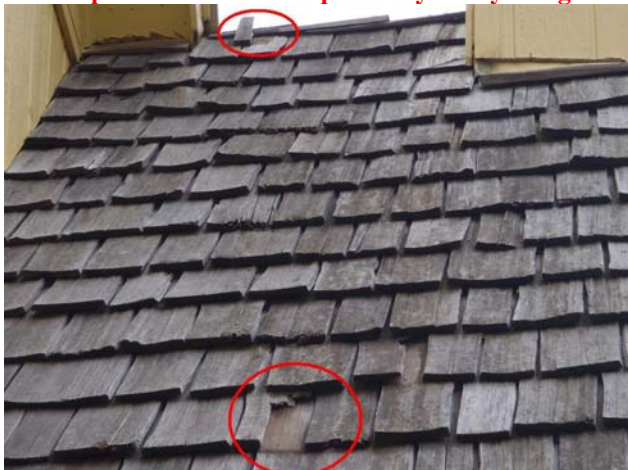
- **Major Concern, Repair:** What appears to be hail damage was observed on the roof. Hail damage can shorten the life of a roof. This should be investigated further and may eligible for an insurance claim. The life expectancy of wood roofs is generally 15 to 20 years with tune-ups normally needed around the 10th year. This will depend on several factors such as the quality of shingle or shake, the slope of the roof (steeper is better), the amount of exposed shingle, and the amount of sun or shade. As with all roofs, annual maintenance is needed. Cracked, curled, or displaced shingles or shakes should be repaired. As a rule of thumb, replacement of the entire roof covering may be logical if more than ten percent of the wood roof requires repair. Split, loose or damaged ridge caps of the roofing require repair.

Will Repair: Roof will be replaced by Larry Vaught Roofing.

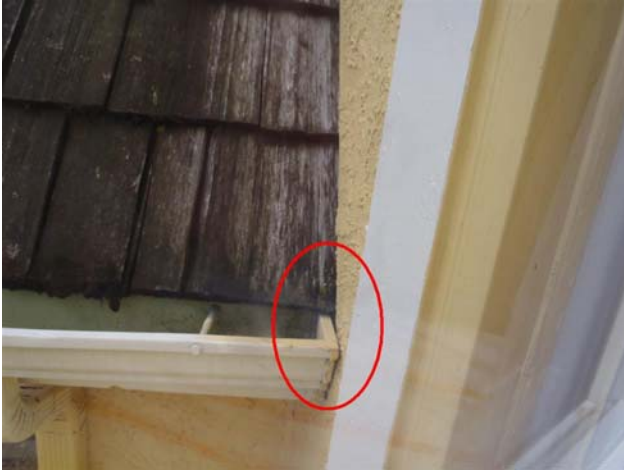
- **Repair:** The installation of kickout flashings on the front of the home is incomplete and should be repaired when making roof repairs to avoid leaks.

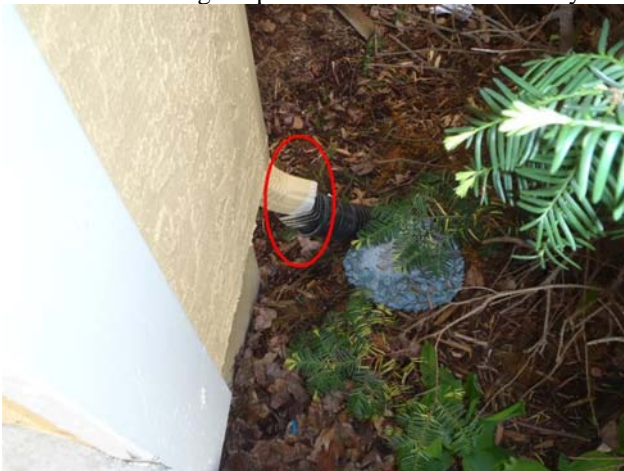
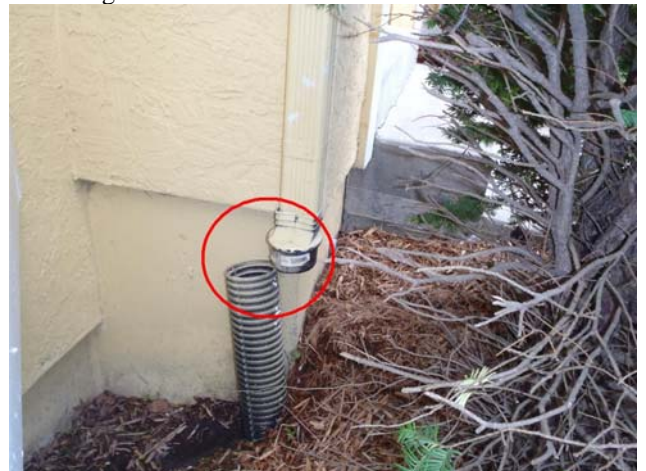
- **Repair:** The gutters require cleaning to avoid spilling roof runoff around the building – a potential source of water entry or water damage.
- **Repair:** Disconnected gutter downspouts should be repaired or replaced as necessary to avoid spilling roof runoff around the building – a potential source of water entry or water damage.

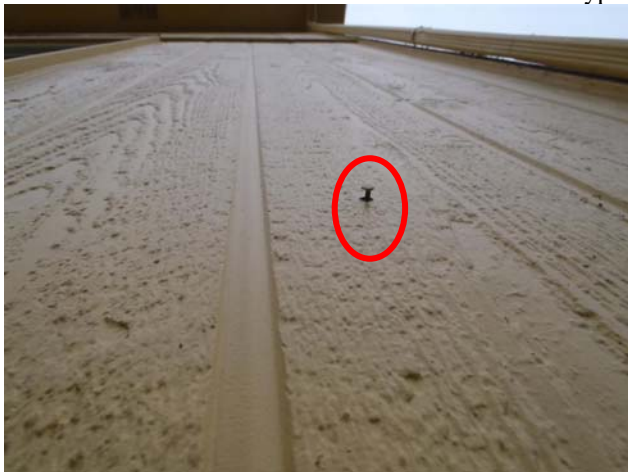
- **Repair:** The exterior siding paint is peeling and/or worn thin in localized areas (i.e. bottom edge of siding.) These areas should be painted to prevent water damage or rot in the future.
- **Monitor, Repair:** Localized loose nails should be secured. Siding of this type requires monitoring and maintenance. It has a tendency to pop out past nail heads creating a space where two panels join together. Re-securing and caulking the seams and nail holes is standard maintenance for this type of siding.

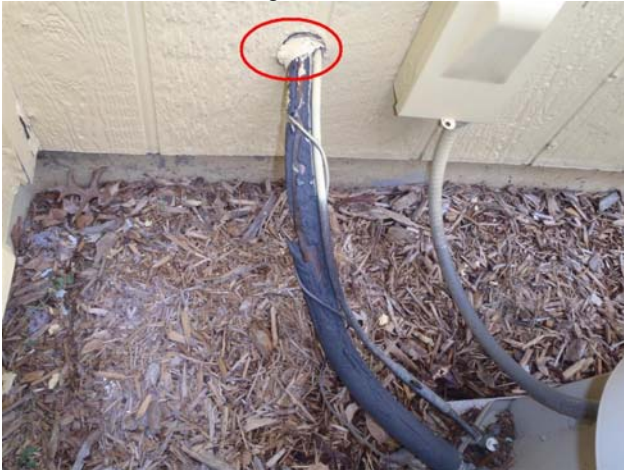
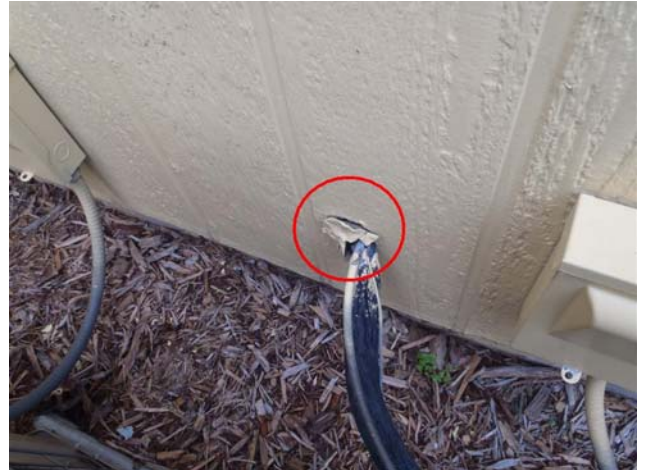
- **Repair:** Any openings in the exterior siding should be sealed. An example is where the air conditioner refrigerant lines enter the house. Caulking is needed.

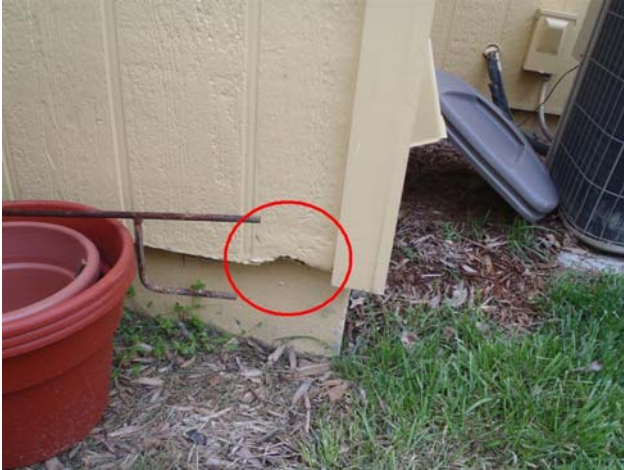
- **Repair:** Localized rot was observed in the siding (i.e. southwest corner.) Following repair of the damaged areas (which should be combined with exterior painting/maintenance) proper maintenance of the siding and control of water from roof or surface runoff can avoid further damage.

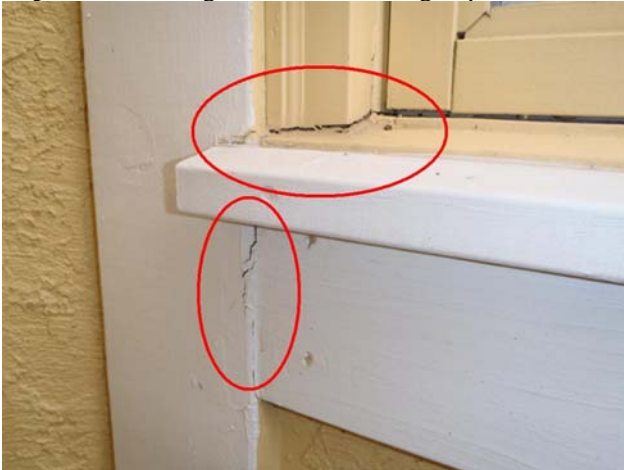
- **Repair:** The siding trim needs caulking improvements in localized areas to prevent water damage and rot.

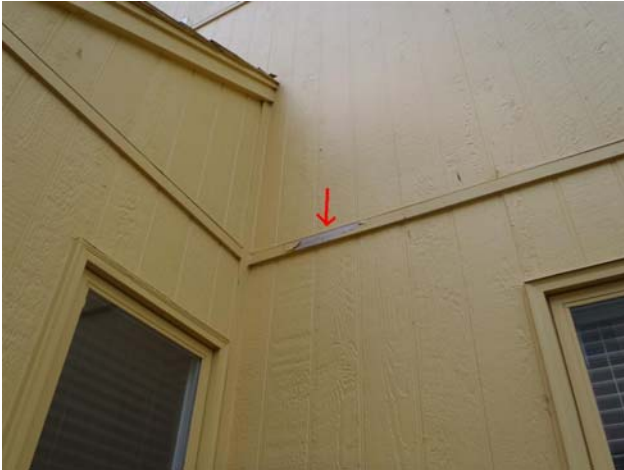
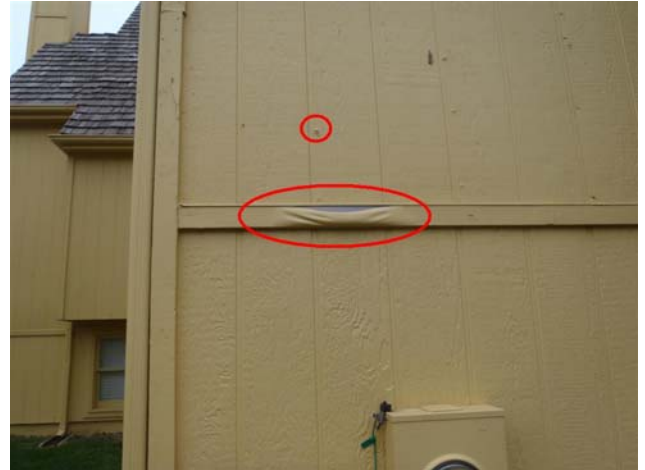
- **Repair:** The paint on the trim around the siding is peeling. These areas should be painted to prevent water damage and rot.

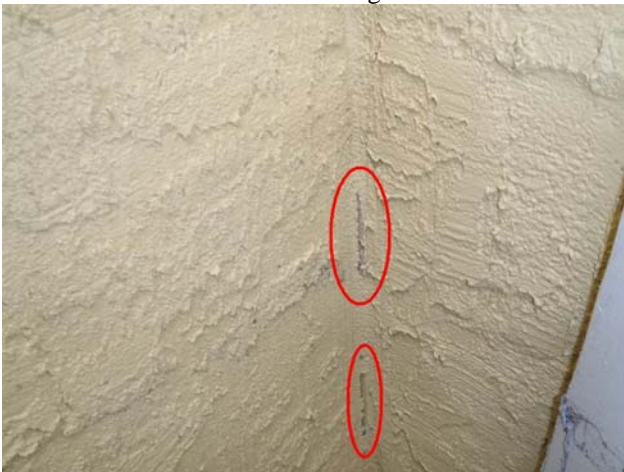
- **Repair:** Minor cracks were observed in the exterior walls. These areas should be repaired to prevent water intrusion. There is extra risk of hidden damage in such areas.

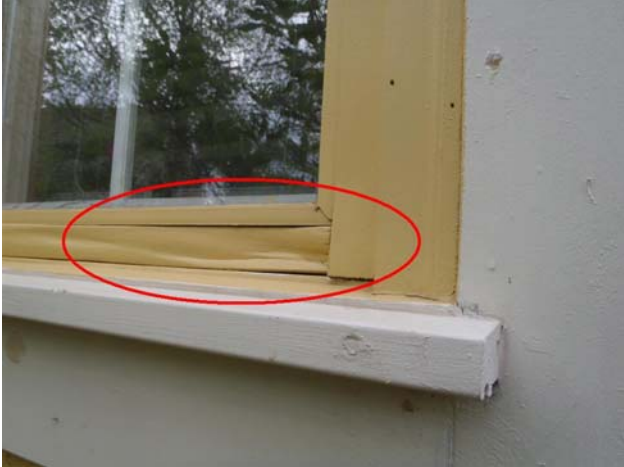
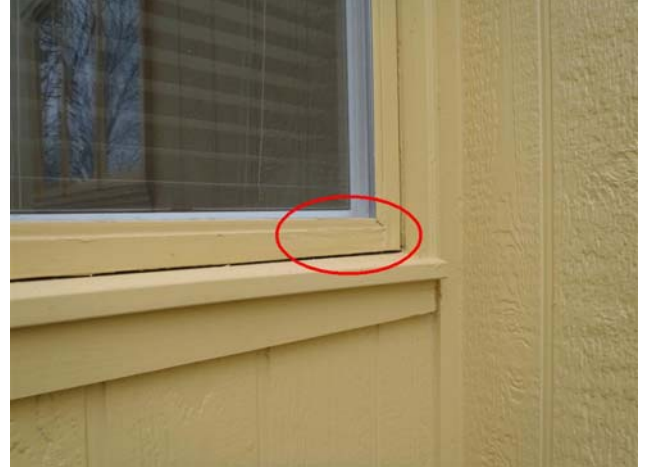
- **Repair:** Some of the window frames require painting and caulking.
- **Repair:** Evidence of rot was visible on window trim/frames (i.e. two front bay windows and laundry room window.) This condition will worsen over time if left unattended. Repair to the window frame can usually be accomplished by a skilled carpenter. It's recommended that a thorough "inventory" be taken by a competent window repair technician to ascertain exactly how many areas will need to be repaired or replaced. Further evaluation by a specialist may well identify additional areas that require servicing.

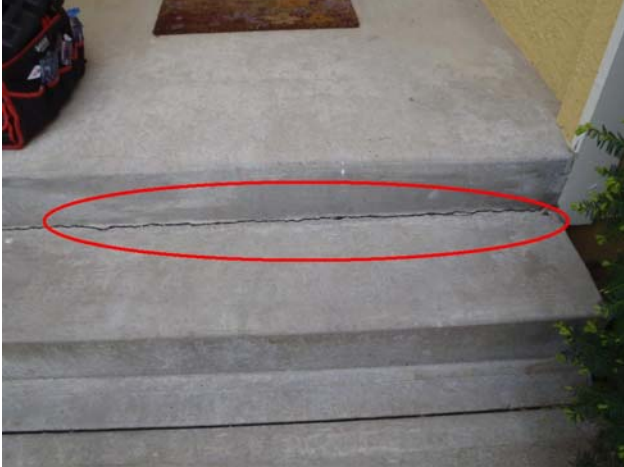
- **Recommend:** The patio steps should be painted or stained to improve durability.
- **Repair, Safety Issue:** Nail pops in the patio steps were observed. This is a safety issue and the nails should be hammered flush.
- **Monitor, Repair:** The patio steps shows evidence of rot. Replacement may eventually be desired. In the interim, localized repairs could be undertaken.
- **Recommend:** The crack between the front steps should be sealed to extend the life of the steps.

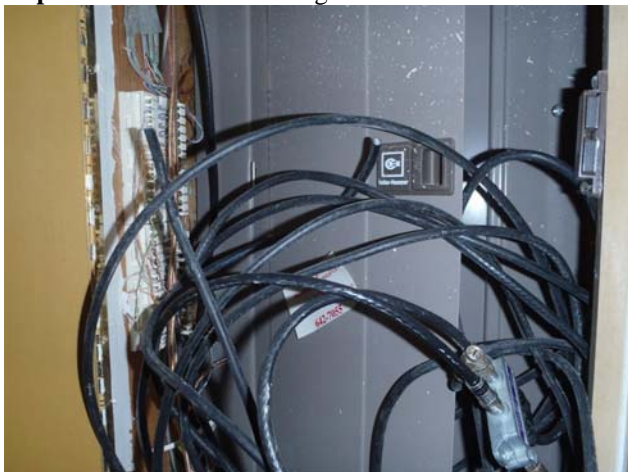
- **Improve:** Loose cable wiring in front of the main electrical panel could be improved.

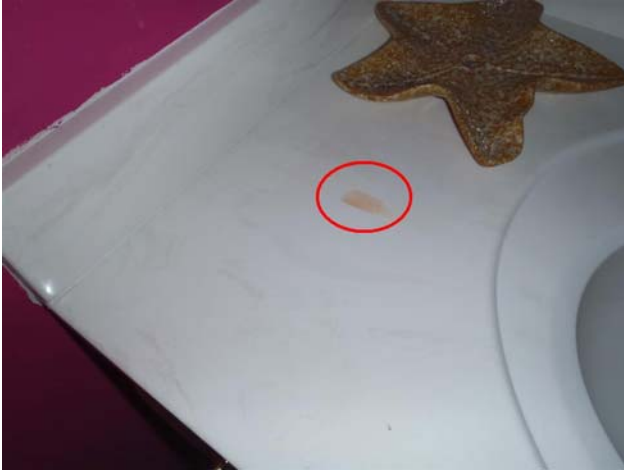
- **Monitor, Repair:** Low hot water pressure was observed at the east kitchen sink. This should be investigated further and repaired if necessary.
- **Repair:** The laundry room sprayer nozzle is inoperative and needs repair.
- **Monitor:** The upstairs east bath, south sink counter is stained.

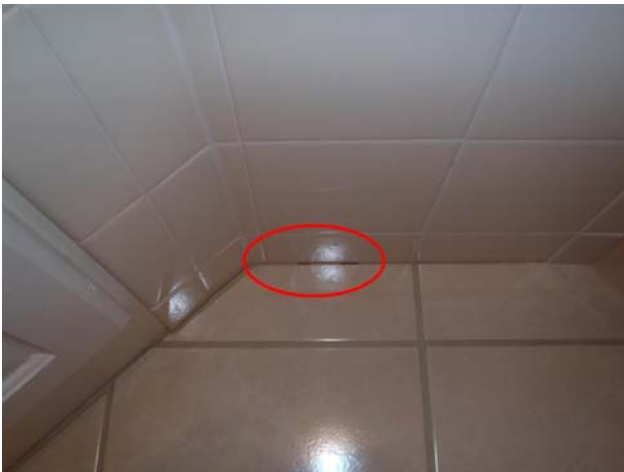
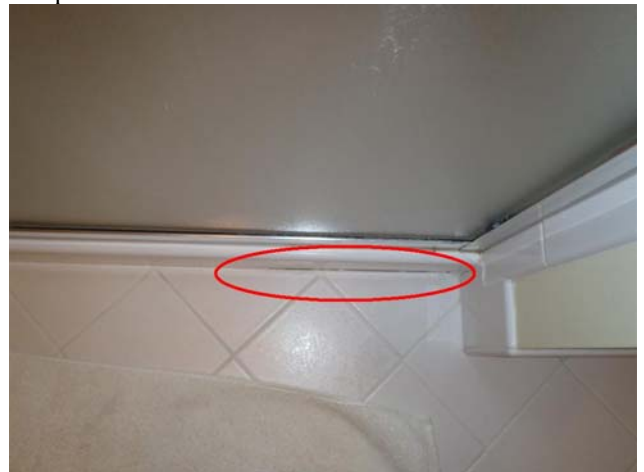
- **Repair:** The upstairs east bath, south sink drain plug is inoperative and needs repair.
- **Repair:** The toilet is loose (i.e. basement bath, upstairs northwest bedroom bath and upstairs east bath.)
- **Repair:** The basement bath shower head is leaky.
- **Improve:** Cracked, deteriorated and/or missing shower stall caulk in the basement bath and master bath should be replaced.
- **Improve:** Cracked, deteriorated and/or missing bathtub and shower enclosure grout and/or caulk in the upstairs northwest bedroom bath shower and master bath tub could be improved.

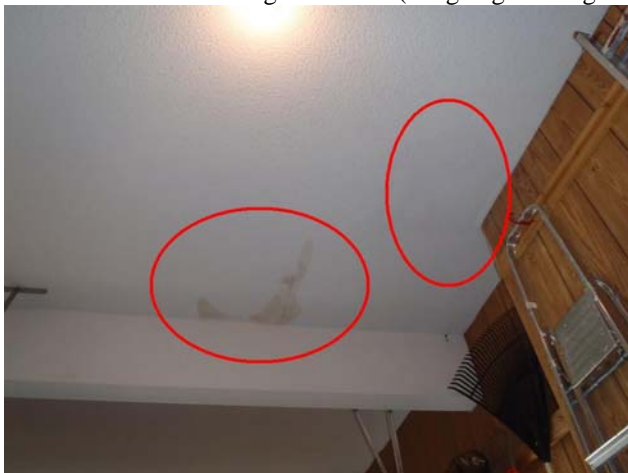
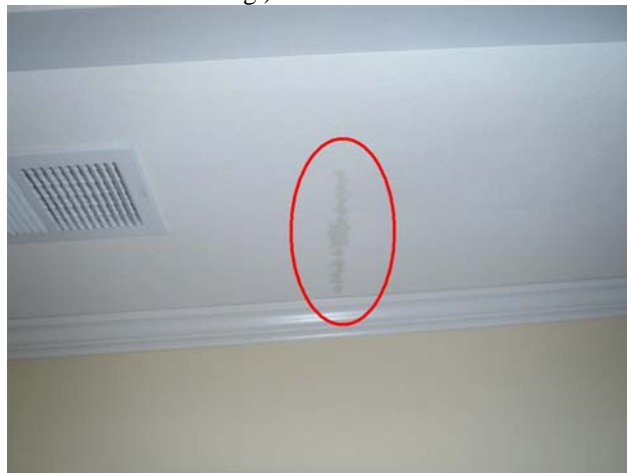
- **Monitor:** Water staining was noted (i.e. garage ceiling and master bedroom ceiling.)

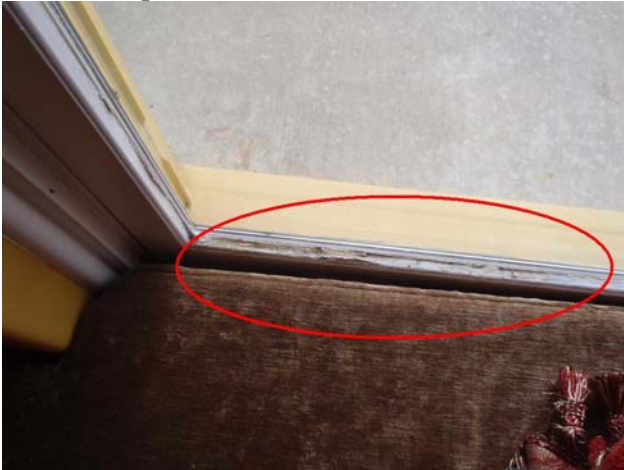
- **Monitor, Repair:** The interior window trim on the northeast basement window is peeling. Repair is discretionary.

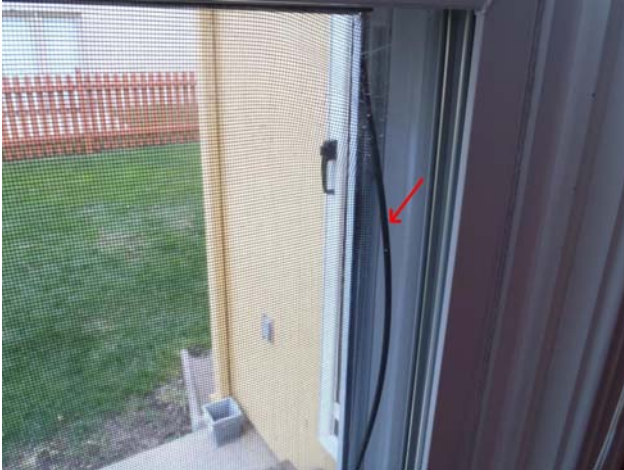
- **Monitor:** A few of the basement window(s) are painted or otherwise stuck shut. Improvement can be undertaken as desired.
- **Repair:** Loose screen was noted on the south living room window.
