# Star Home Inspection Services

## *Home Inspection Report*

**912 W Woodside Dr, Olathe, KS 66061**

**Report Number: 05062009-1A**

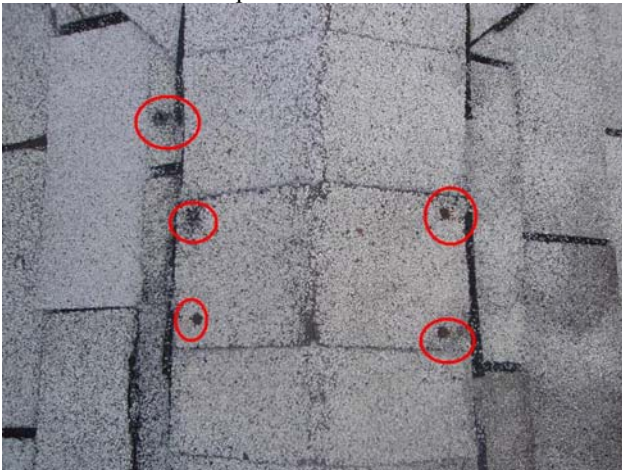
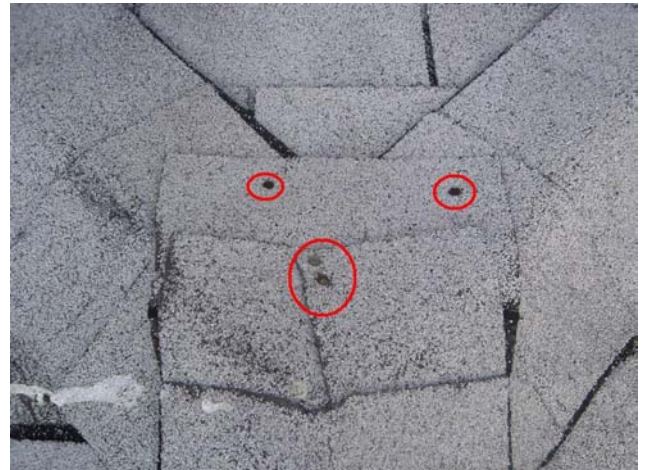
- **Repair:** Exposed nail heads were observed in the roofing shingles and/or ridge caps. All exposed nail heads should be caulked to reduce the potential of leaks.

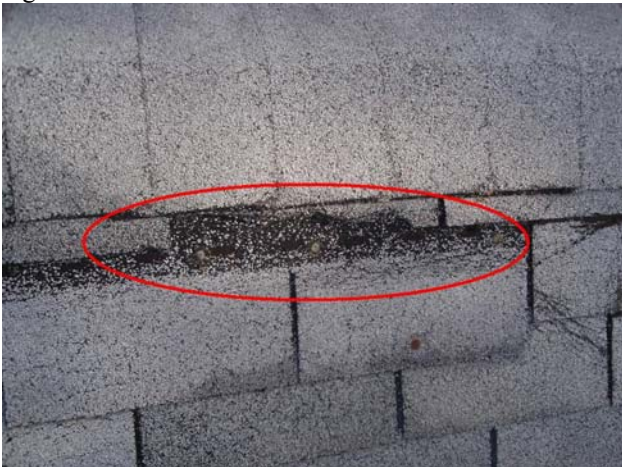
- **Monitor:** Missing tabs observed at ridge cap. These areas should be monitored closely, especially after instances of high wind.

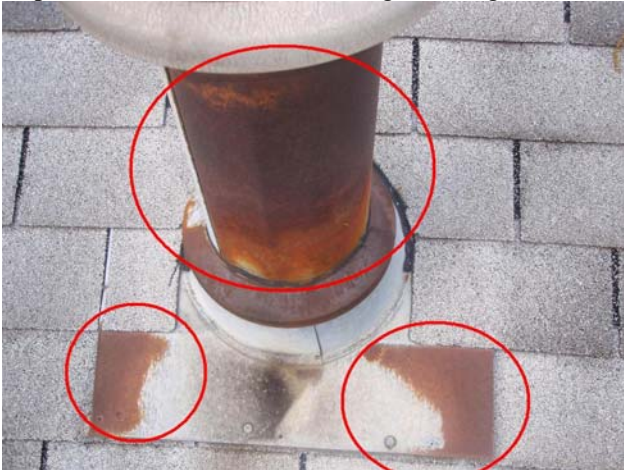
- **Improve:** The furnace vent flashing is rusting. Recommend it be painted to extend its life. **Repaired (painted)**

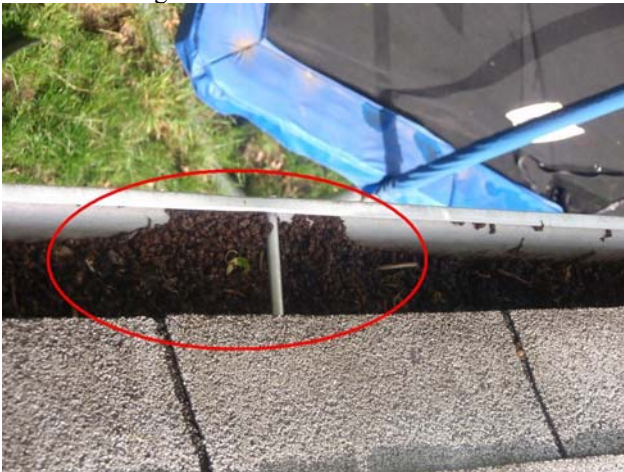
- **Repair:** The gutters require cleaning to avoid spilling roof runoff around the building – a potential source of water entry or water damage.
