**Star
Home
Inspection Services**

Home Inspection Report

9200 Wyandotte St, Kansas City, MO 64114

Inspection Date: 06/03/2009

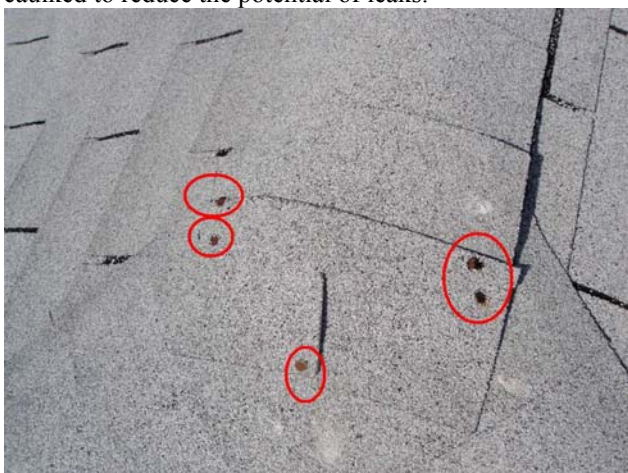
- **Repair:** Exposed nail heads were observed in the roofing shingles and/or ridge caps. All exposed nail heads should be caulked to reduce the potential of leaks.

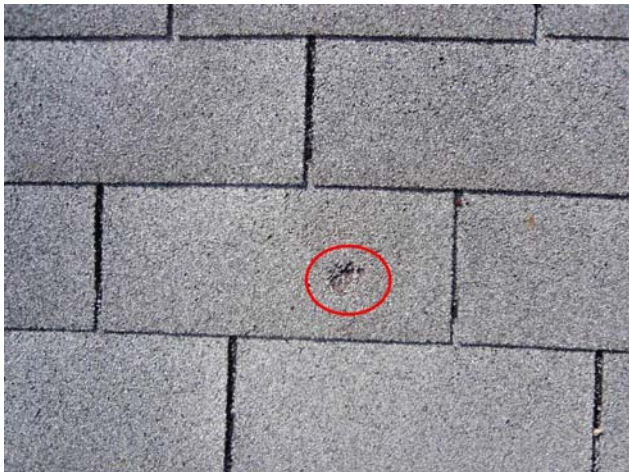
- **Monitor:** Damage to a roof tab was observed. This area should be monitored, caulking at the damaged tab may be desirable.

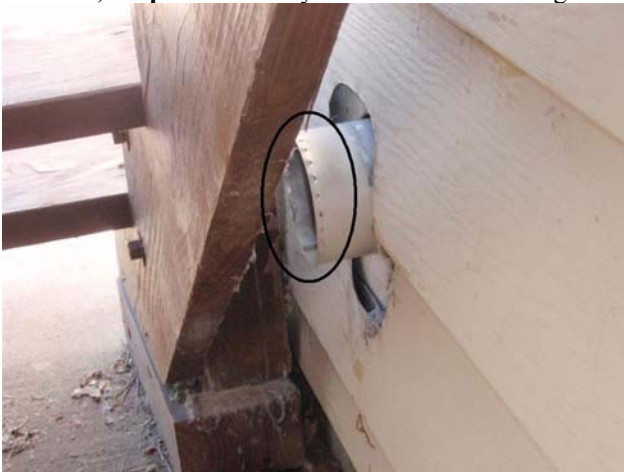
- **Monitor, Repair:** Localized damage of the vinyl was observed near the overhead garage doors.
- **Monitor, Improve:** The dryer vent cover is missing. This should be improved if practical.

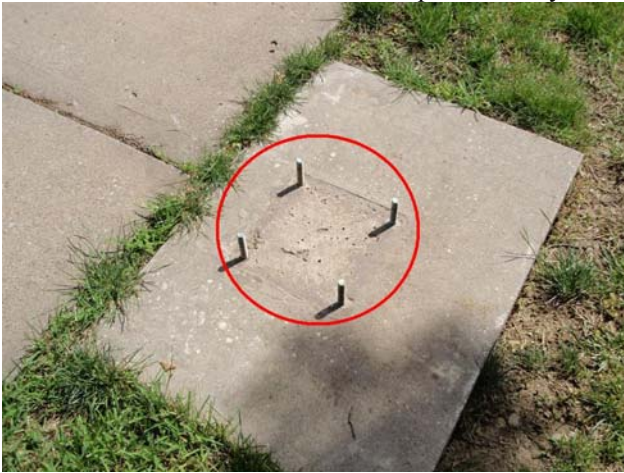
- **Monitor:** The driveway has settled and cracked. Persisting movement may result in the need for repairs.
- **Repair, Safety Issue:** The driveway presents a trip hazard. This condition should be altered for improved safety.
- **Repair, Safety Issue:** The bolts for a previous basketball goal should be covered or cut off flush with the pavement. This condition should be altered for improved safety.

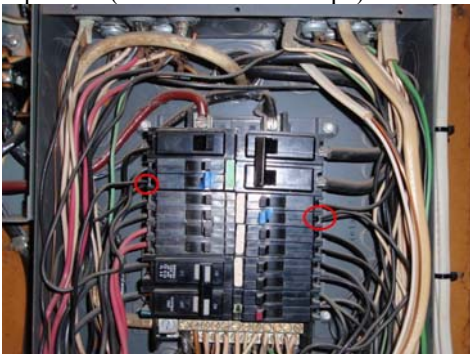
- **Repair:** Oversized breaker within the main distribution panel for the air condition should be replaced. The data plate on the unit specifies a maximum breaker size of 35 Amps and the one in the panel is 40 Amps.
- **Repair:** Circuits within the main distribution panel that are doubled up (referred to as "double taps") should be separated (marked with blue tape). Each circuit should be served by a separate fuse or breaker.

Energy Source:	•Electricity
Central System Type:	•Air Cooled Central Air Conditioning •Manufacturer: Lennox
	•Serial Number: 5899F 18106
Size of Circuit:	•Circuit Size: Minimum Circuit Size 21.2 Amps Maximum Circuit Breaker Size 35 Amps •Breaker Size In Main Panel: 40
Other Components:	•House Fan

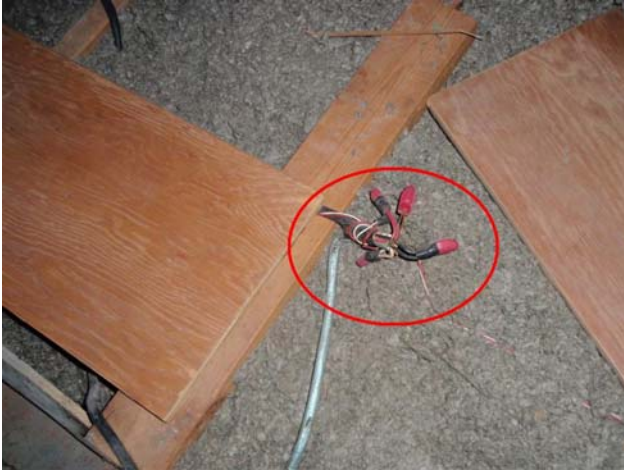
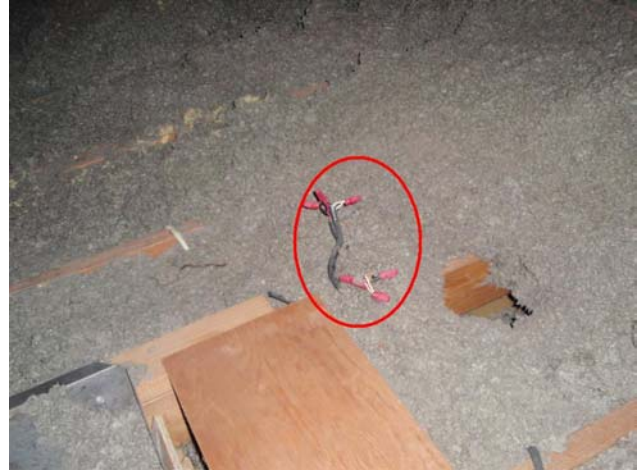
- **Monitor, Repair:** Extension cords should not be used as permanent wiring. This wiring servicing the garage door openers should be removed and replaced with permanent wiring and an outlet(s).
- **Repair:** Improper electrical connections should be repaired. All electrical connections should be made inside junction boxes fitted with cover plates (examples in attic).

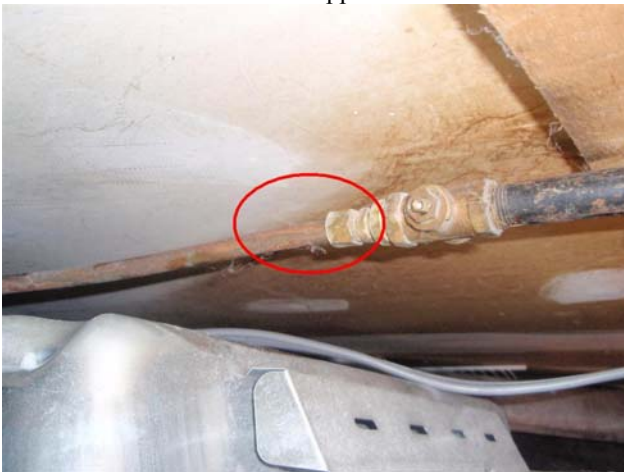
- **Monitor:** Copper tubing is no longer suitable for gas piping at some utility company providers. It's recommended the utility company provider be contacted regarding the suitability of copper piping and whether this unused pipe at the dryer should be disconnected and capped off.

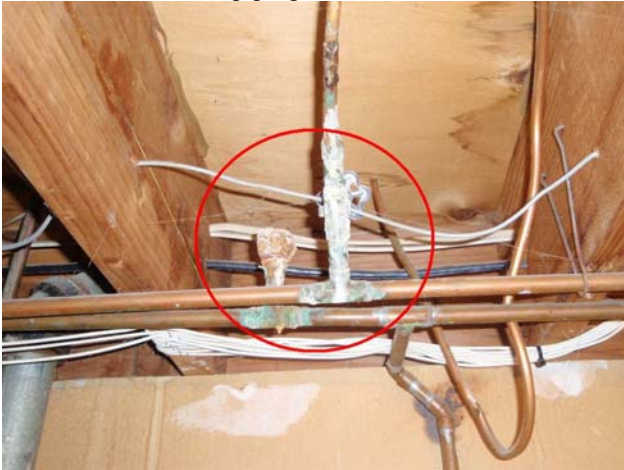
- **Monitor:** The water piping above the washer shows evidence of previous leakage.
