**Star
Home
Inspection Services**

Home Inspection Report

923 SW Foxtail Dr Grain Valley, MO 64029

Inspection Date: 03/29/2010

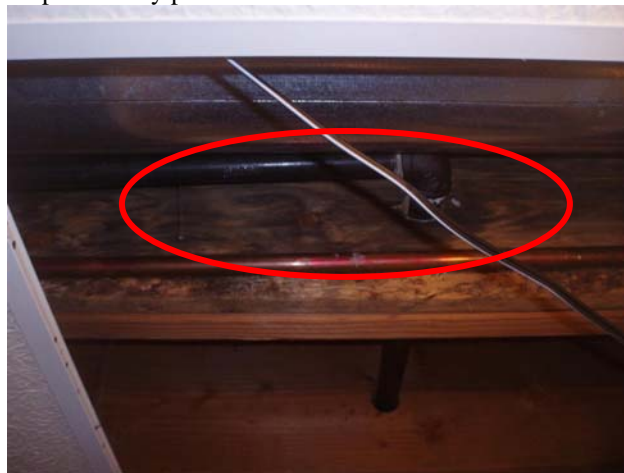
Floors

- **Monitor:** Construction mold was visible on some floor joists. This is mold that grows on the lumber while lying in the weather during construction. Most homes have some level of this mold and it goes dormant once removed from the elements and normally does not present any problems.

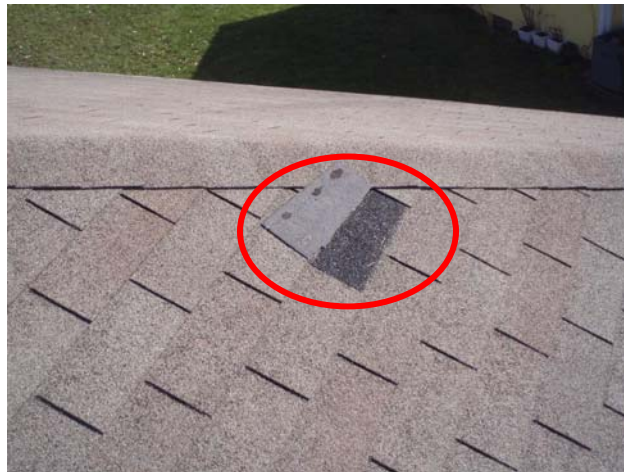
Sloped Roofing

- **Monitor, Repair:** Missing tabs were observed. Repairs are recommended.

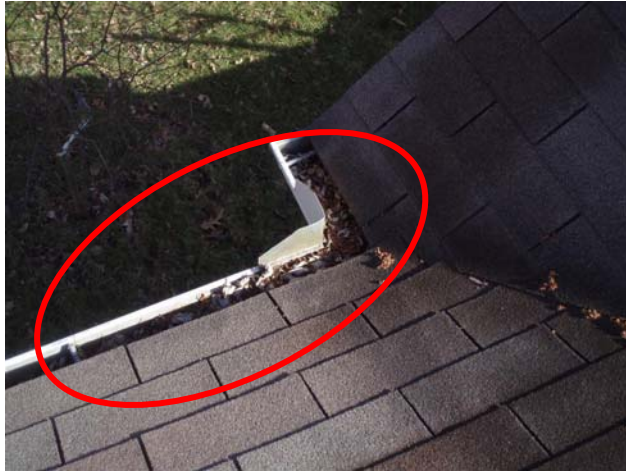
Gutters & Downspouts

- **Repair:** The gutters require cleaning to avoid spilling roof runoff around the building – a potential source of water entry or water damage.

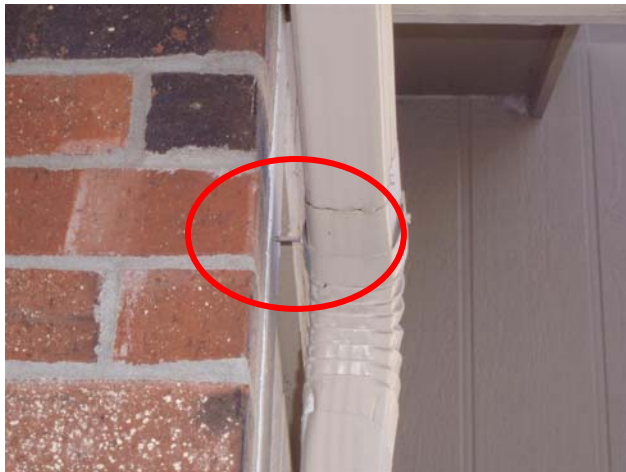
- **Repair:** The gutter on the northwest corner of the house is pulling away from the siding. The gutter should be re-secured.

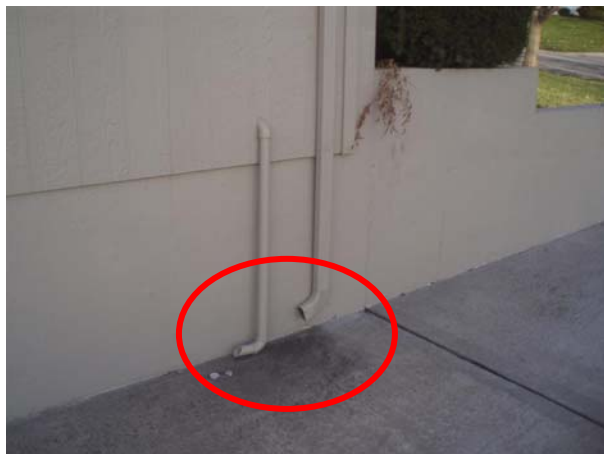
- **Repair:** The downspouts on the northeast corner of the house and along the driveway should discharge water at least five (5) feet from the. Storm water should be encouraged to flow away from the building at the point of discharge.

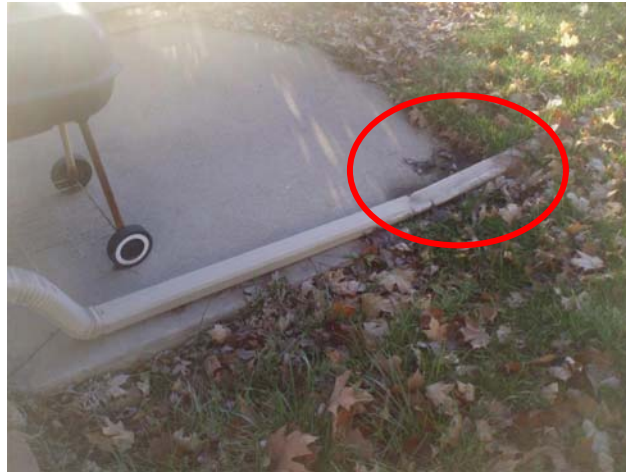
- **Repair:** The downspout on the southwest corner of the house has been damaged and should be replaced to ensure proper storm water flow.

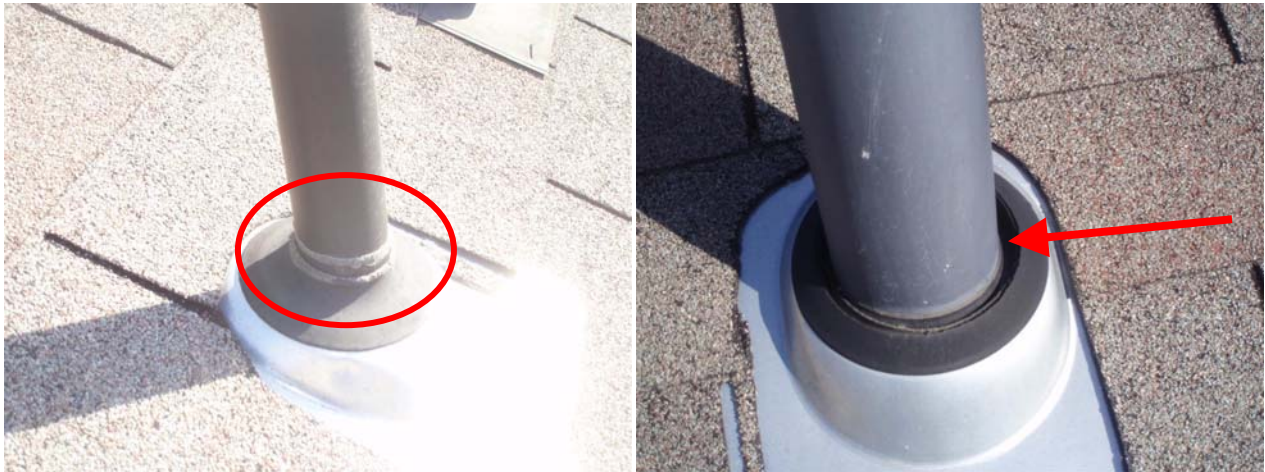
Flashings

- **Monitor, Repair:** The plumbing vent flashing boot and radon vent flashing boots have split or are pulling away from the pipe making them vulnerable to leaks. It's recommended that the boot be caulked or the flashing replaced.

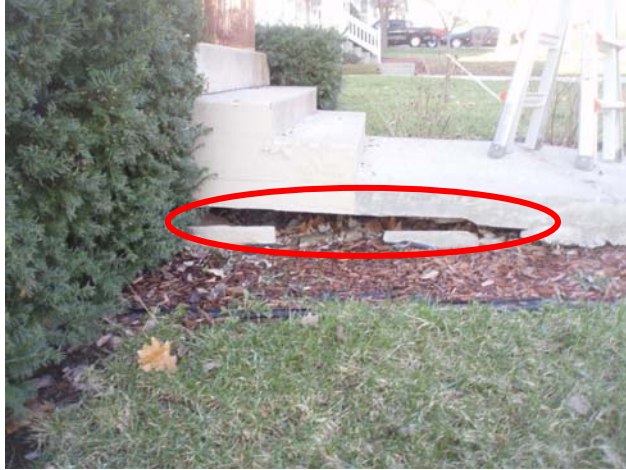
Porch

- **Monitor, Repair:** The steps serving the porch have settled and there is an absence of soil underneath due to settlement and/or erosion. It's recommended the cavity be filled to help prevent further settlement.

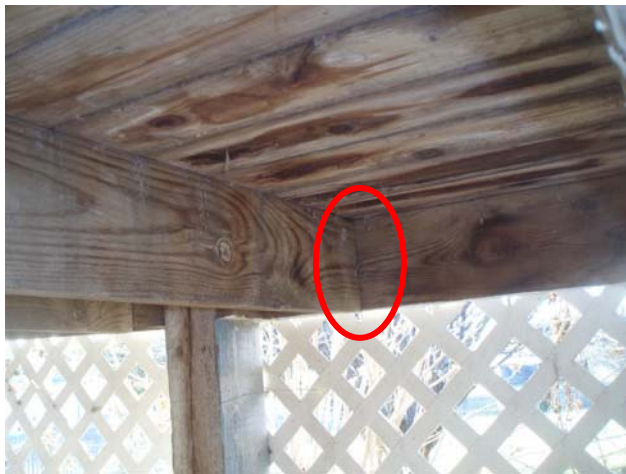
Deck

- **Recommend:** The deck should be painted or stained to improve durability.
- **Recommend:** Joist hangers should be installed where missing.

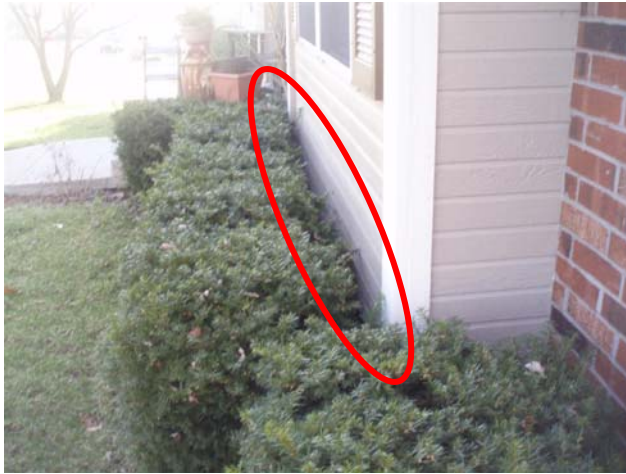
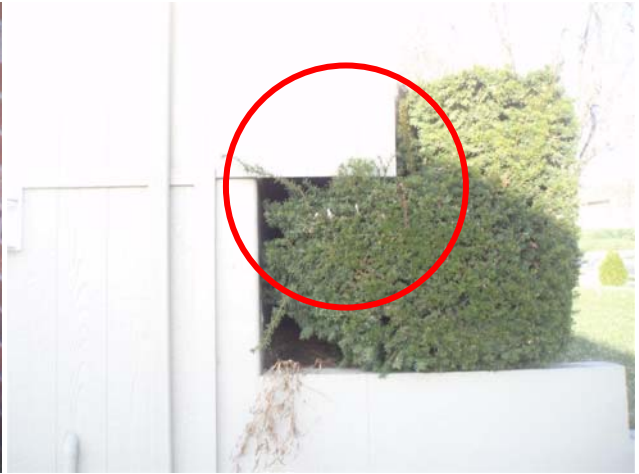
Landscaping

- **Monitor:** Shrubs, bushes and/or vines growing on exterior walls should be kept trimmed away from the structure to reduce the risk of water damage and insect infestation.

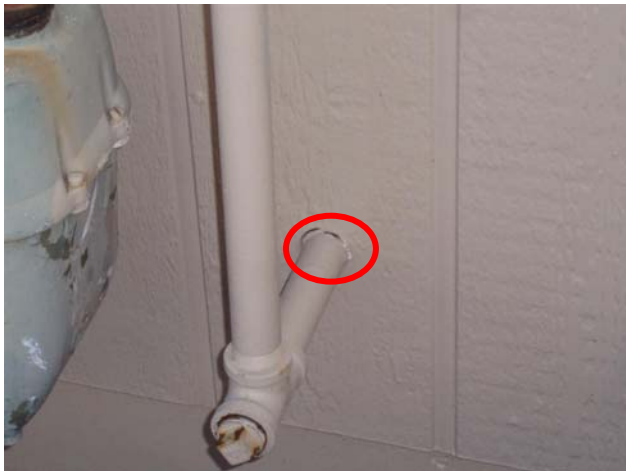
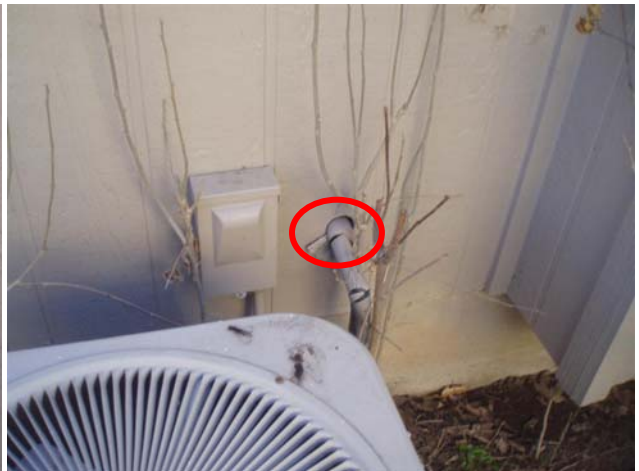
- **Repair:** Any openings in the exterior siding should be sealed. The locations where the gas supply line and air conditioner refrigerant lines enter the house need caulking.

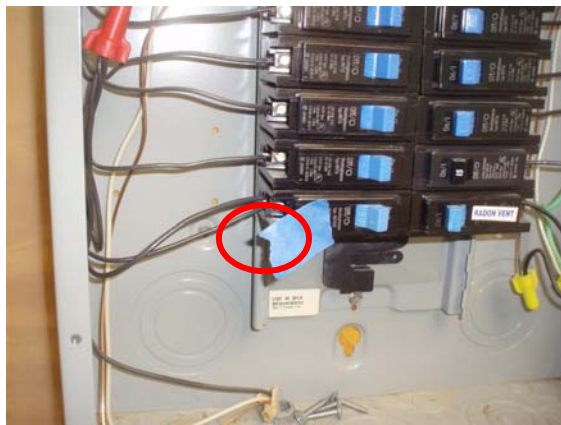
Main Panel

- **Repair:** Additional screws are needed to properly secure the main panel cover plate.
- **Repair:** Circuits within the main distribution panel that are doubled up (referred to as "double taps") should be separated. Each circuit should be served by a separate fuse or breaker.

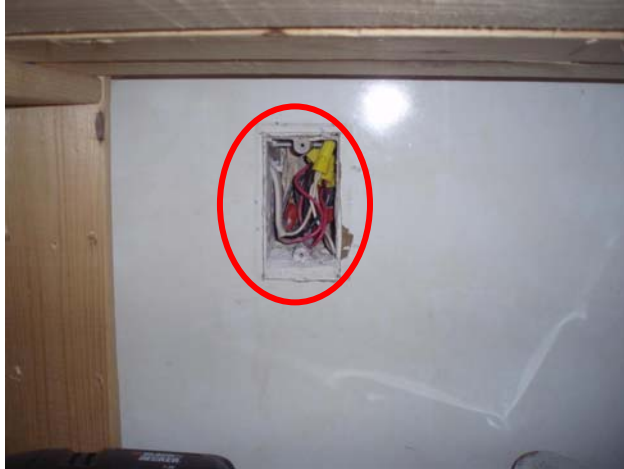
Switches

- **Repair:** Missing switch/outlet cover plate in the garage should be replaced to avoid a shock hazard. Additionally, the switch cover plate in the front, middle bedroom is loose and should be secured.

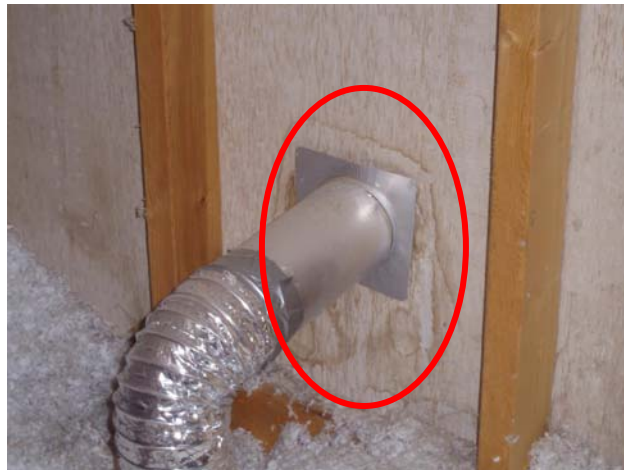
- **Monitor:** Water staining was noted where the kitchen vent exhaust exits through the siding. There is no evidence of active water infiltration.

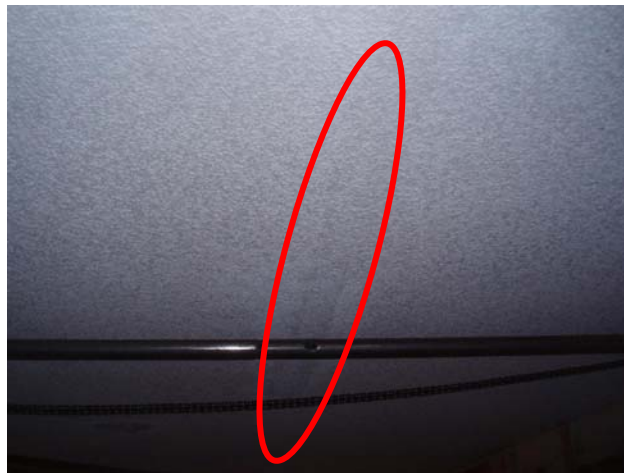
Wall / Ceiling Finishes

- **Monitor:** Water staining and repaired water damage was noted in the garage near the south side of the house.
