**Star
Home
Inspection Services**

Home Inspection Report

9301 N Kentucky Ave Kansas City, MO 64157

Report Number: 10072009-1A

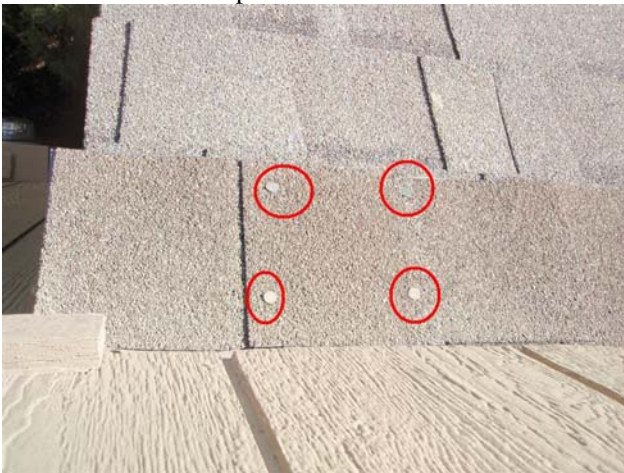
- **Repair:** Exposed nail heads were observed in the roofing shingles and/or ridge caps. All exposed nail heads should be caulked to reduce the potential of leaks.

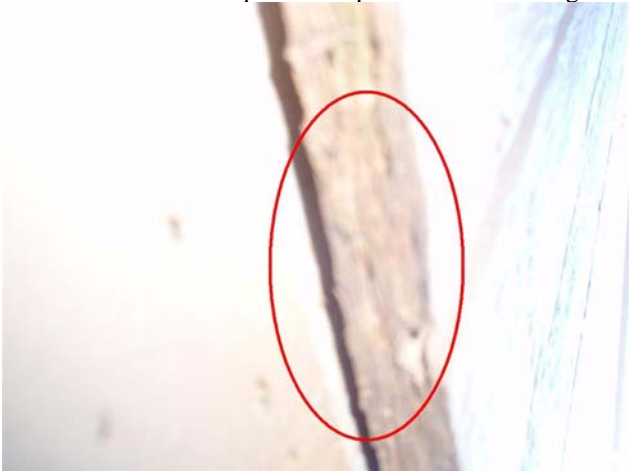
- **Repair:** The exterior siding paint is peeling and/or worn thin in localized areas (i.e. bottom edge at southwest corner). These areas should be painted to prevent water damage or rot in the future.
- **Monitor:** Siding of this type requires monitoring and maintenance. It has a tendency to pop out past nail heads creating a space where two panels join together. Re-securing and caulking the seams and nail holes is standard maintenance for this type of siding.
- **Repair:** Any openings in the exterior siding should be sealed. An example is where the air conditioner refrigerant lines enter the house. Caulking is needed. **REPAIRED**

- **Repair:** The exterior siding paint is peeling and/or worn thin in localized areas (i.e. bottom edge at southwest corner). These areas should be painted to prevent water damage or rot in the future.

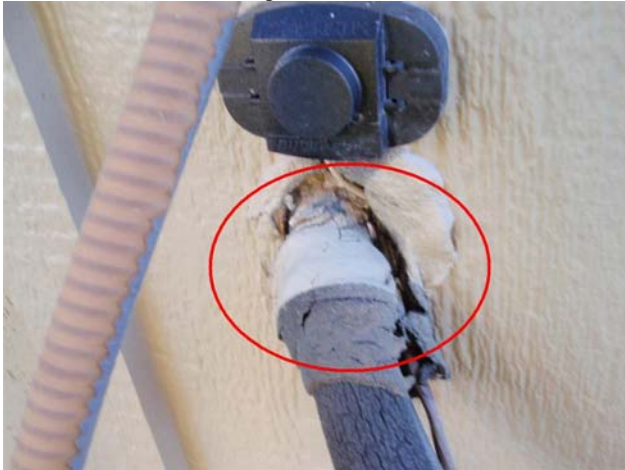
- **Repair:** Any openings in the exterior siding should be sealed. An example is where the air conditioner refrigerant lines enter the house. Caulking is needed. **REPAIRED**

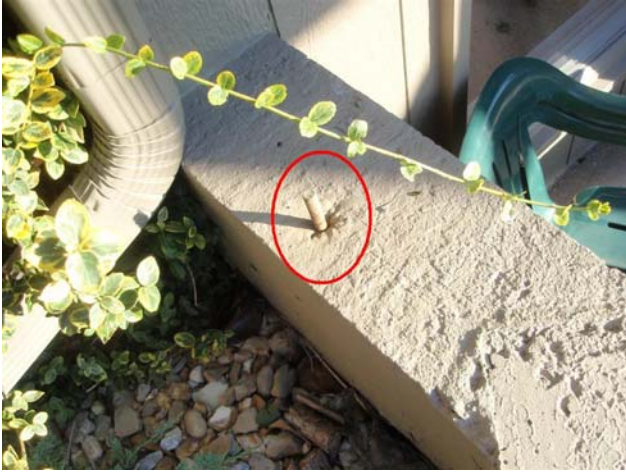
- **Repair:** Shrubs, bushes and/or vines growing on exterior walls need to be trimmed away from the structure to reduce the risk of water damage and insect infestation. **REPAIRED**
- **Repair, Safety Issue:** The bolt protruding from the southwest patio concrete retaining wall should be cut flush and caulked.

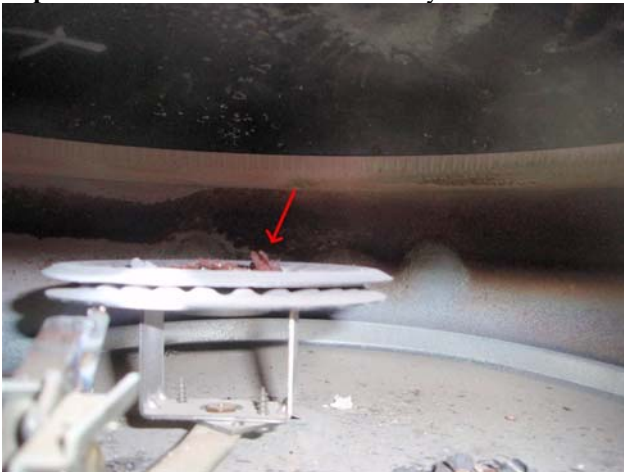
- **Monitor:** Water heaters have a typical life expectancy of 7 to 12 years. The existing unit is approaching or has exceeded this age range. One cannot predict with certainty when replacement will become necessary.
- **Repair:** The water heater burner is dirty. It should be cleaned and adjusted.

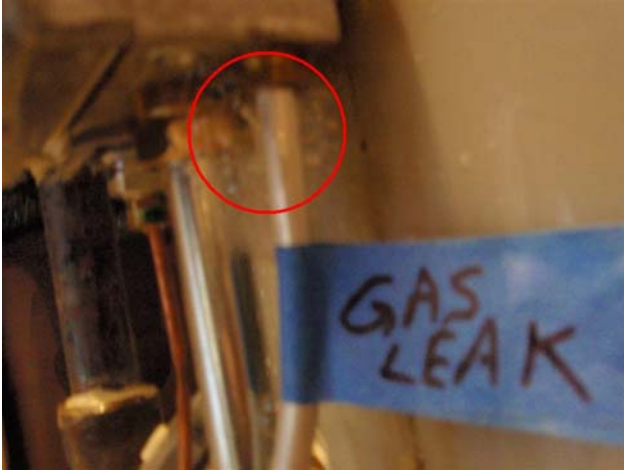
- **Repair, Safety Issue:** *A gas leak was detected at the bottom of the water heater controls with a TIF 8800 gas/carbon monoxide detector and confirmed with soapy water. This is a serious safety concern. It is recommended that the gas utility, HVAC company or plumber be engaged as soon as possible to make the necessary repairs. The current occupants of the home should also be notified.* **REPAIRED**
