# Star Home Inspection Services

## *Home Inspection Report*

**9512 N Lane Ave Kansas City, MO 64157**

**Inspection Date: 10/22/2010**

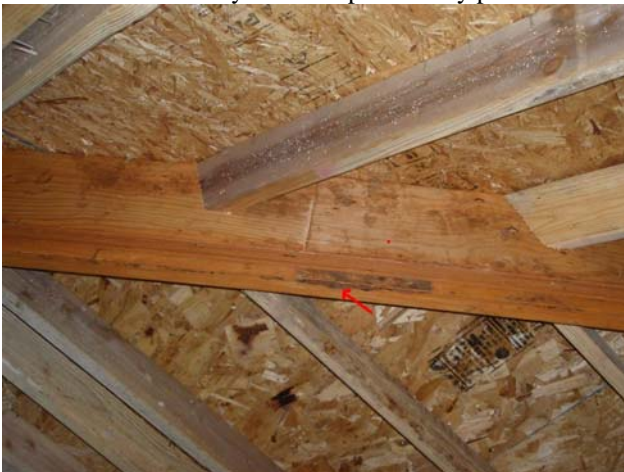
- **Monitor:** Construction mold was visible on some roof rafters. This is mold that grows on the lumber while lying in the weather during construction. Most homes have some level of this mold and it goes dormant once removed from the elements and normally does not present any problems.

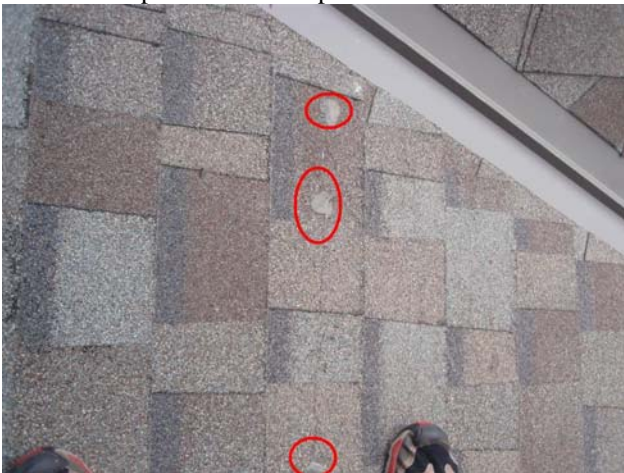
- **Monitor:** Prior repairs to the roofing are evident over the front porch roof covering. This would suggest that problems have been experienced in the past. This area should be monitored.

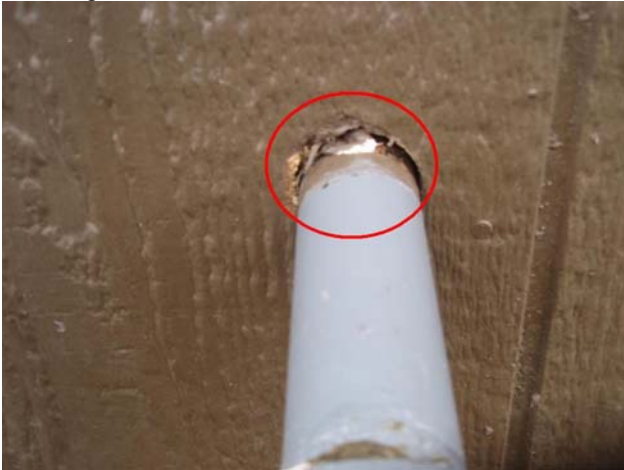
- **Repair:** Any openings in the exterior siding should be sealed. An example is where the air gas line enters the house. Caulking is needed.

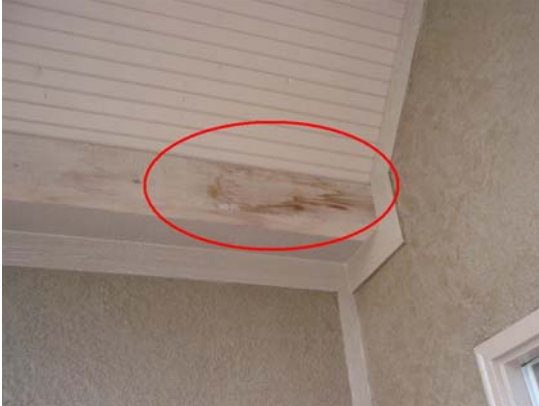
- **Monitor:** Water stain at the porch cover support beam near the front porch was observed. See roofing section of report regarding previous repairs above this location.

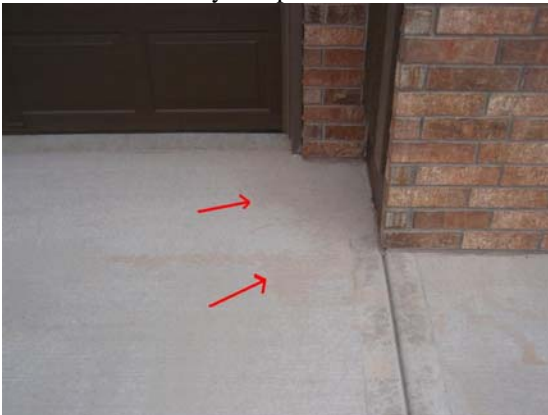
- **Note:** The driveway and porch surface was observed to have minor paint staining.

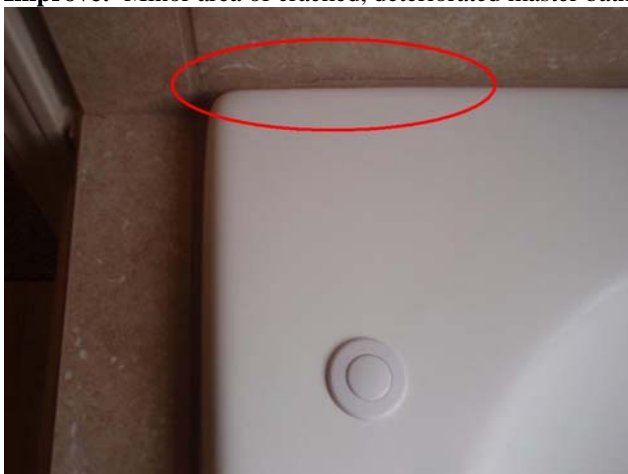
- **Repair:** Hot and cold are reversed at the jack and jill bath shower.
- **Improve:** Minor area of cracked, deteriorated master bathtub enclosure caulk could be improved.

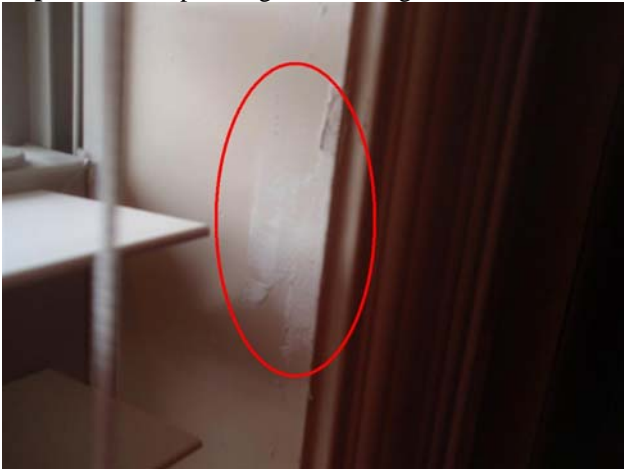
- **Improve:** The spackling at the dining room interior window trim could be improved. Repair is discretionary.
