Star Home Inspection Services

Home Inspection Report

9600 W 129th St Overland Park, KS 66213

Report Number: 04052010-1A

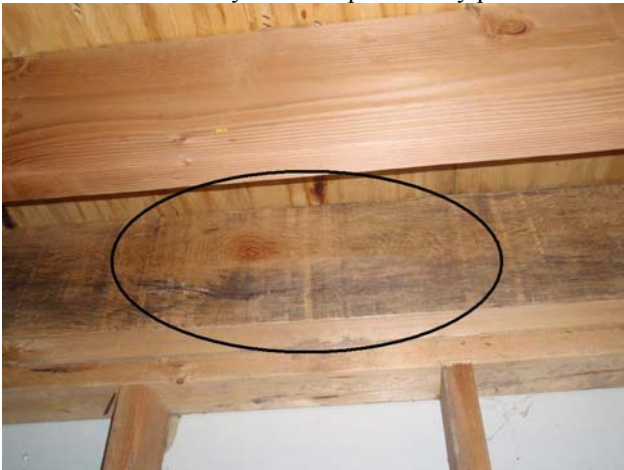
- **Monitor:** Some of the metal support columns in the basement supporting the main beam are out of plumb. No evidence of significant structural movement was observed.
- **Monitor:** Construction mold was visible on some floor joists. This is mold that grows on the lumber while lying in the weather during construction. Most homes have some level of this mold and it goes dormant once removed from the elements and normally does not present any problems.

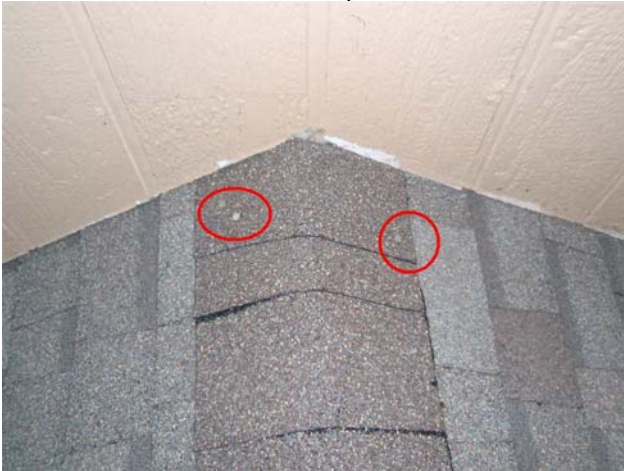
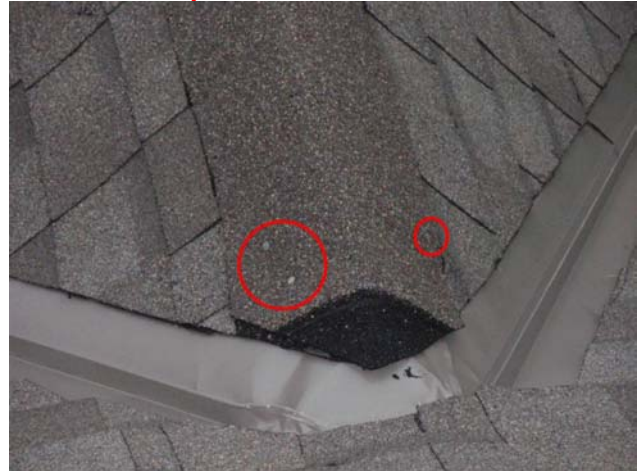
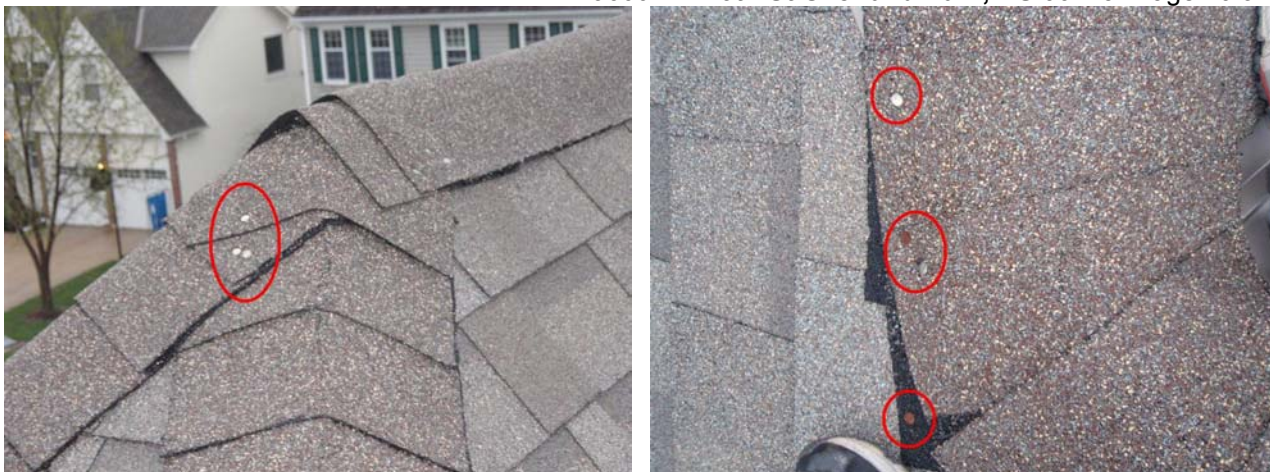
- **Recommend:** Exposed nail heads were observed in the roofing shingles and/or ridge caps. All exposed nail heads should be caulked to reduce the potential of leaks. **REPAIRED – caulked exposed nail heads**

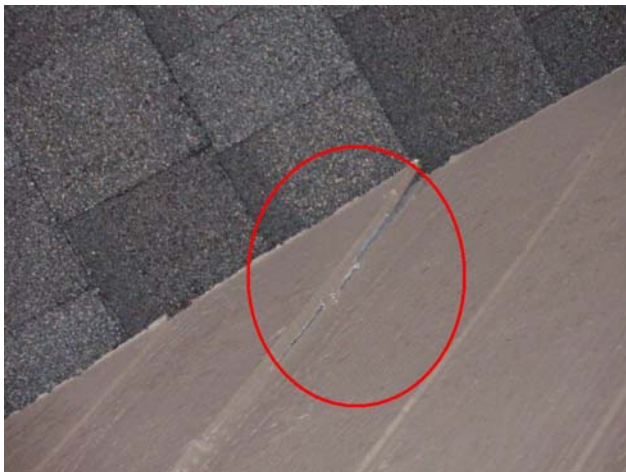
- **Repair:** Siding of this type requires considerable monitoring and maintenance. It has a tendency to pop out past nail heads creating a space where two panels join together. Re-securing and caulking the seams and nail holes is standard maintenance for this type of siding (i.e. area at east side roof step up siding.) **REPAIRED – re-secured and caulked seams and nail holes**

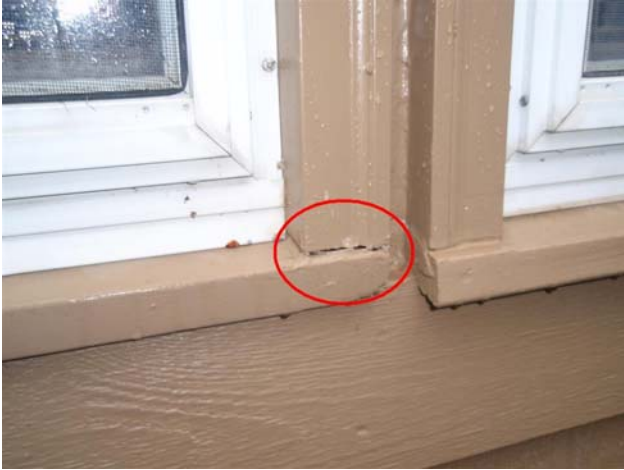
- **Repair:** The window trim at the west side requires caulking. **REPAIRED**

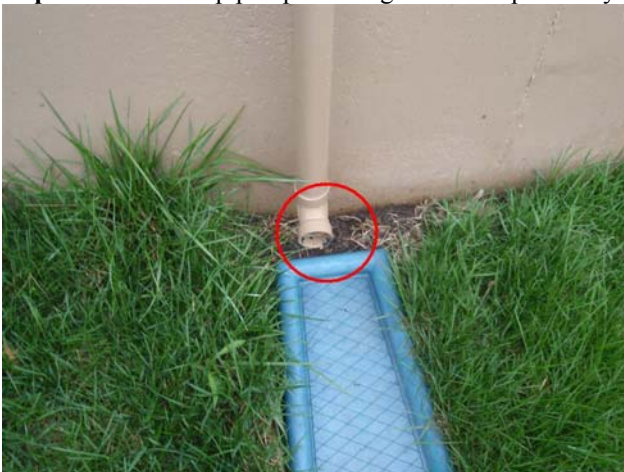
- **Monitor:** The grading should be maintained to promote the flow of storm water away from the house. This can often be accomplished by the addition of top soil. The ground should slope away from the house at a rate of one inch per foot for at least the first five feet. At least eight (8) inches of clearance should be maintained between soil level and the bottom of exterior wall siding. *It should be understood that it is impossible to predict whether moisture penetration will pose a problem in the future. If another rain occurs before closing, it's recommended the basement be viewed again for any signs of moisture penetration.*
- **Improve:** The sump pump discharges in close proximity to the foundation. Recommend an extension tube be added.
