Home Inspection Report

9601 Riggs St, Overland Park, KS 66212

Inspection Date: 3/5/2009

Report Number: 03052009-2A

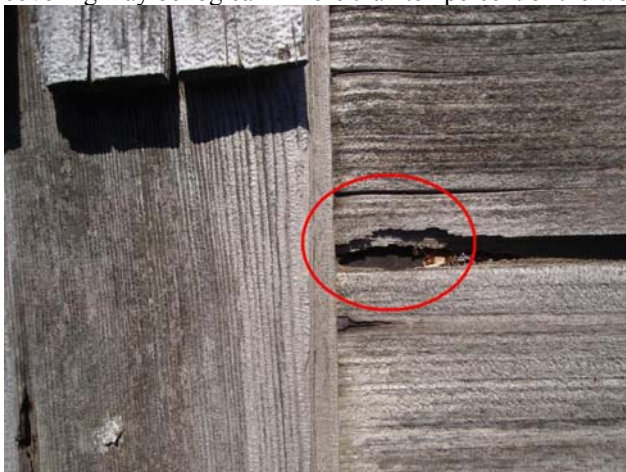
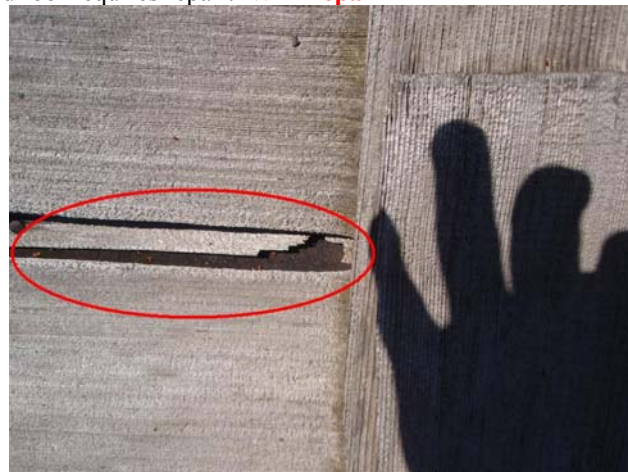
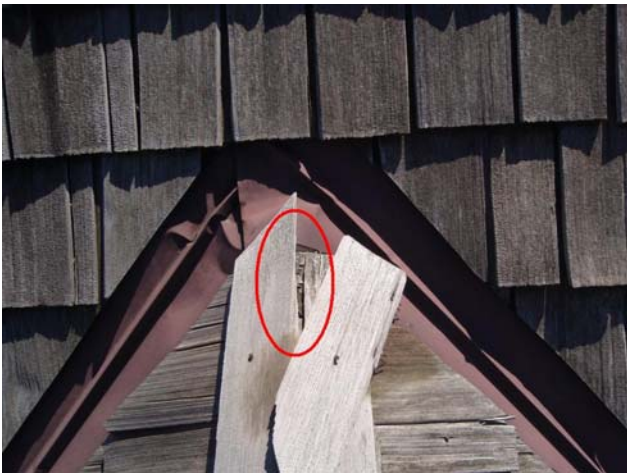
Sloped Roofing

- **Monitor, Repair:** Minor repairs to the roofing are needed. Damaged or missing roofing material should be repaired. Exposed sheathing is visible where the roofing is damaged. Damaged or missing roofing material should be repaired. Split, loose or damaged ridge caps of the roofing require repair. The life expectancy of wood roofs is generally 15 to 20 years. This will depend on several factors such as the quality of shingle or shake, the slope of the roof (steeper is better), the amount of exposed shingle, and the amount of sun or shade. As with all roofs, annual maintenance is needed. Cracked, curled, or displaced shingles or shakes should be repaired. As a rule of thumb, replacement of the entire roof covering may be logical if more than ten percent of the wood roof requires repair. **Will Repair**

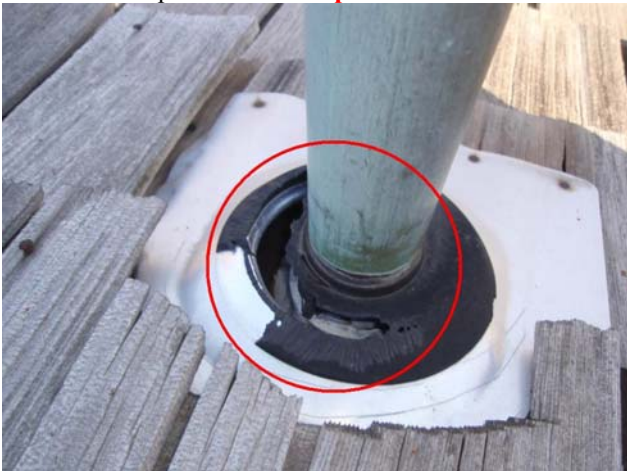
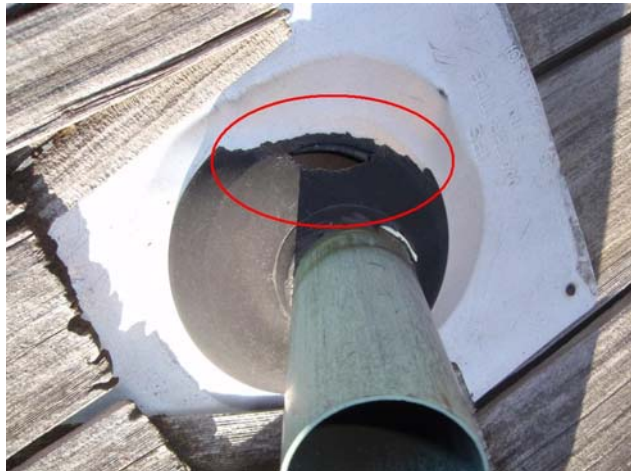
Flashings

- **Monitor, Repair:** The plumbing vent flashing boots are split making them vulnerable to leaks. It's recommended that the boots be replaced. **Will Repair**

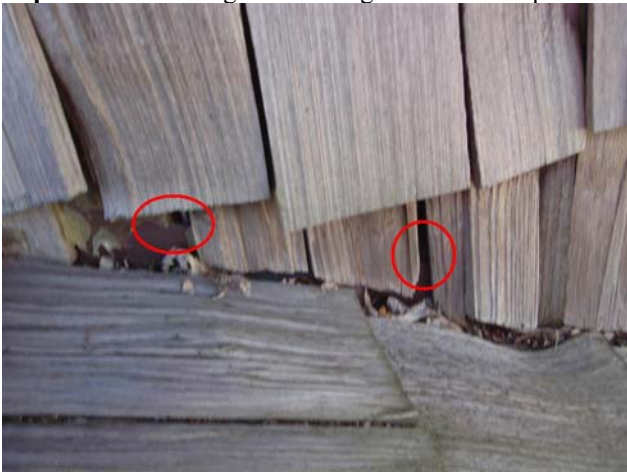
- **Repair:** The flashing at the siding over the front porch should be caulked to avoid leaks. **Will Repair**

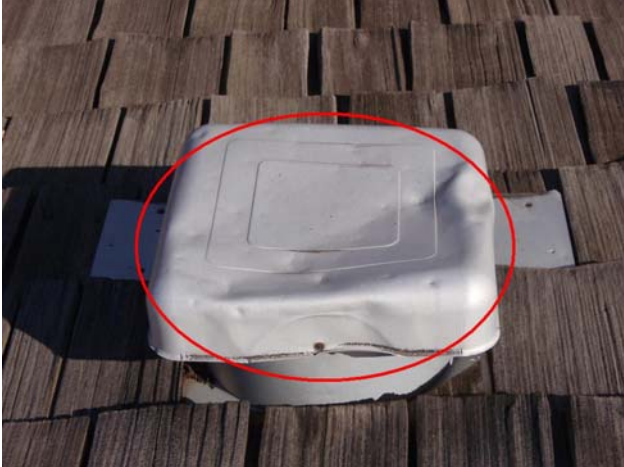
- **Monitor:** The roof vent shows evidence of hail damage. This is cosmetic. Repairs are discretionary.

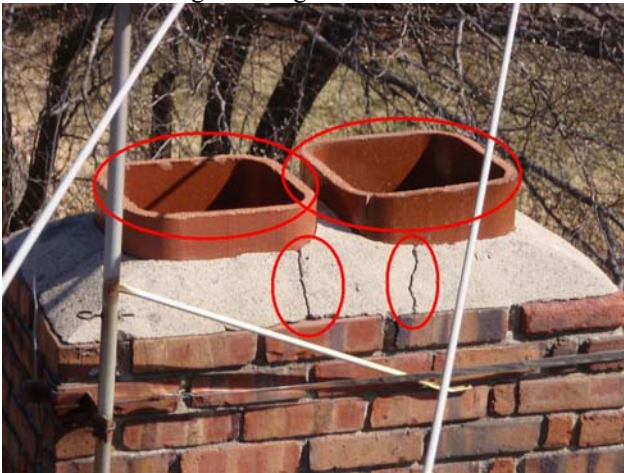
Chimneys

- **Monitor, Repair:** The cap of the masonry chimney is cracked. These cracks should be sealed or caulked before winter to prevent damage from freezing water. **Will Repair**
- **Repair:** A rain cap and vermin screen should be installed on the masonry chimney and the chimney flue should be checked for damage. Damaged flues can be unsafe. **Will Repair & will sweep chimney**

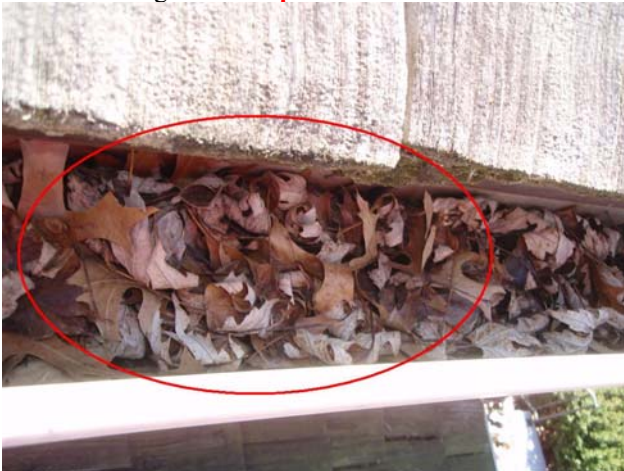
Gutters & Downspouts

- **Repair:** The gutters require cleaning to avoid spilling roof runoff around the building – a potential source of water entry or water damage. **Will Repair**

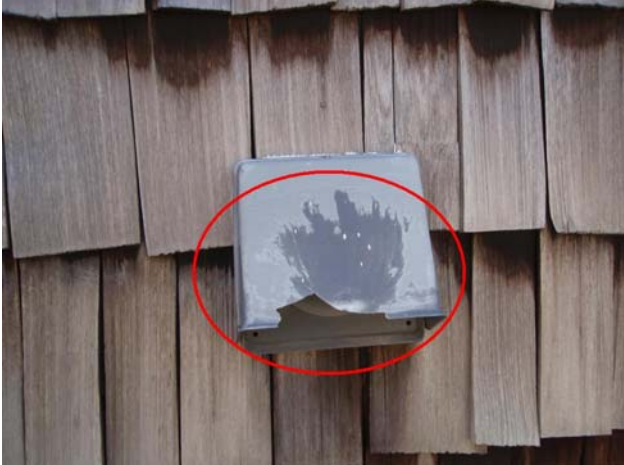
Exterior Walls

- **Improve:** The cooktop downdraft exterior vent cover is damaged.

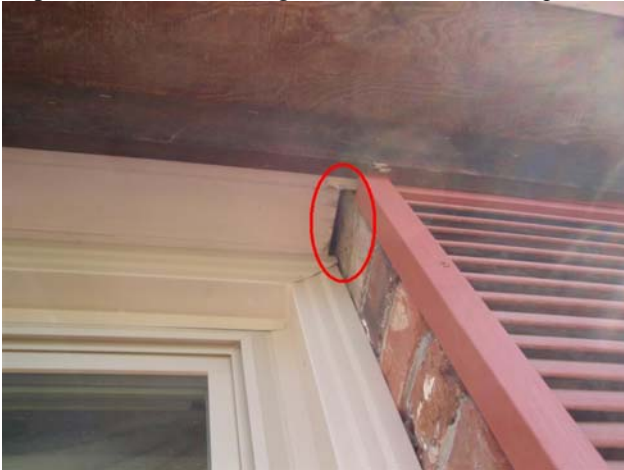
Windows

- **Improve:** The front living room north window requires caulking at the top corners. **Will Repair**

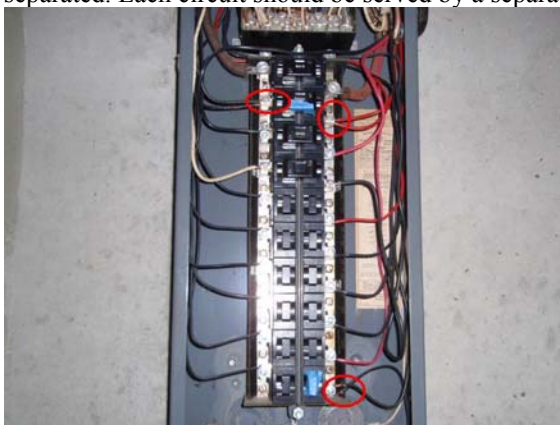
Main Panel

- **Repair:** Circuits within the main distribution panel that are doubled up (referred to as "double taps") should be separated. Each circuit should be served by a separate fuse or breaker. **Will Repair**

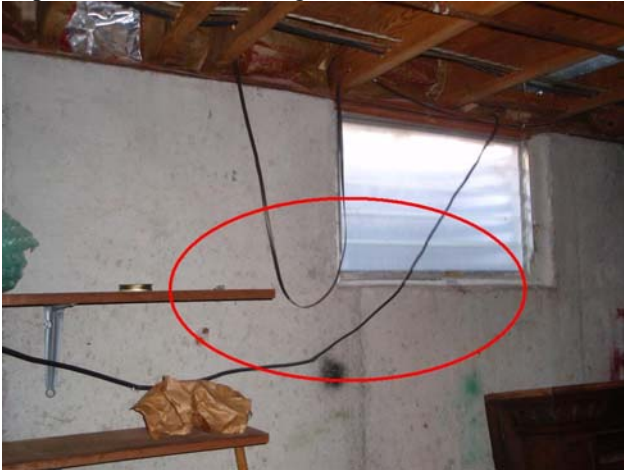
Distribution Wiring

- **Repair:** Loose cable wiring in the basement should be secured. **Will Repair**

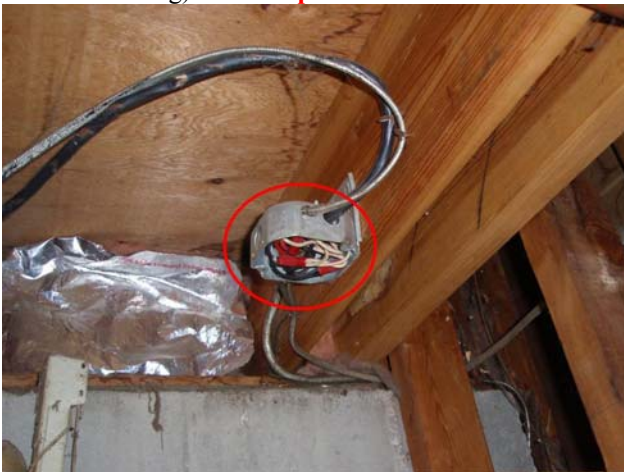
- **Repair:** All junction boxes should be fitted with cover plates, in order to protect the wire connections (example at basement ceiling). **Will Repair**

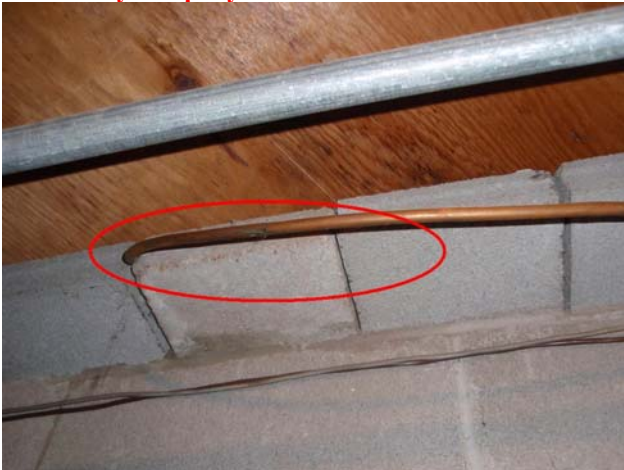
Gas Piping

- **Monitor, Repair:** Copper tubing is no longer suitable for gas piping in some gas utility locations. It's recommended to check with the local gas utility company regarding the suitability of this piping servicing the fireplace. **Will contact local utility company**

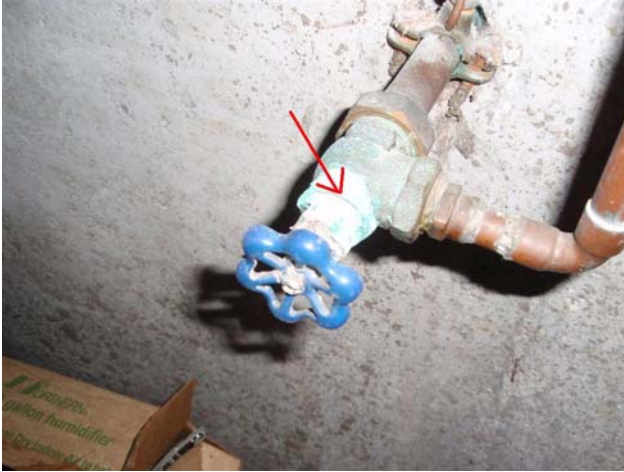
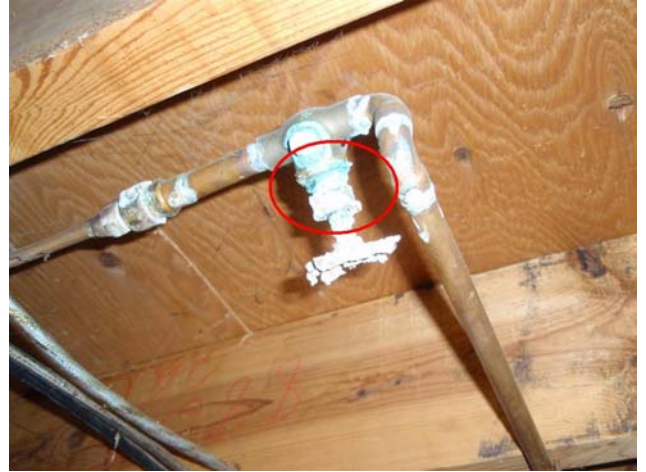
Supply Plumbing

- **Monitor:** The supply piping shows evidence of previous leakage at the handle at main supply and at shutoff supply handle to the dishwasher.
