Star Home Inspection Services

Home Inspection Report

9700 W 105th St Overland Park, KS 66212

Report Number: 02192010-1A

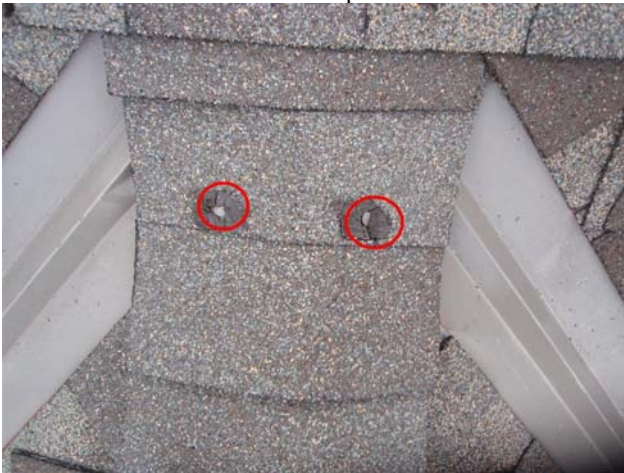
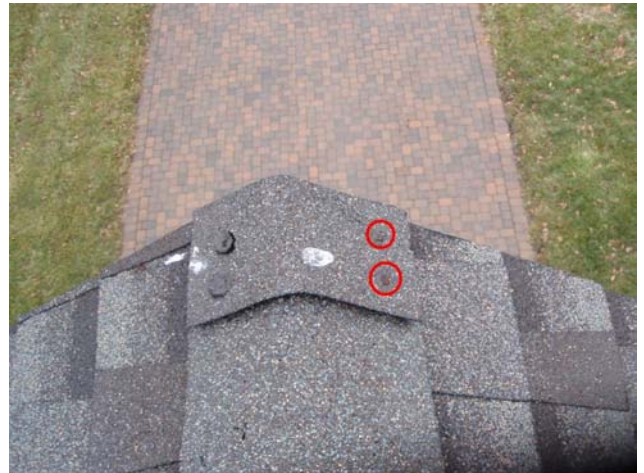
- **Recommend:** Exposed nail heads were observed in the roofing shingles and/or ridge caps. All exposed nail heads should be caulked to reduce the potential of leaks. **REPAIRED**

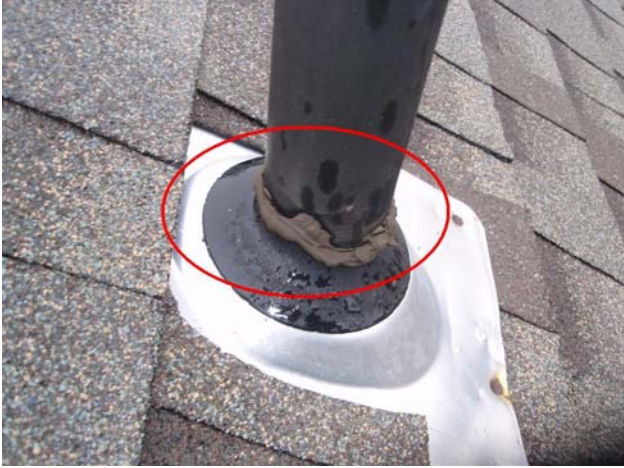
- **Monitor:** The plumbing vent flashing boots have been caulked and may be vulnerable to leaks. These flashings should be monitored closely.

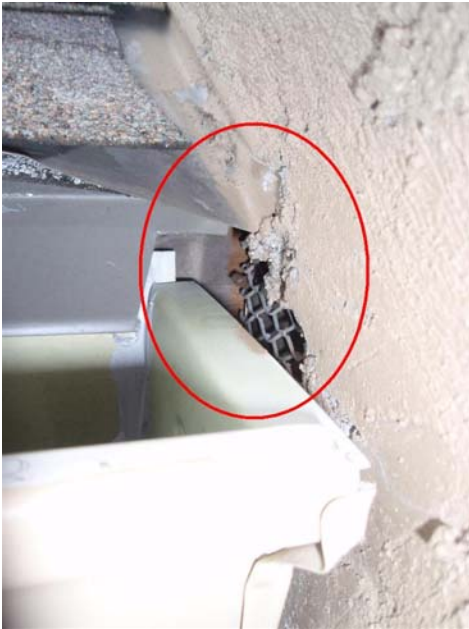
- **Repair:** The installation of the flashing is incomplete (kick-out/diverter flashing needed) and stucco deterioration was observed at the corner of the stucco at the gutter end cap east of the front porch. This should be repaired to avoid leaks.

REPAIRED

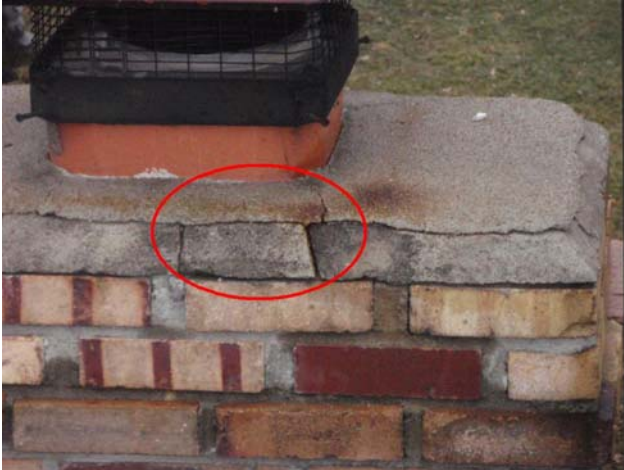
- **Monitor, Repair:** The cap of the masonry chimney is cracked. These cracks should be sealed or caulked before winter to prevent damage from freezing water. **REPAIRED**

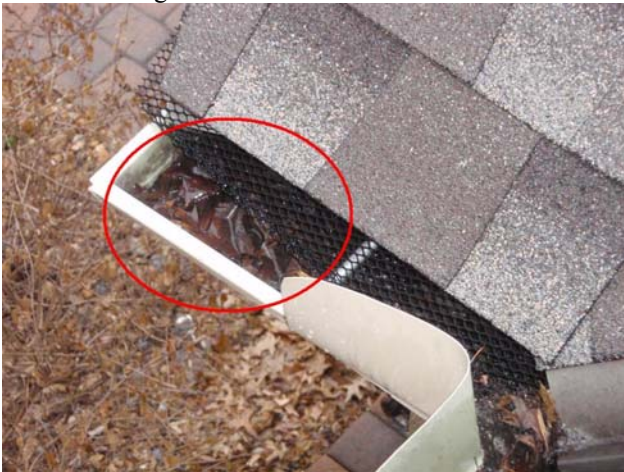
- **Repair:** The gutters require cleaning to avoid spilling roof runoff around the building – a potential source of water entry or water damage. **REPAIRED**

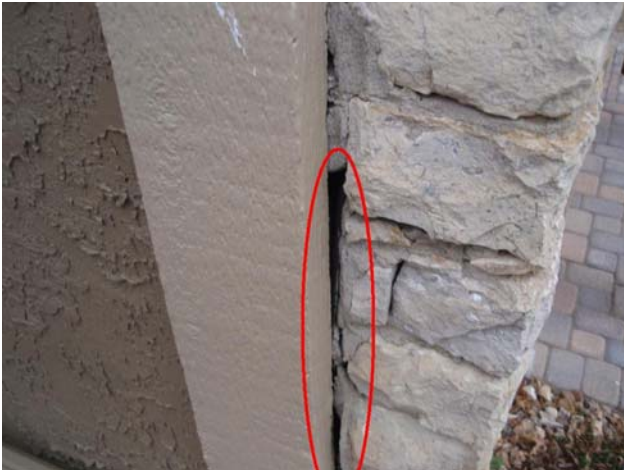
- **Repair:** Localized pointing of deteriorated mortar between the stone of the exterior wall is advisable to prevent further deterioration. **REPAIRED**

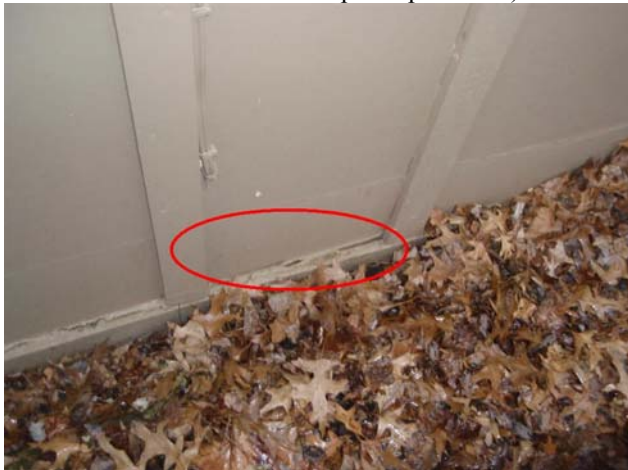
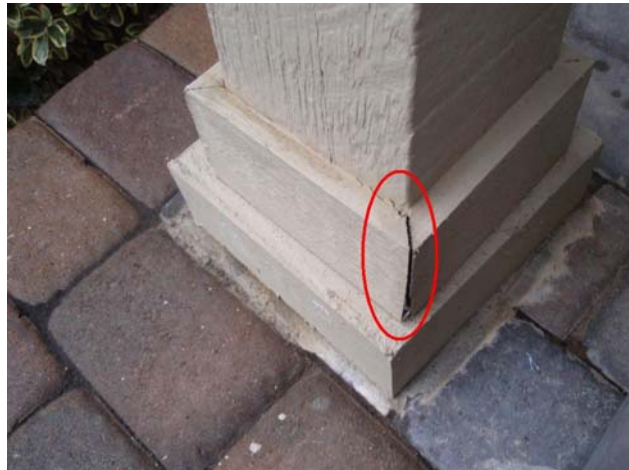
- **Repair:** Wood/soil contact at the base of the siding should be eliminated. Rotted or damaged siding that is uncovered should be repaired. These areas are at risk of additional hidden damage.
- **Repair:** The siding trim needs caulking improvements in localized areas to prevent water damage and rot (i.e. back lower horizontal trim and front porch post trim.) **REPAIRED**

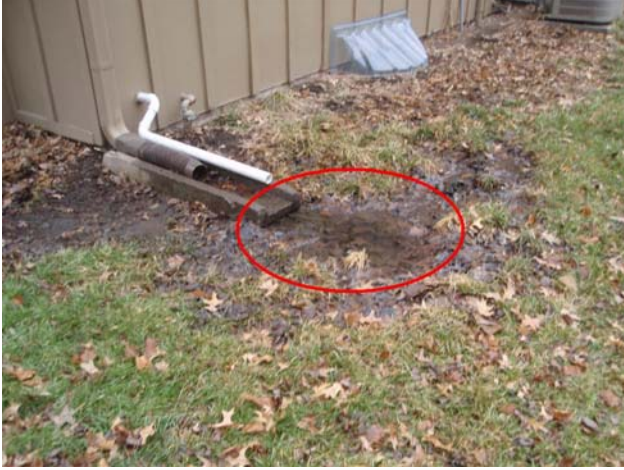
- **Recommend:** The grading should be improved to promote the flow of storm water away from the house (i.e. erosion of top soil at northwest downspout discharge.) This can often be accomplished by the addition of top soil. The ground should slope away from the house at a rate of one inch per foot for at least the first five feet. At least eight (8) inches of clearance should be maintained between soil level and the bottom of exterior wall siding. *It should be understood that it is impossible to predict whether moisture penetration will pose a problem in the future.*

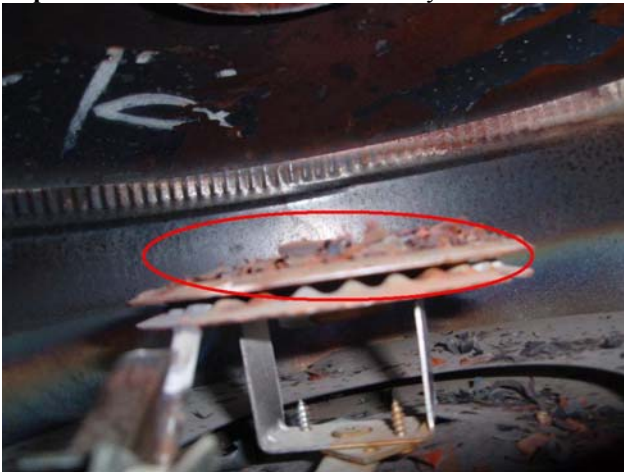
- **Monitor:** Water heaters have a typical life expectancy of 7 to 12 years. The existing unit is approaching or has exceeded this age range. One cannot predict with certainty when replacement will become necessary.
- **Repair:** The water heater burner is dirty. It should be cleaned and adjusted.
