**Star  
Home  
Inspection Services**

*Home Inspection Report*

**9733 Glenwood St Overland Park, KS 66212**

**Report Number: 02012011-2L**

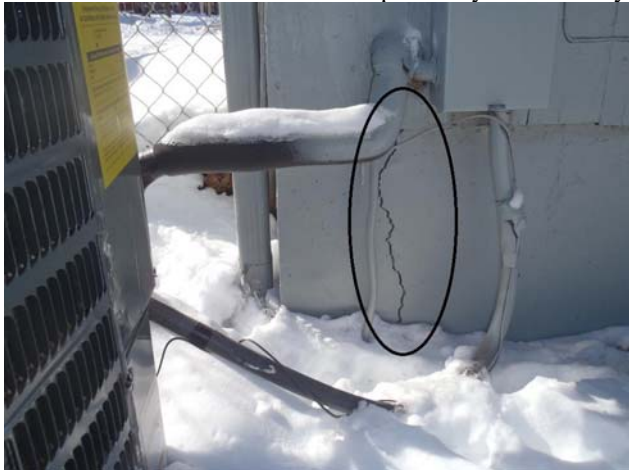
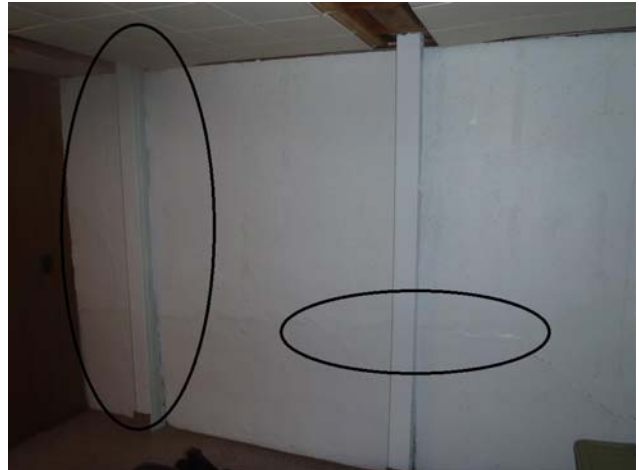
- **Monitor:** Some foundation bowing and cracking was observed. The foundation wall(s) appears to have been properly reinforced with steel beams. This damage is usually the result of excessive soil or frost pressure on the foundation. Lot drainage and foundation improvements should be monitored to keep water away from the building. If additional movement is observed more repairs may be necessary.

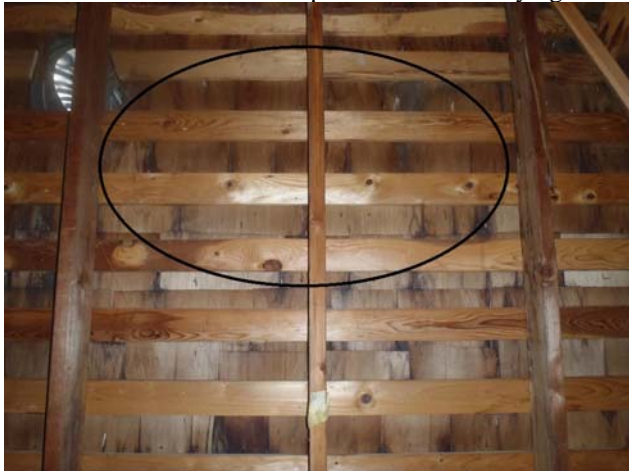
- **Note:** The composite roof has been installed over a wood shingle roof. This was an acceptable practice for many years but some insurance companies are now denying home owner coverage with this configuration.

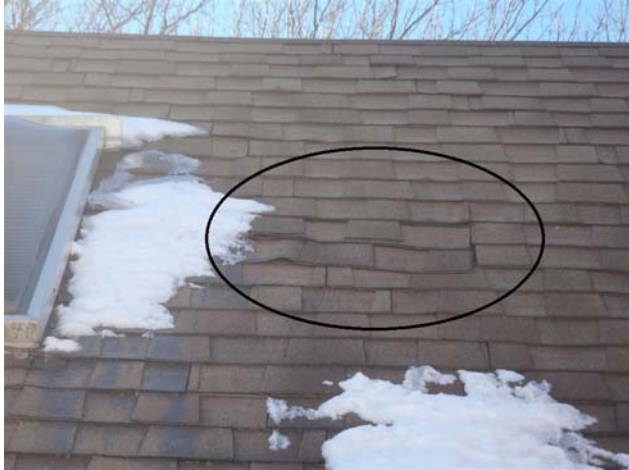
- **Monitor:** Some unevenness in the shingles was observed. This is most likely due to being installed over a wood shingle roof..

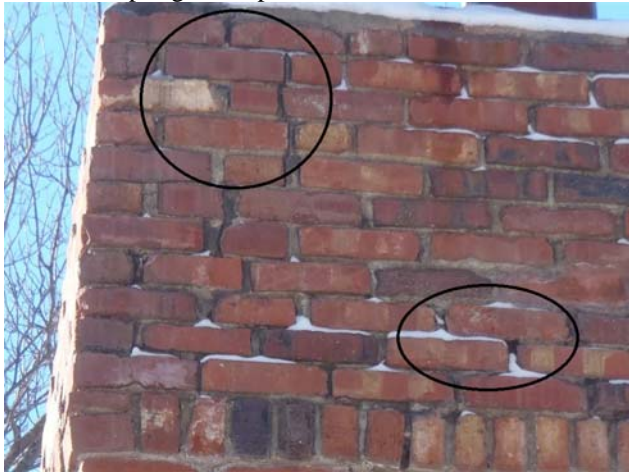
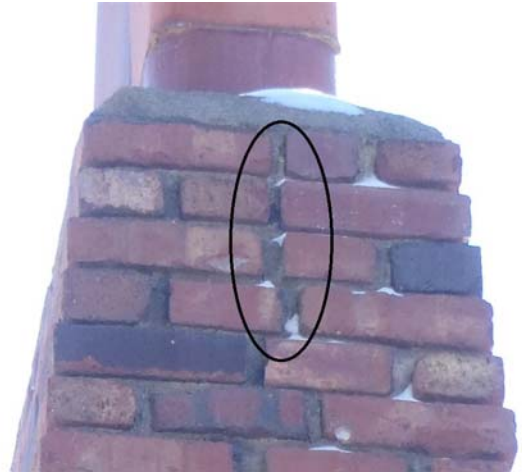
- **Monitor, Repair:** The masonry chimney shows signs of minor re-pointing (replacing the mortar between the bricks) that may be needed. Although repair is not critical at this time it should be monitored closely. A closer look is advisable in the spring and repaired at that time if needed.

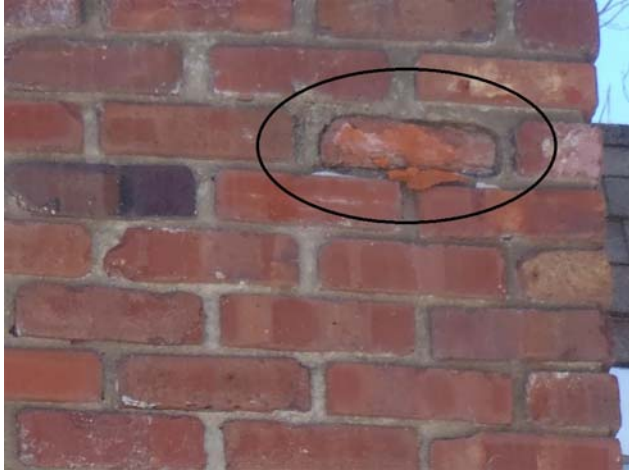
- **Monitor, Repair:** The masonry chimney shows evidence of spalling (surface deterioration of the masonry). Repair is not critical at this time but this condition should be monitored.

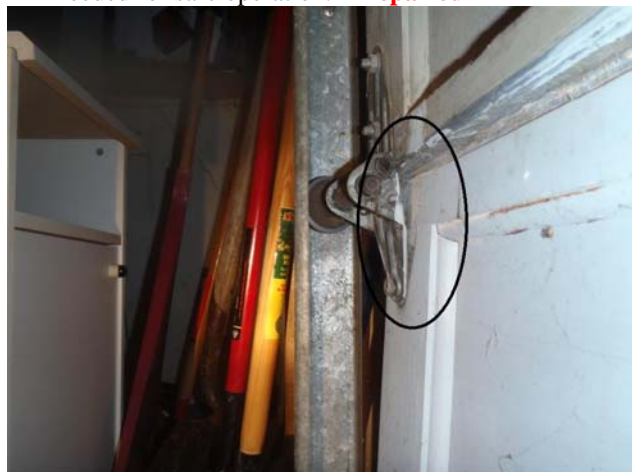
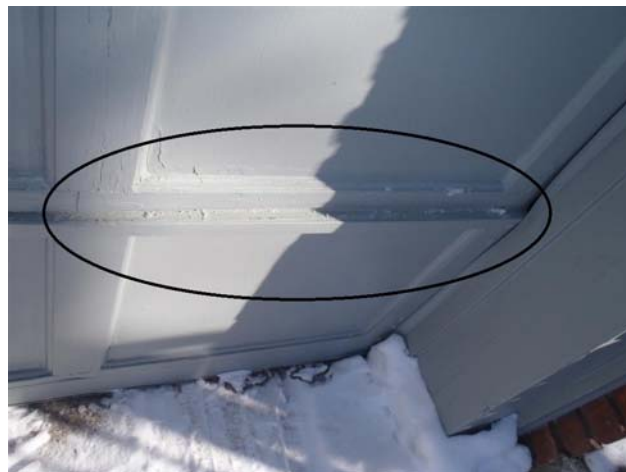
- **Repair, Safety Issue:** The lower panels on the south overhead garage door are uneven due to a loose hinge. Repair is needed for safe operation. **Repaired**

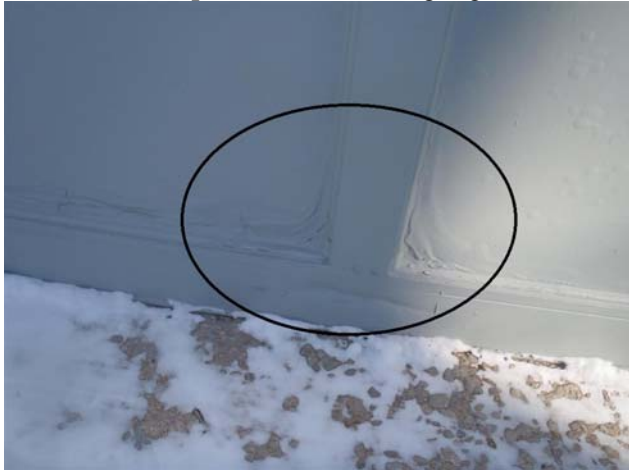
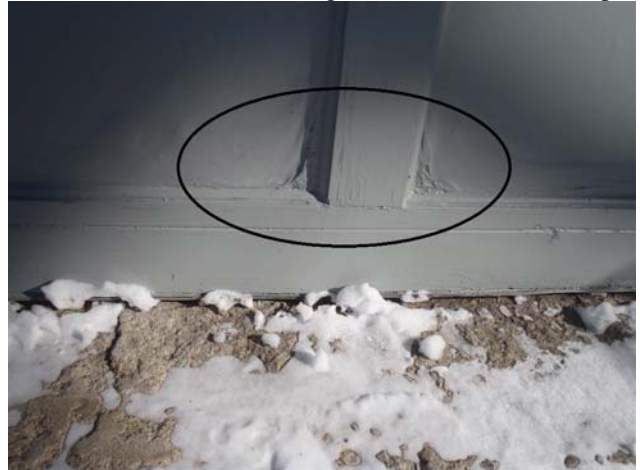
- **Monitor, Repair:** Both overhead garage doors show evidence of localized water damage and/or rot and needs repairs.

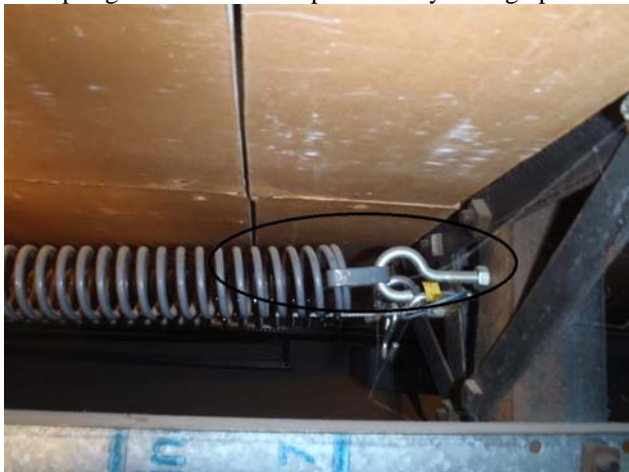
- **Repair, Safety Issue:** No safety springs/cables were noted on the south garage door springs. The installation of the springs/cables would improve safety during operation.

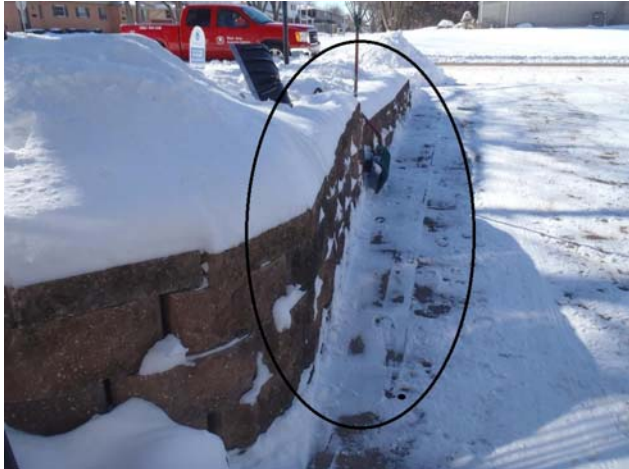
- **Monitor:** It's difficult to tell with the snow cover but the retaining wall may have some slight movement occurring. This condition should be monitored. It is impossible to determine the rate of movement during a one time visit to the house.

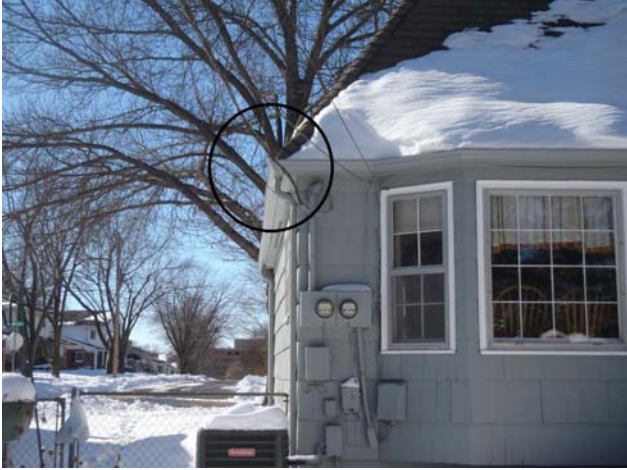
- **Improve:** The service wires do not have adequate clearance from the ground for today's standards. The top of the service mast and the service wires should be at least fifteen (15) feet from the ground. If electrical work is planned that requires a permit the home owner may be required to improve the clearance.

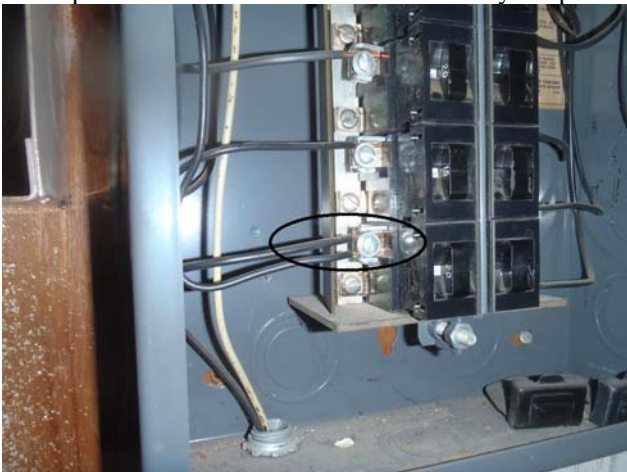
- **Repair:** Oversized breaker within the main distribution panel for the air condition should be replaced if there is no fuse or breaker in the quick disconnect outside by the unit. The data plate on the unit specifies a maximum breaker size of 30 Amps and the one in the panel is 40 Amps.
- **Repair:** Circuits within the main distribution panel that are doubled up (referred to as "double taps") should be separated. Each circuit should be served by a separate fuse or breaker. **Repaired**

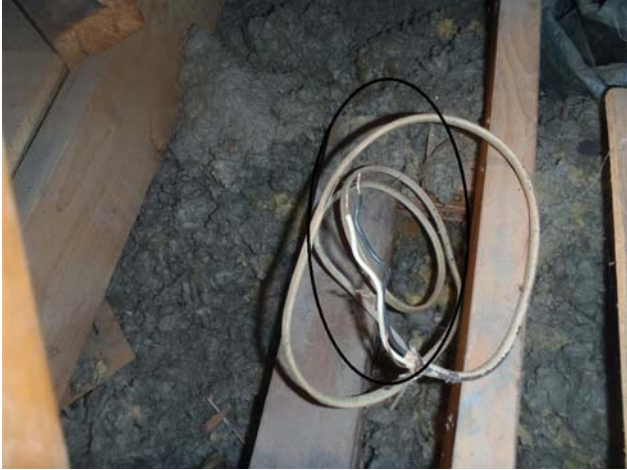
- **Repair:** Abandoned wiring in the attic should be removed or appropriately terminated. **Repaired**

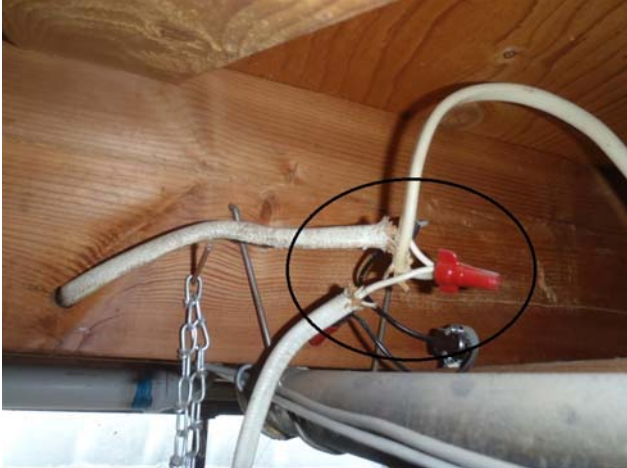
- **Repair:** Improper electrical connections over the workbench light should be repaired. All electrical connections should be made inside junction boxes fitted with cover plates. **Repaired**

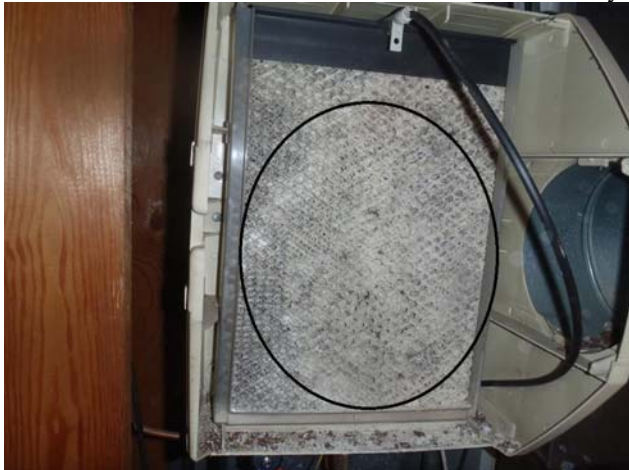
- **Repair:** The humidifier has lacked maintenance and is inoperative. Cleaning and repairs should be undertaken. Watch out for humidifier leaks into the furnace where costly (and hidden) damage can occur.

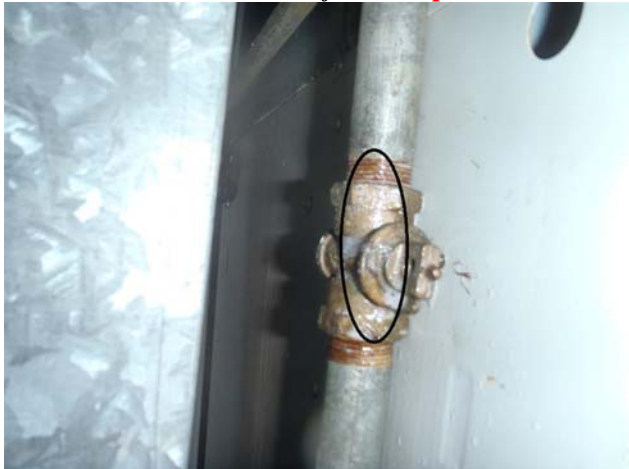
- **Repair, Safety Issue:** *A gas leak was detected with a TIF 8800 gas/carbon monoxide detector and confirmed with soapy water in the furnace shut off valve. This is a safety concern. It is recommended that the gas utility, HVAC company or plumber be engaged as soon as possible to make the necessary repairs. The current occupants of the home should also be notified. **Repaired***

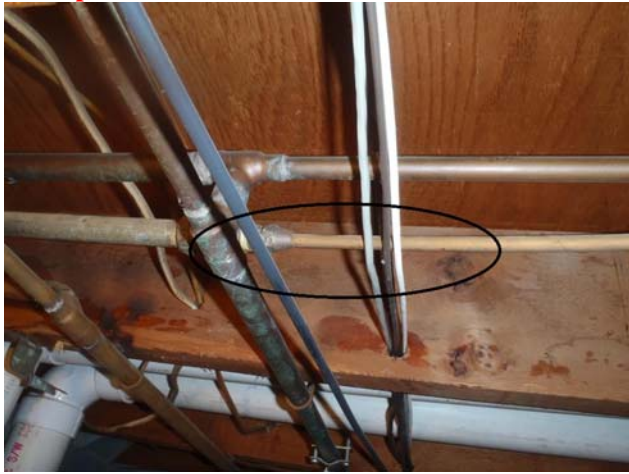
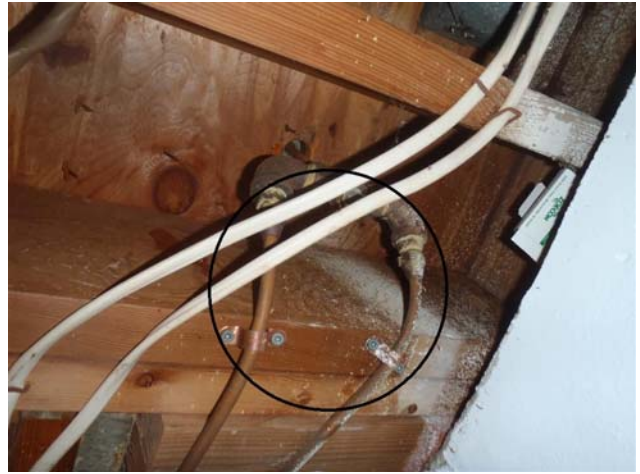
- **Monitor, Repair:** Copper tubing and galvanized steel is no longer suitable for gas piping by most gas utility companies. This should be confirmed or verified with the local gas company and if confirmed it's recommended any copper tubing or galvanized pipe be replaced with one of suitable material. **All piping approved by the Gas Company when leak repaired**

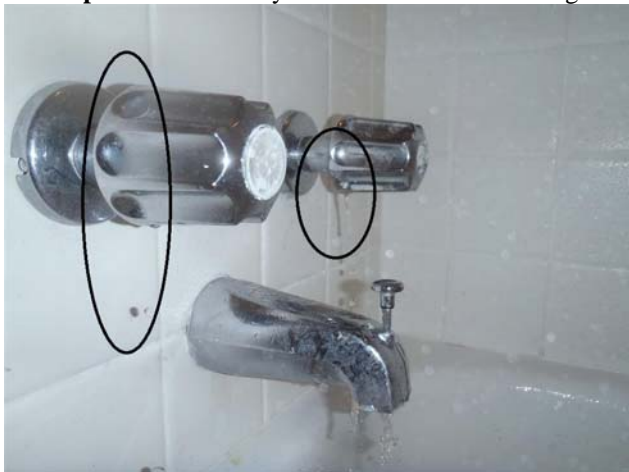
- **Repair:** The hallway bathtub faucets are leaking.

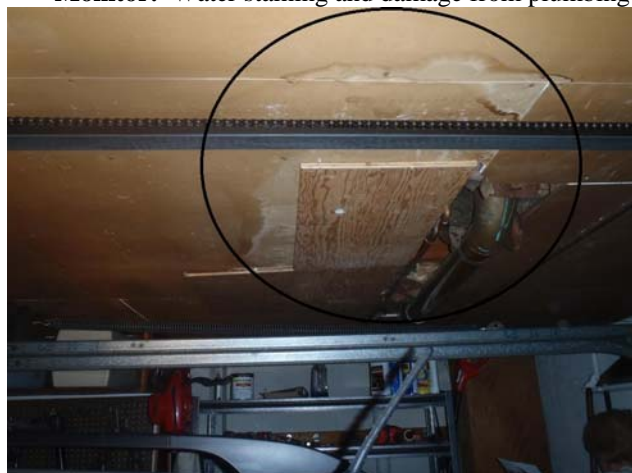
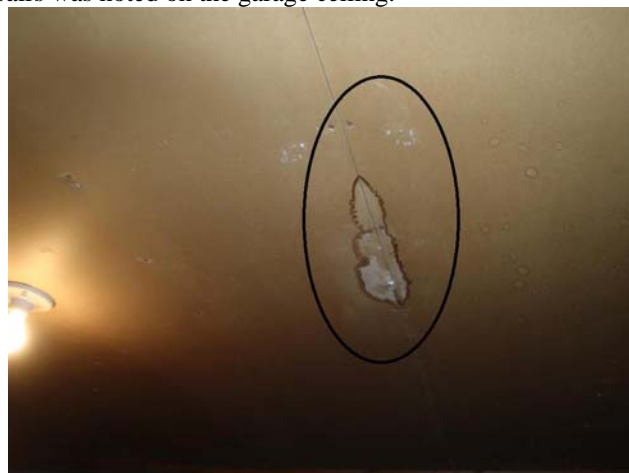
- **Monitor:** Water staining and damage from plumbing repairs was noted on the garage ceiling.

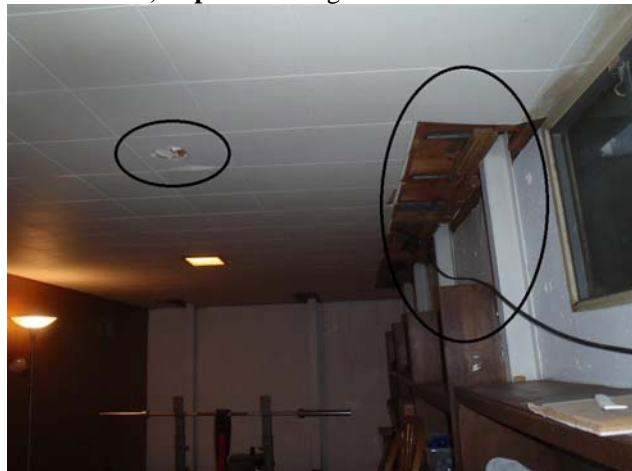
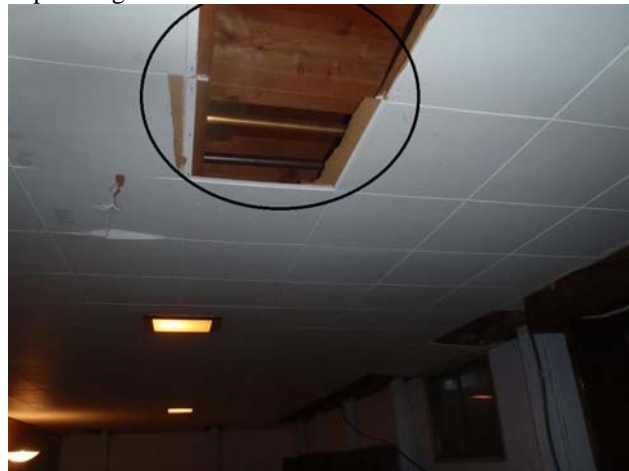
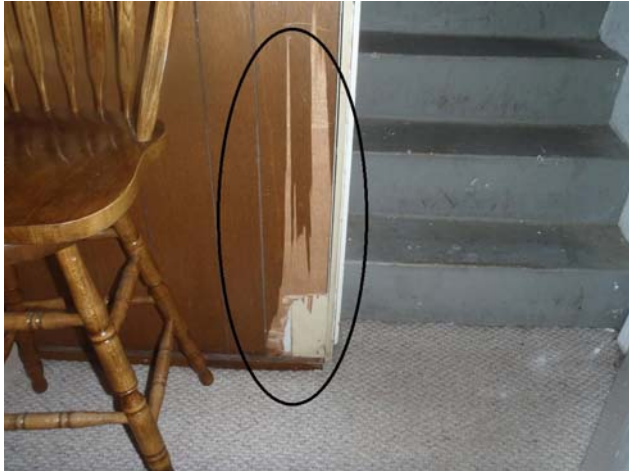
- **Monitor, Repair:** Damage to the basement tile ceiling and paneling was observed.

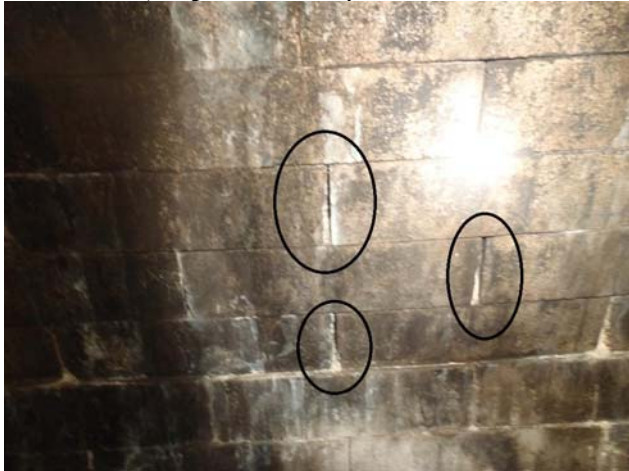
- **Monitor, Repair:** The fireplace firebox mortar should be improved.
