# Star Home Inspection Services

## *Home Inspection Report*

**9812 Linwood Blvd, Independence, MO 64052**

**Report Number: 03122009-2A**

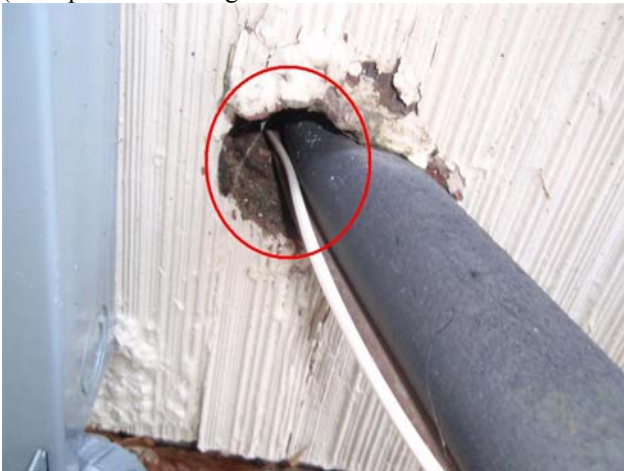
- **Improve:** All wood debris and/or trash should be removed from the crawl space. Organic debris around a property increases risk of insect or rot damage.
- **Improve:** All potential vermin entry points to the crawl space should be sealed to reduce risk of pest activity or damage (example where refrigerant lines from air conditioner enter crawl space).

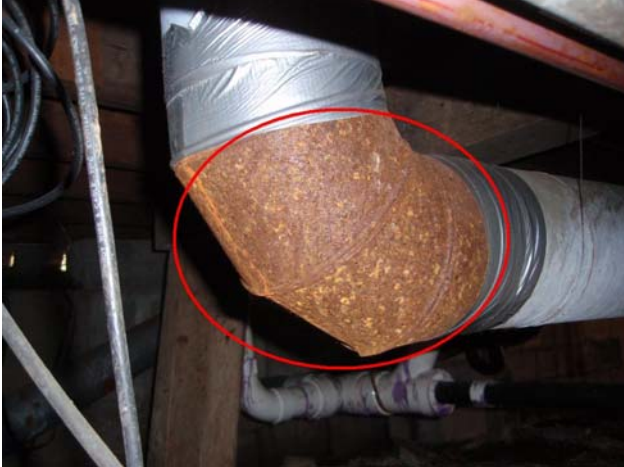
- **Monitor:** Surface corrosion of a duct elbow in the crawl space was noted.

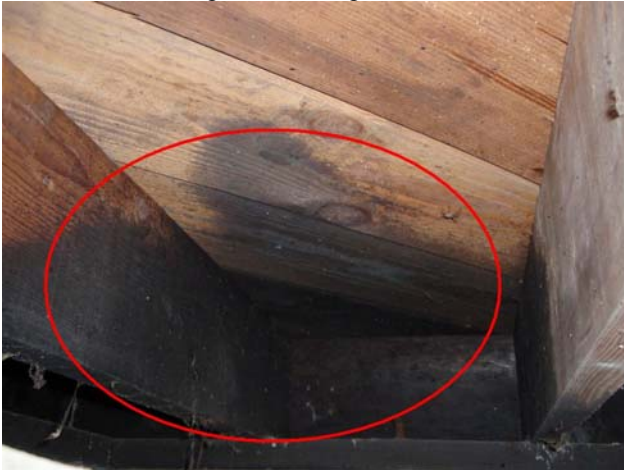
- **Monitor:** The floor structure shows evidence of previous smoke damage at the outside edges of the floor joists in the crawl space where smoke staining is present from a fire 20 years ago. This information was disclosed to the current owner of the home prior to their purchase.

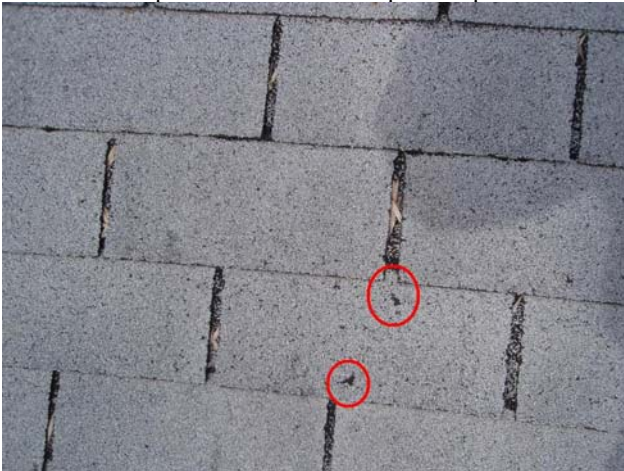
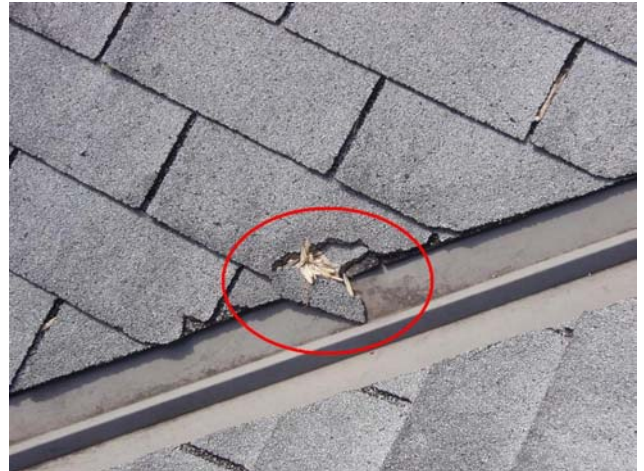
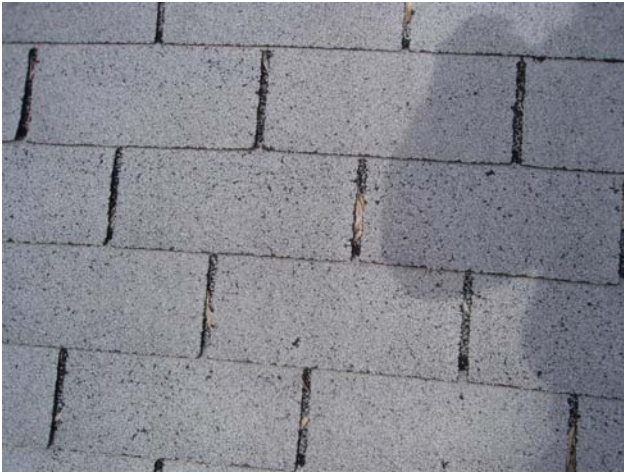
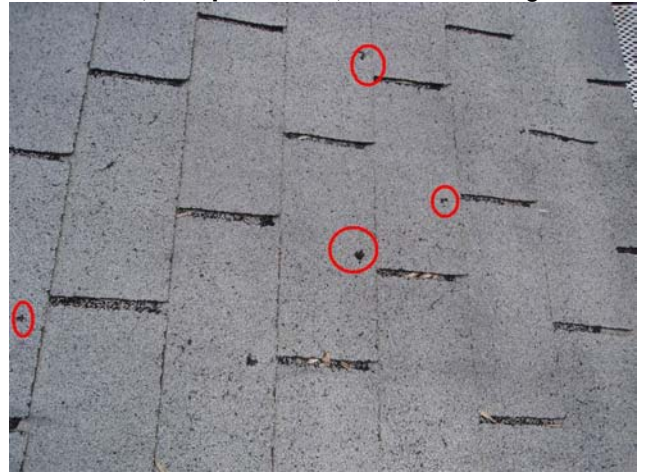
- **Monitor, Repair:** The roofing is near the end of its life. Watch for leaks and expect to replace the roof soon. Older roofs are, by their nature, a high maintenance roof. Annual inspection and repair should be anticipated. In addition, the older flashings should be monitored. In some cases, a deteriorated flashing can result in expensive repairs, because sections of the roofing have to be removed. As a rule of thumb, replacement of the entire roof covering may be logical if more than ten percent of the roof requires repair.

- It is recommended that the present layers of roofing materials be removed prior to re-roofing. This adds cost of demolition and debris removal to the re-roof cost.

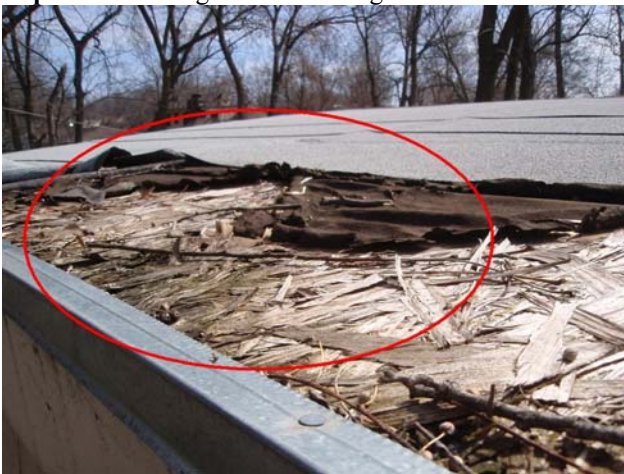
- **Repair:** Sheathing and roof damage was observed at the shed. Repairs are needed.

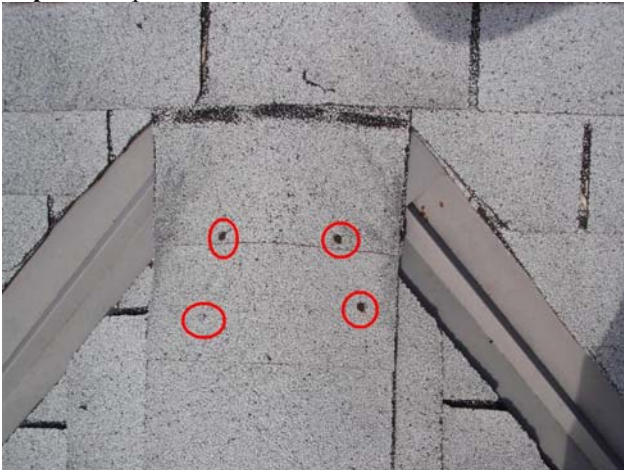
- **Repair:** Exposed nail heads were observed. These should be caulked.

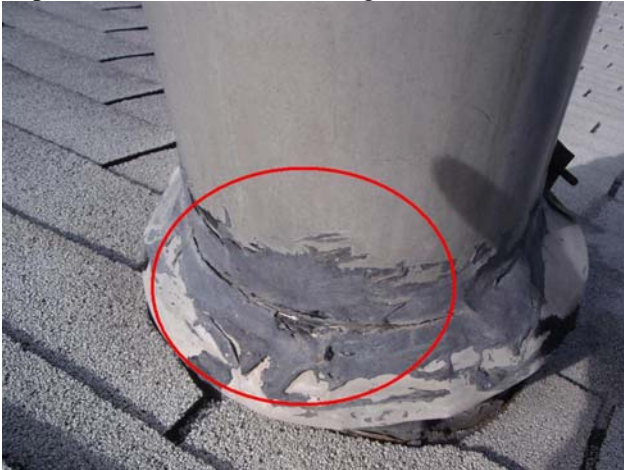
- **Repair:** The furnace vent flashing should be caulked to avoid leaks.

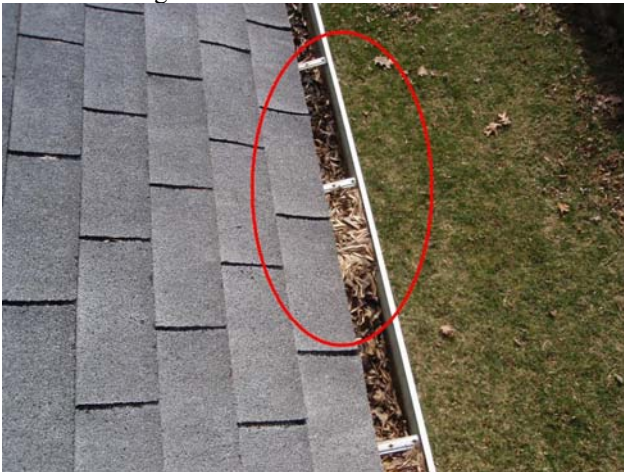
- **Repair:** The gutters require cleaning to avoid spilling roof runoff around the building – a potential source of water entry or water damage.

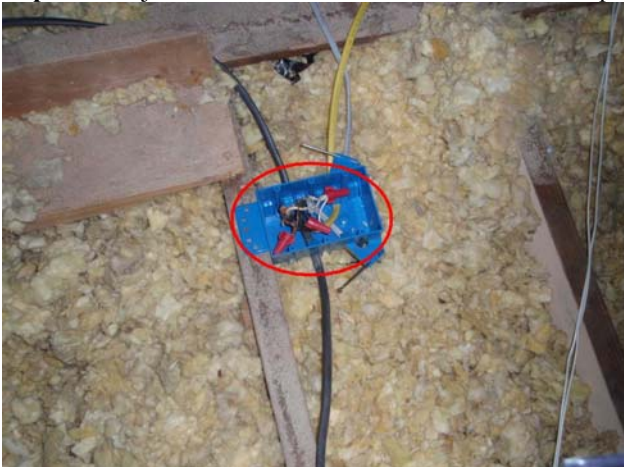
- **Repair:** Loose wiring in the crawl space should be secured.
- **Repair:** All junction boxes should be fitted with cover plates, in order to protect the wire connections (example in attic).
