**Star
Home
Inspection Services**

Home Inspection Report

9916 Lamar, Overland Park, KS 66207

Report Number: 06022008-1G

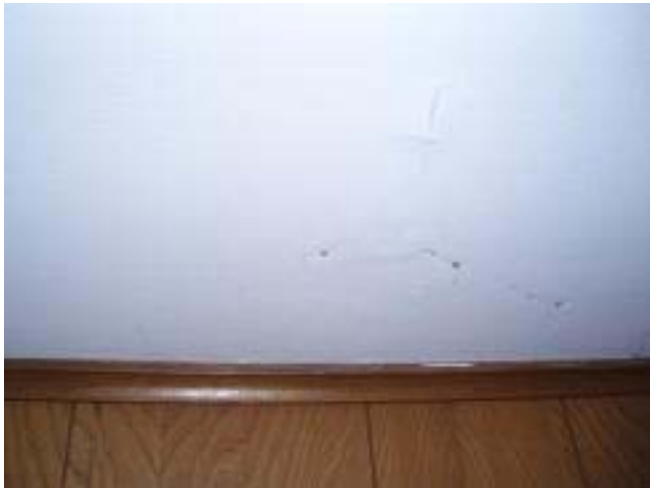
- **Repair:** Evidence of termite damage was observed and there is risk of additional hidden damage since termites can do a substantial amount of damage. If the property has not already been treated, a licensed pest control specialist should be engaged to eliminate further termite activity within the home. Damaged wood should be repaired or replaced. Any wood soil contact should be eliminated.

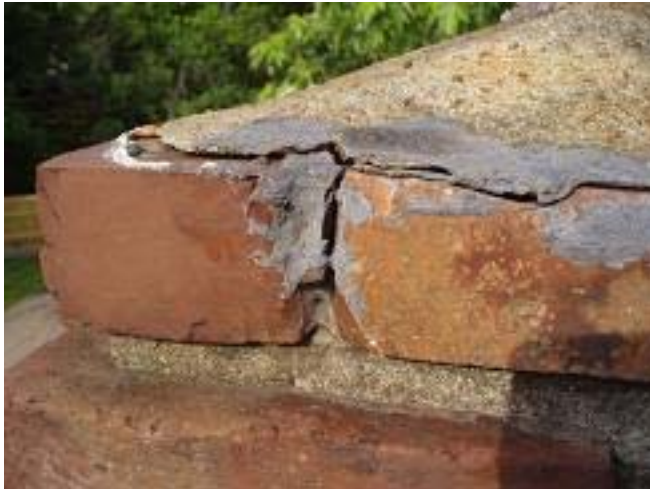
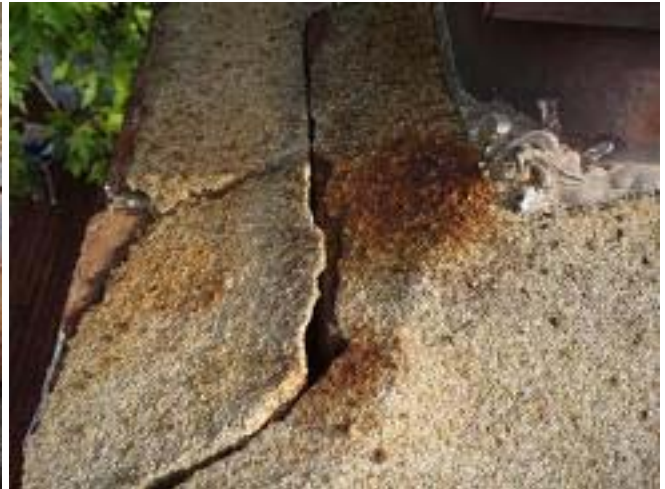
Chimneys

- **Repair:** The masonry chimney needs re-pointing (replacing the mortar between the bricks) to avoid water damage.
- **Repair:** The cap of the masonry chimney should be replaced and the chimney flue should be checked for damage. Damaged flues can be unsafe.

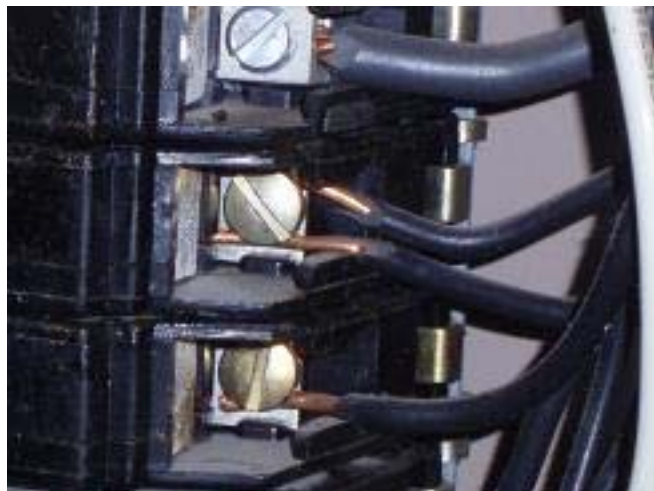
Main Panel

- **Repair:** Circuits within the main distribution panel that are doubled up (referred to as “double taps”) should be separated. Each circuit should be served by a separate fuse or breaker.

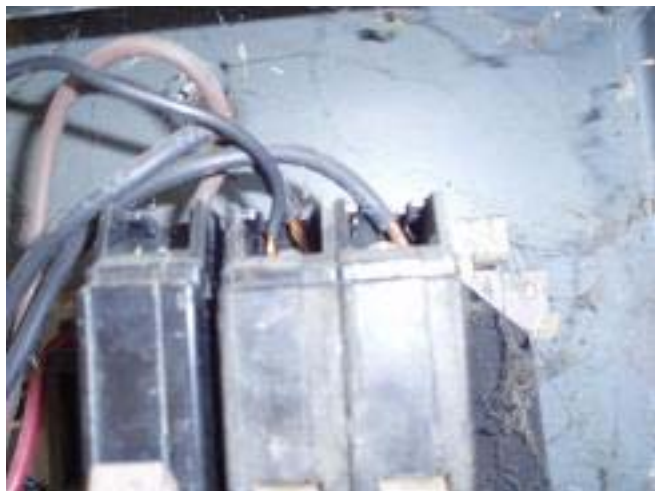
Auxiliary Panel(s)

- **Repair:** Circuits within the auxiliary panel that are doubled up (referred to as “double taps”) should be separated. Each circuit should be served by a separate fuse or breaker.

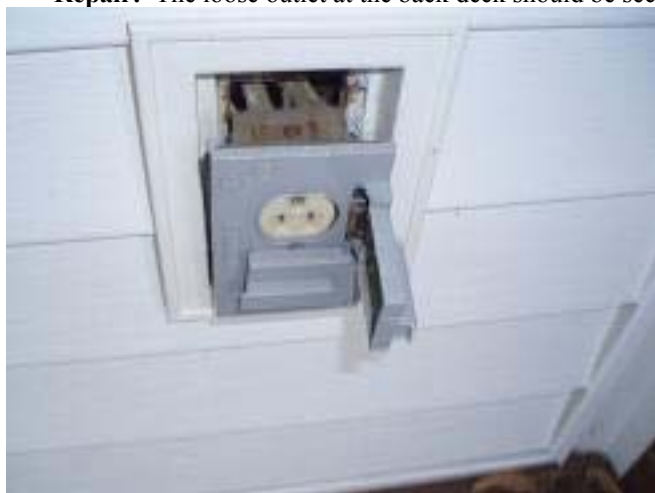
- **Repair:** A handful of outlets have reversed polarity (i.e. it is wired backwards) and are tagged RevPol. These outlets and the circuit should be investigated and repaired as necessary.
- **Repair:** The loose outlet at the back deck should be secured or replaced.

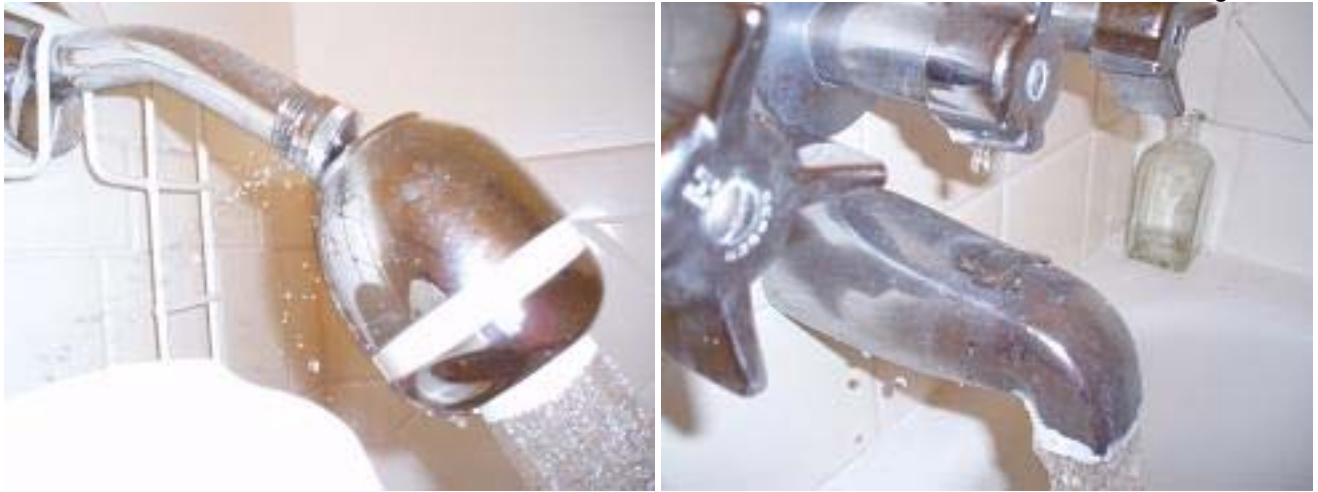
Fixtures

- **Monitor:** The majority of plumbing fixtures are older.
- **Repair:** The tub faucets are leaking.
- **Improve:** The master shower fixtures are loose.
- **Repair:** The shower head is leaky in the tub.
- **Improve:** Cracked, deteriorated and/or missing bathroom grout and caulk should be replaced.
